Alder Woodland – Tree condition assessment survey:

Mound Alderwoods Site of Special Scientific Interest and Special Area of Conservation

Commissioned Report No. 499

Hendry, S.J. & Edwards, C.E. (2012). Alder Woodland – Tree condition assessment survey: Mound Alderwoods Site of Special Scientific Interest and Special Area of Conservation. *Scottish Natural Heritage Commissioned Report No. 499*

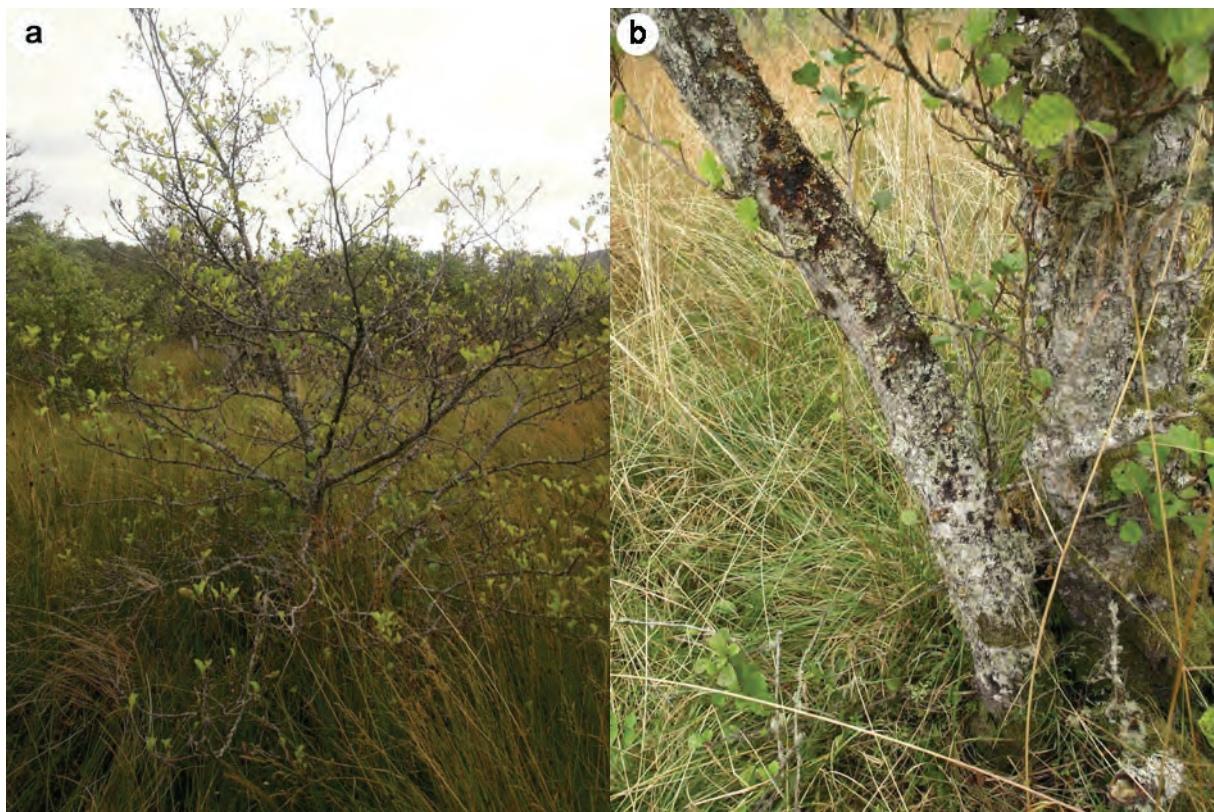
As well as the symptoms mentioned above, trees located to the north of the river Fleet (points 12-19) generally displayed a reduction in leaf size. Stem bleeding in the form of tarry or rusty spots was also evident on a proportion of symptomatic alders (Figure 3). Stem bleeding was always associated with necrosis of the underlying bark, with one or more necrotic lesions typically extending to the base of the affected stems and into one or more of the surface lateral roots (Figure 4). Thorough inspection of the root collars of symptomatic trees without stem bleeding also revealed the presence of ascending bark lesions in many cases.

Figure 3: Typical symptoms associated with dieback of alders in the northern part of the Mound Alderwoods: a. Small alder at point 13 with thin crown, small chlorotic leaves and recent mortality of fine twigs; b. Larger alder at point 19 displaying tarry / rusty spotting on stem to a height of 1.5m

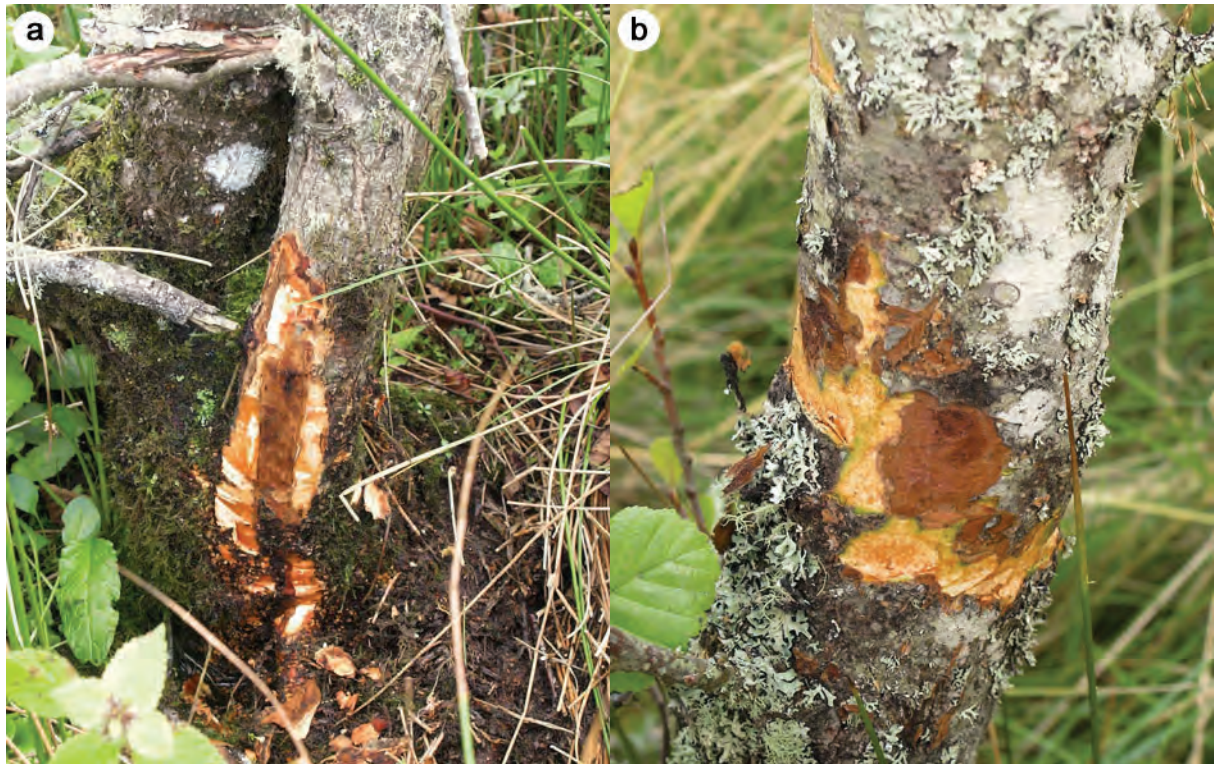
Figure 4: Bark lesions in alder stems from the area north of the River Fleet: a. Lesion extending upwards from root collar and down into surface lateral root on tree at point 13; b. Superficial lesion in outer phloem of tree at point 14.

In addition, occasional trees with tarry spots on their stems were found to have isolated superficial necrotic patches in the phloem⁴ which were not connected to more extensive stem lesions (Figure 4).

Laboratory isolations conducted on bark tissue excised from the margins of lesions on the stems of trees at points 12, 14, 15, 16, 17 and 19 yielded cultures of the alder pathogen *Phytophthora alni*. Isolations from root lesions on trees at points 13 and 19, and from soil adjacent to affected trees (containing fine root material but no structural roots) at points 15 and 19 also yielded cultures of *P. alni*. No other potential pathogens were isolated from the samples concerned, nor were any recognised foliar, shoot or bark pathogens detected on moribund⁵ or recently dead material collected from the crowns of affected trees. Whilst occasional instances of bud mining by *Epinotia tenerana* and of leaf damage likely to have been caused by *Chrysomela aenea* were noted, insect damage to the trees which were examined had been extremely light during the 2011 growing season.

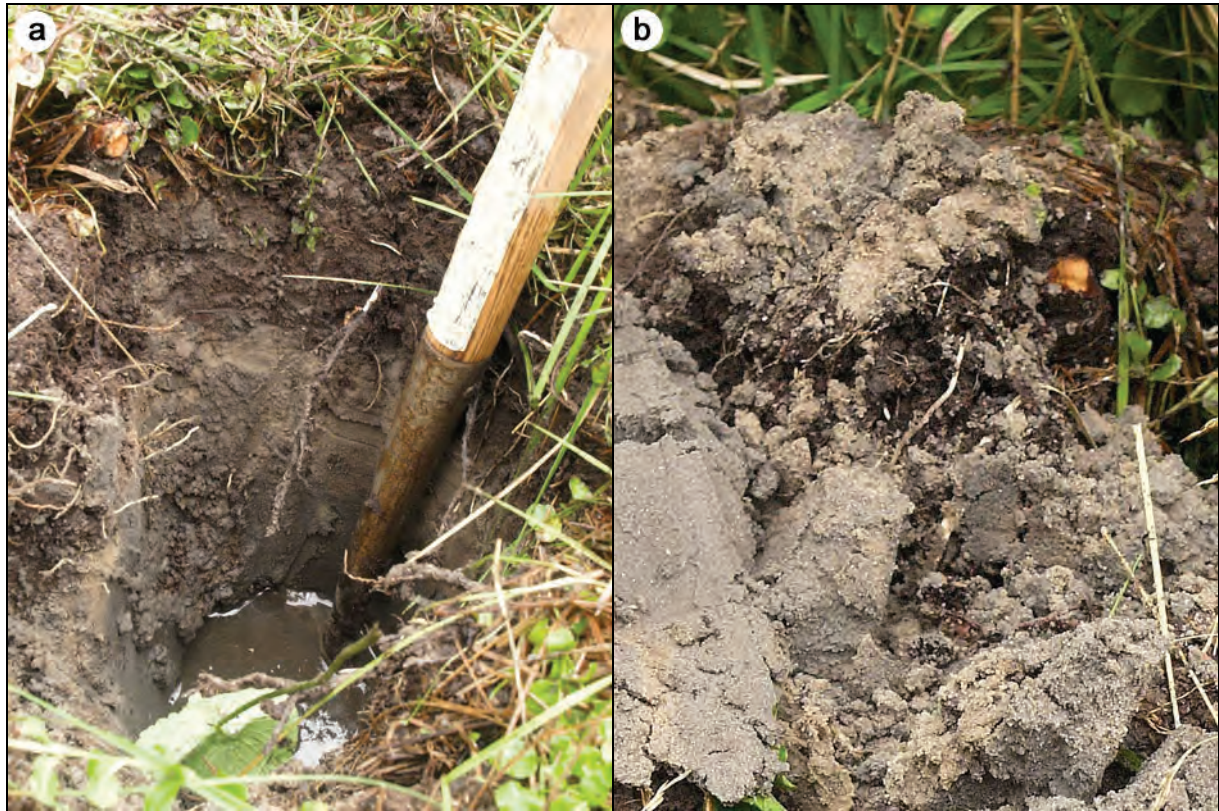
silt and well-aerated sandy layers but were not detected within the gleyed sand. No attempt was made to reveal structural roots which might have penetrated into the gleyed subsoil in order to determine their condition.

Figure 5: a. Soil pit at point 17 showing upper horizon of silt, lower horizons of well- and poorly- oxygenated sand, and water table level. Note live alder root extending from back face of pit. b. Detail of well-oxygenated (yellow) and gleyed (grey) sand.

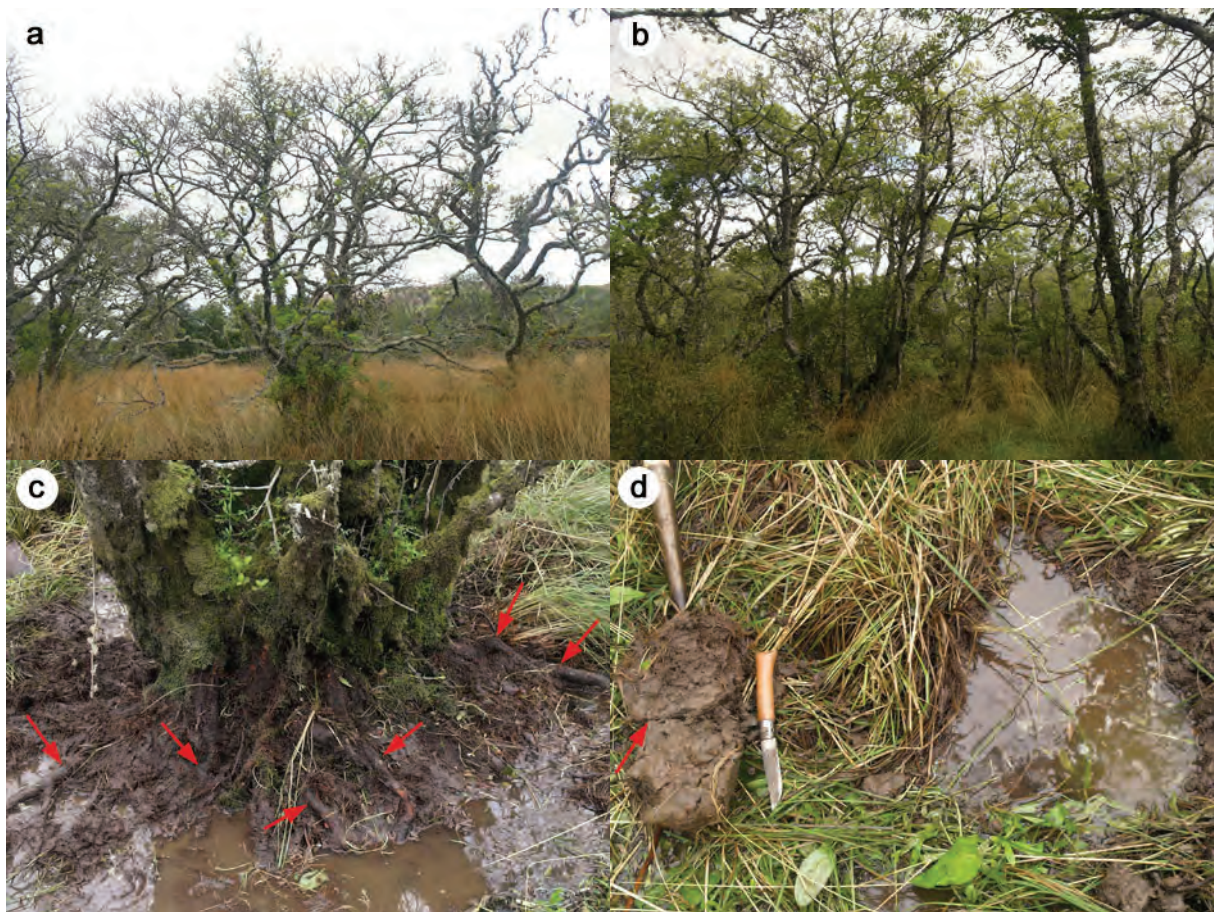
Dieback-affected trees located to the south of the River Fleet (points 4, 5 and 6 in Figure 2) did not display the consistent reduction in leaf size which was observed in declining alders on the northern side of the river. Moreover, neither stem bleeding nor stem lesions were detected on the southern trees. Instead, excavations revealed extensive mortality of the fine and structural roots with little or no bark death evident above the level of the root collar. Structural roots were typically found to be alive at their insertion points and for some distance distal⁷ to this before a region of variable length (ranging from a few centimetres to a few tens of centimetres in extent) with moribund bark was encountered (Figure 6). No sharp junction between live and moribund bark was present but a gradation of consistency and colouration was evident in both the phloem and underlying xylem⁸, with necrotic tissue becoming more water-soaked and darkly stained with distance from the root collar. Distal to this moribund region, structural roots were blackened and water-saturated with the bark often detaching from the underlying xylem which was characteristically stained a blue-black colour.

Figure 6: Typical symptoms associated with dieback of alders in the southern part of the Mound Alderwoods. a. Multi-stemmed tree near point 6 with little foliage; b. High but thin crowns of predominantly single-stemmed alders at point 4; c. Root system of tree at point 4 – structural roots are dead distal to the arrowed points; d. Soil pit indicating level of water table (right) and extracted profile (left) indicating extremely limited rooting depth (arrowed).

The poor growth displayed by affected alders in recent years, the even distribution of shoot and branch mortality throughout their crowns, the absence of any recognised shoot or bark pathogens and the progressive nature of the dieback are all indicative of root system dysfunction in these trees. The apparent absence of any root pathogens associated with the extensive root mortality which was revealed by excavation, the lack of well-demarcated lesions in dying roots, and the diffuse staining observed in the phloem and xylem of moribund and dead roots, constitute strong evidence that waterlogging is involved in the causation of dieback in the area south of the River Fleet. Study of the soil in this area confirms that the water table is elevated and the soil profile below about 30cm is anoxic.

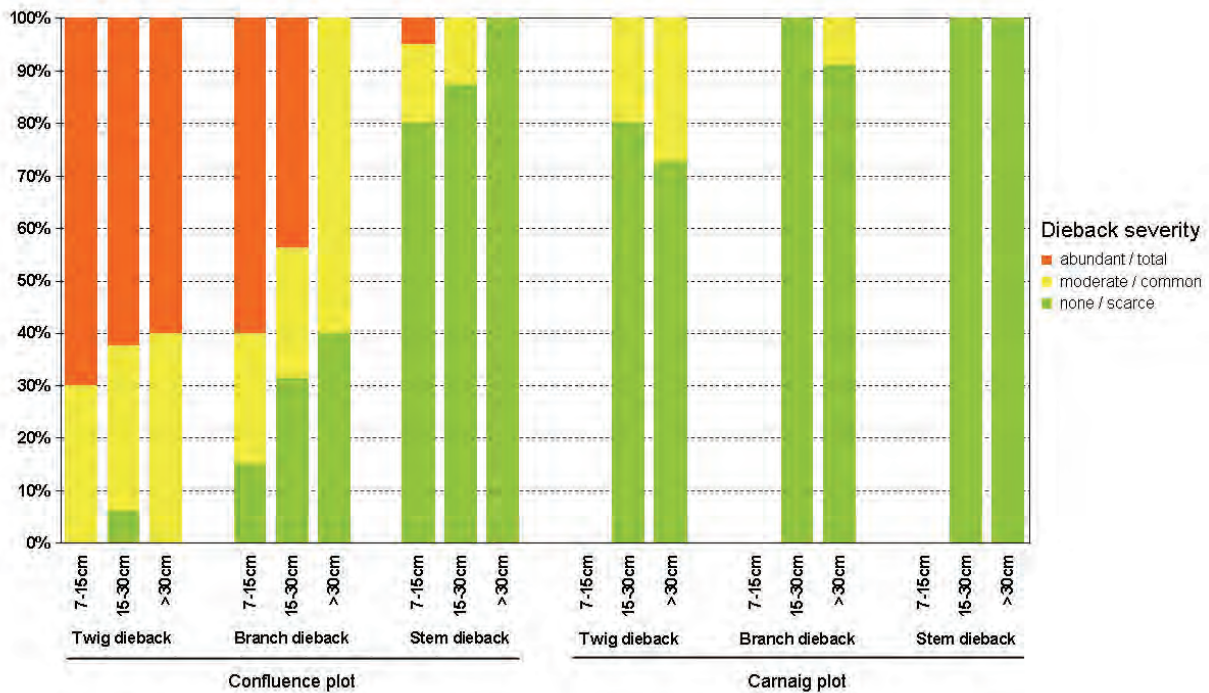
Figure 7: Proportions of living stems in different diameter classes displaying twig, branch and stem dieback of varying severities

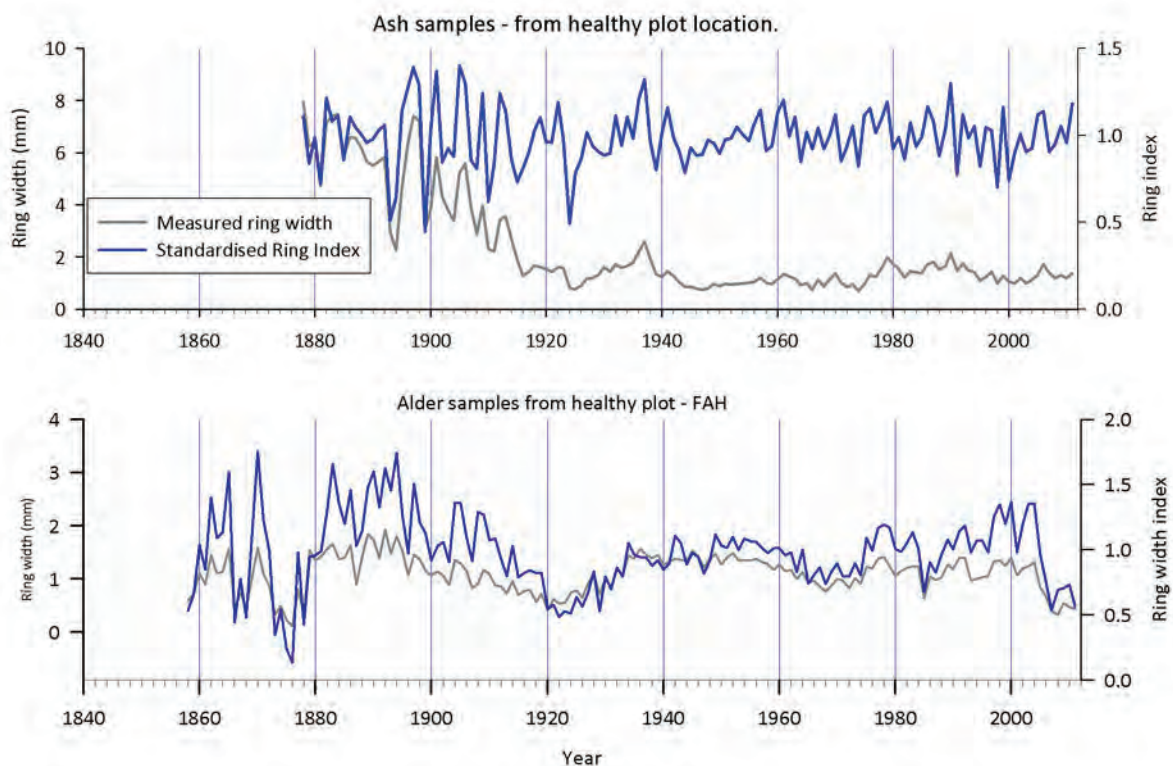
Both alder and ash samples were collected at plot FAH and Figure 10 allows a comparison of the relative growth of the two species on the same site. Interpretation of the diagrams, with reference also to the individual ring patterns seen during analysis, suggests the site was occupied by some old alder (1860's) but that most recruitment of alder and ash in this area occurred in the 1880's. The growth curve shows a decline between 1880 – 1920 which is likely to be due to inter-tree competition due to rapid recruitment and initial growth of alder and ash on the site. This is followed by a long period of relative steady growth, although some variability can be seen probably due to tree deaths and short term climatic fluctuations. Of particular note is the decline in growth noted in the alder in the early 2000s which is not replicated in the ash. Indeed, it appears that the ash have increased in growth in response to the slight decline in the alders' vigour; although the time periods for analysis are short and the growth pattern changes of the two species could be unrelated.

Figure 10: Annual ring growth patterns for the healthy plot alder and the intermixed ash. Note the different Y-axis scales. The alder show a decrease in growth in the last 10 years that is not replicated in the ash samples.

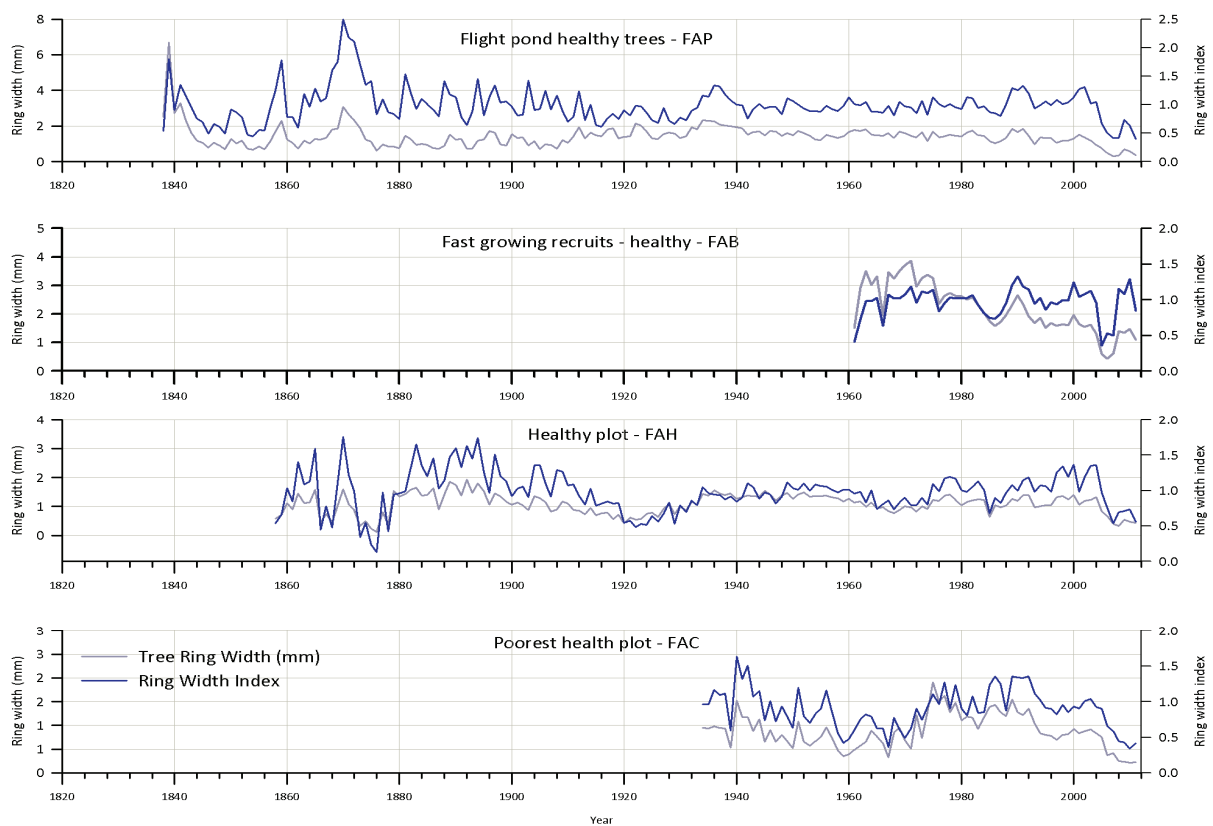
All samples show a reduction in growth (in standardised Ring Index): since the late 1990s in the case of the poorest plot (FAC) and since the early 2000s at all sites (Figure 11). Only the faster growing young alder on the drier site (FAB) show a recovery from this initial decline in growth; all other samples have continued to decline although the rate and extent differs between samples. This is more easily seen when a reduced growth curve period is plotted (Figure 12)

Figure 11: Growth curves for all alder samples. Note the different scales for the y-axis.

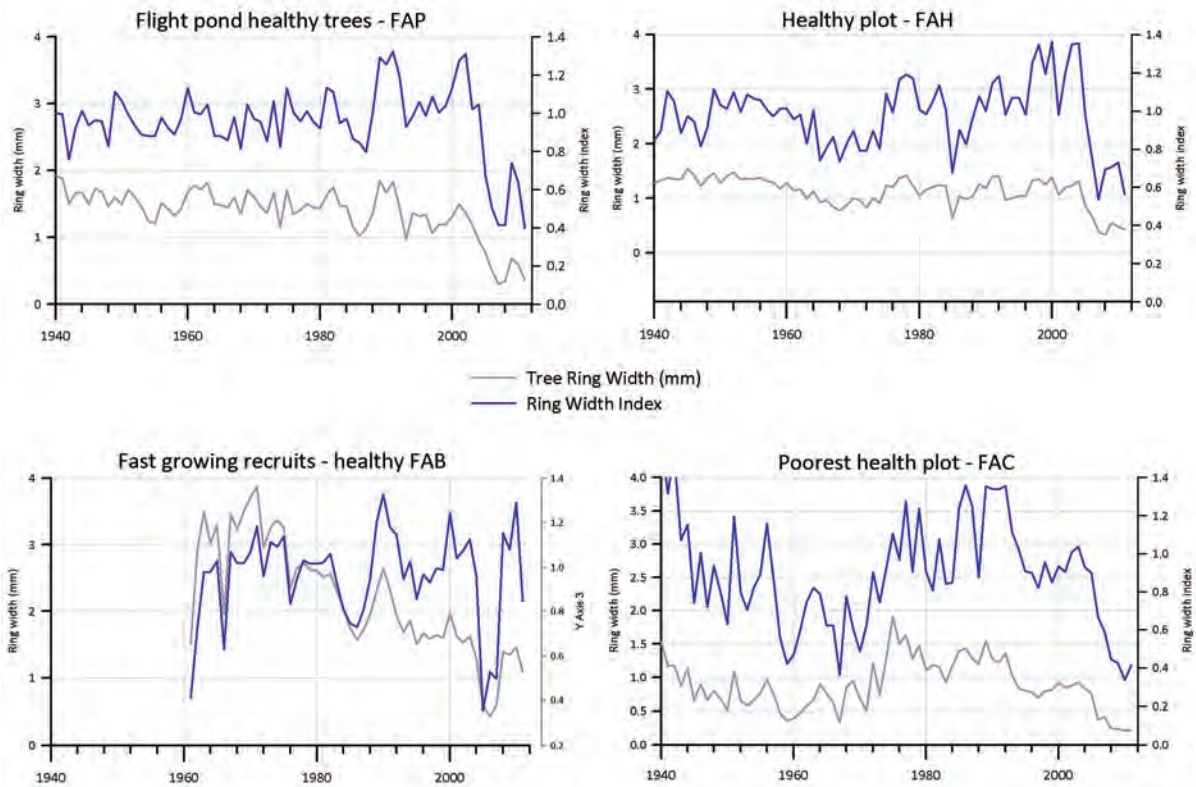
Closer examination of the growth curves for the last 60 years (Figure 12) clearly show a period of reduced growth over the last decade. However the decline appears to begin at different dates in each sample location: earliest in the poorest health plot (FAC) and most recently in the healthy plot FAH. Only the young fast growing trees associated with the Scots pine in the south east location (FAB) show any recovery to this decline. This rate and severity of decline is not replicated elsewhere in the history of the samples.

Figure 12: Comparison of growth curves for the alder samples since the 1940s
