# The Scottish Beaver Trial: Fluvial geomorphology and river habitat 2008-2013, final report

**Commissioned Report No. 683**

**Project No: 7062**

**Contractor: Centre for River Ecosystem Science, University of Stirling**

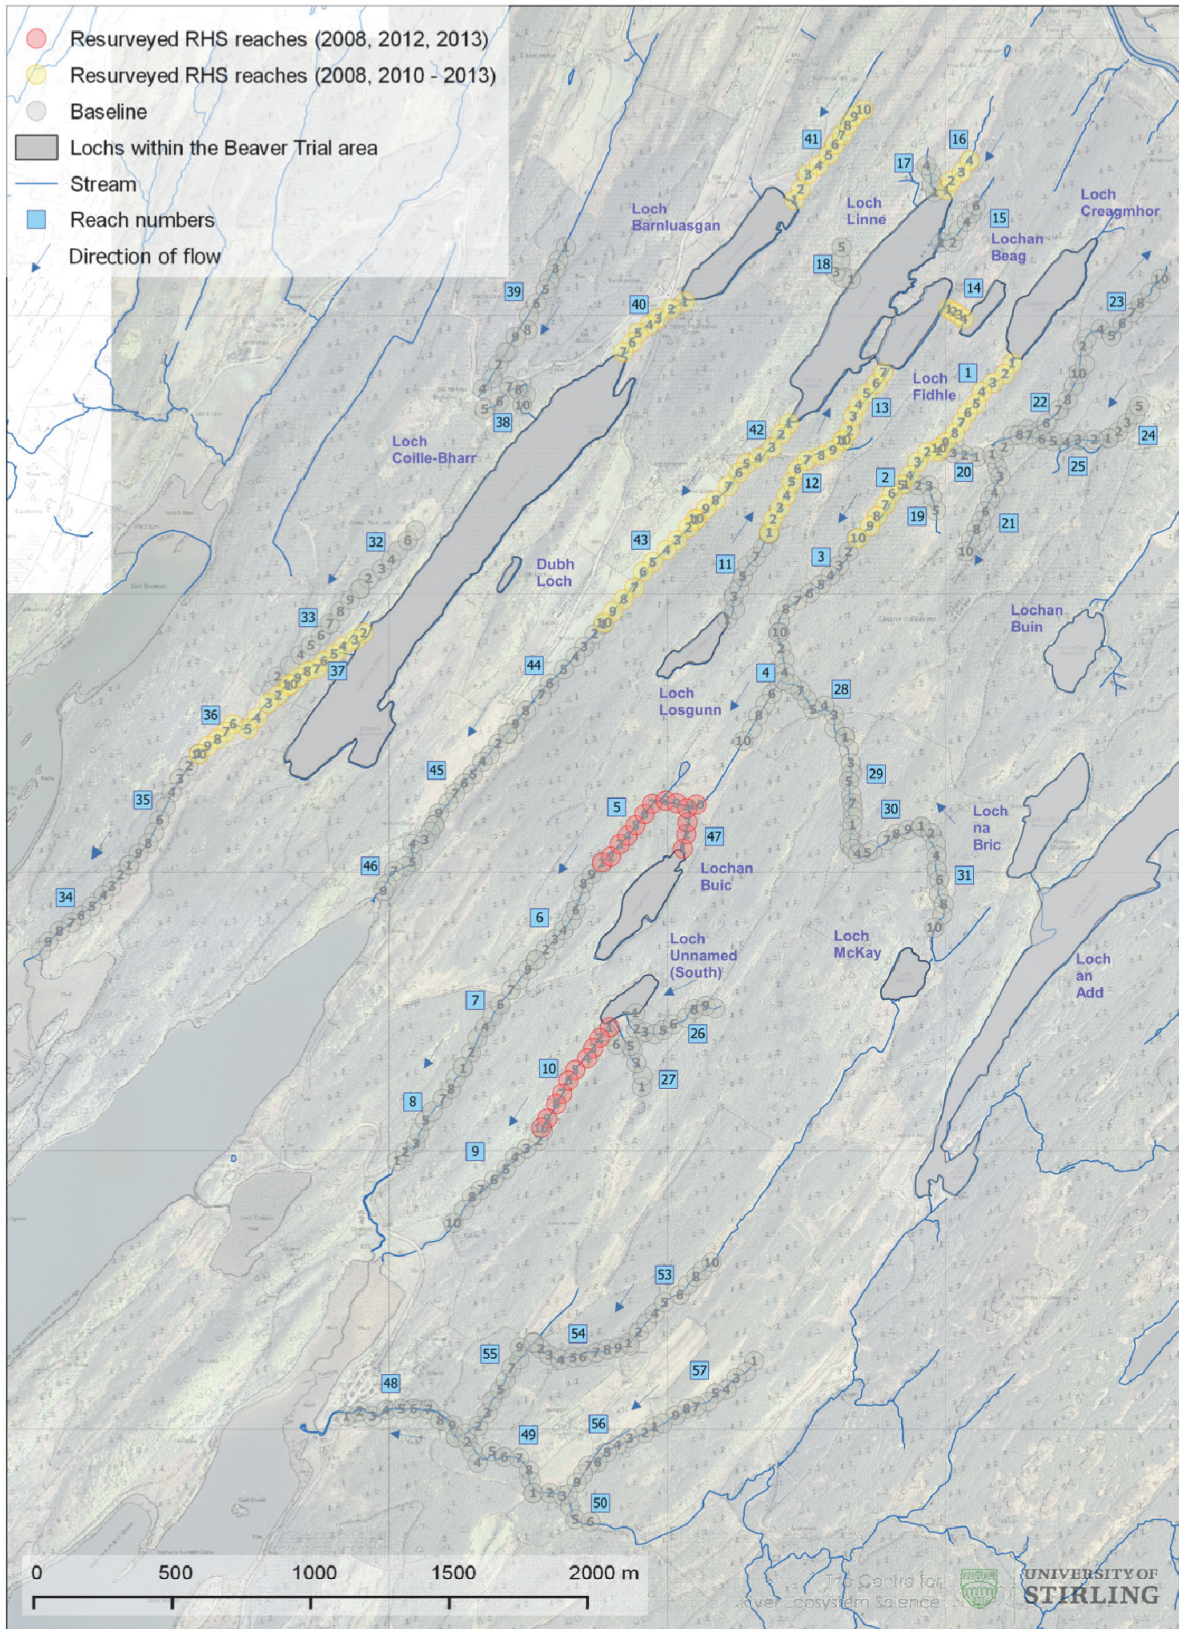
Figure 1. Spot-check locations on interim survey reaches. Mapping data reproduced by permission of Ordnance Survey on behalf of HMSO. © Crown Copyright. All rights reserved.

Between November 2008 and January 2009, 55 reaches covering 21.5 km of streams in the Knapdale area were surveyed to produce a baseline data set. Where appropriate, the reaches coincided with those used in previous surveys undertaken in 2002 (Gilvear, 2002). Most reaches were 450–500 m long, but 18 were shorter as the confluence with a larger watercourse or the tidal limit of the stream prevented a full reach length from being surveyed. Since the primary focus of the investigation was on trends in habitat and associated features at individual sites over time in relation to levels of beaver activity, rather than a comparison of absolute values between sites, no correction was made to allow for the non-standard length of some reaches. The spot-check locations for all of the survey reaches are shown in Figure 1.

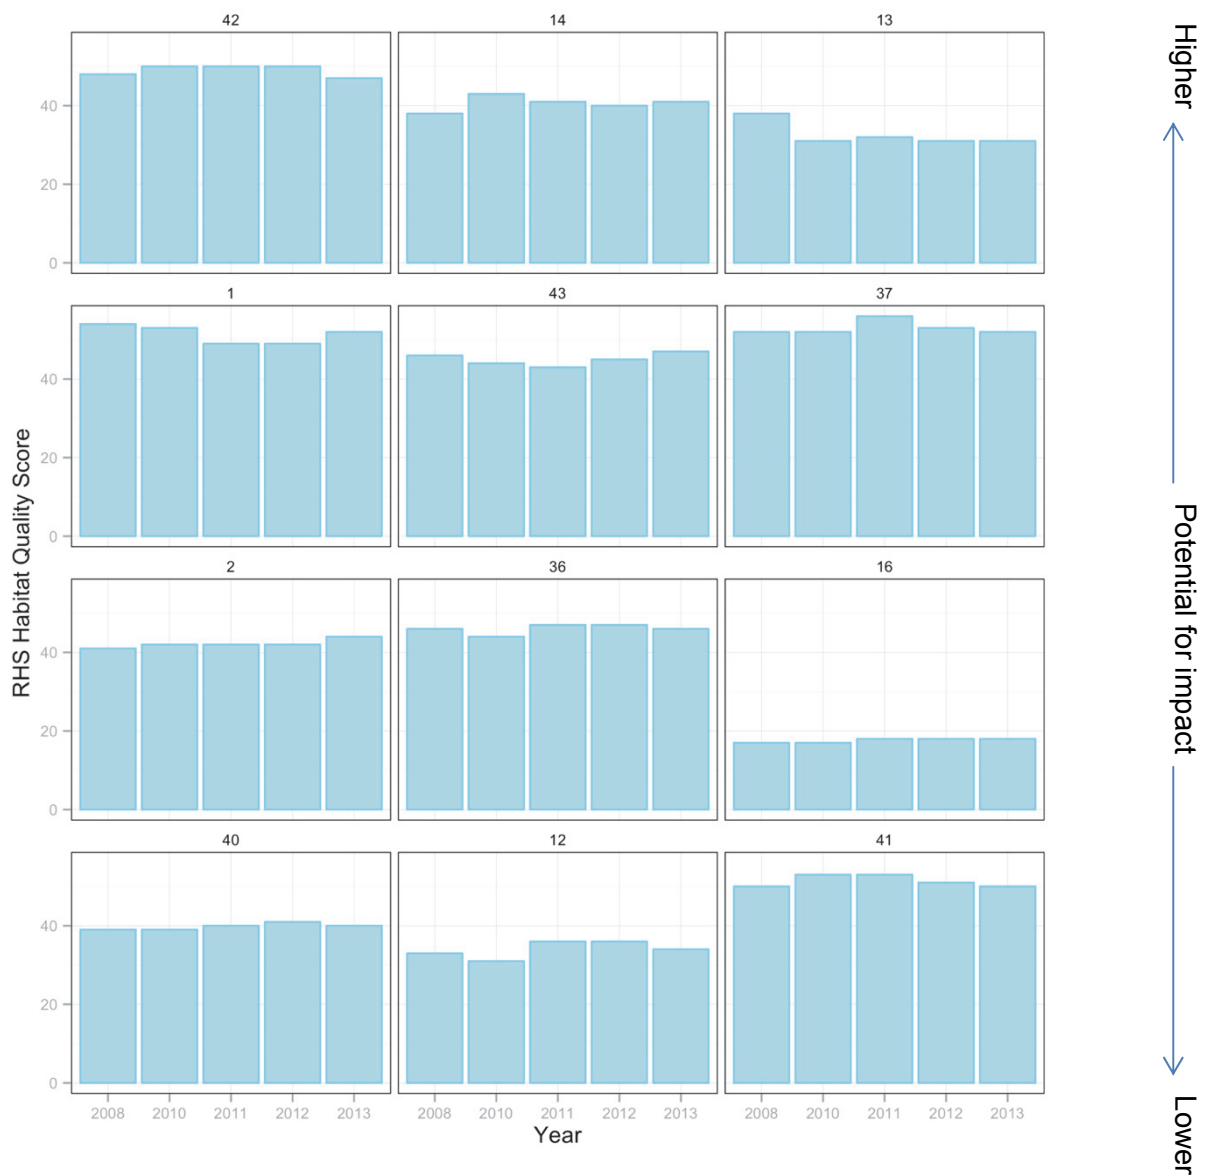
**Figure 2. Habitat Quality Scores for each of the reaches surveyed annually between 2008 and 2013**

Note: The RHS HQS score is based on a summation of the spot check data for a reach. Since the focus is on trends in HQS scores at individual reaches over time rather than a comparison between reaches no correction has been made for shorter reaches that contained less than the standard 10 RHS spot checks.

Stream habitat monitoring, undertaken at the reach scale using RHS, allowed habitats to be documented. The data collected were used to calculate Habitat Quality Scores (HQS). This index provided a general indication of the habitat diversity present within a reach, based on a tally of the natural features recorded. Scoring features included gravel bars, eroding cliffs, large woody debris, waterfalls, back waters and floodplain wetlands. The diversity of bed substrate and flow types also contributed, as did bankside vegetation and land use. The scores, calculated for each of the 12 annually surveyed reaches, are shown in Figure 2. The scores for reaches with a complete set of spot-checks are similar to the modal value of 40-50 for comparable stream types in the RHS database (Raven *et al.*, 1998). The scores

support the field observations that there was no trend of change in habitat structure or diversity for the duration of the trial. Within-reach variability in HQS is relatively small and can be accounted for by natural (non-beaver) or surveyor variability.

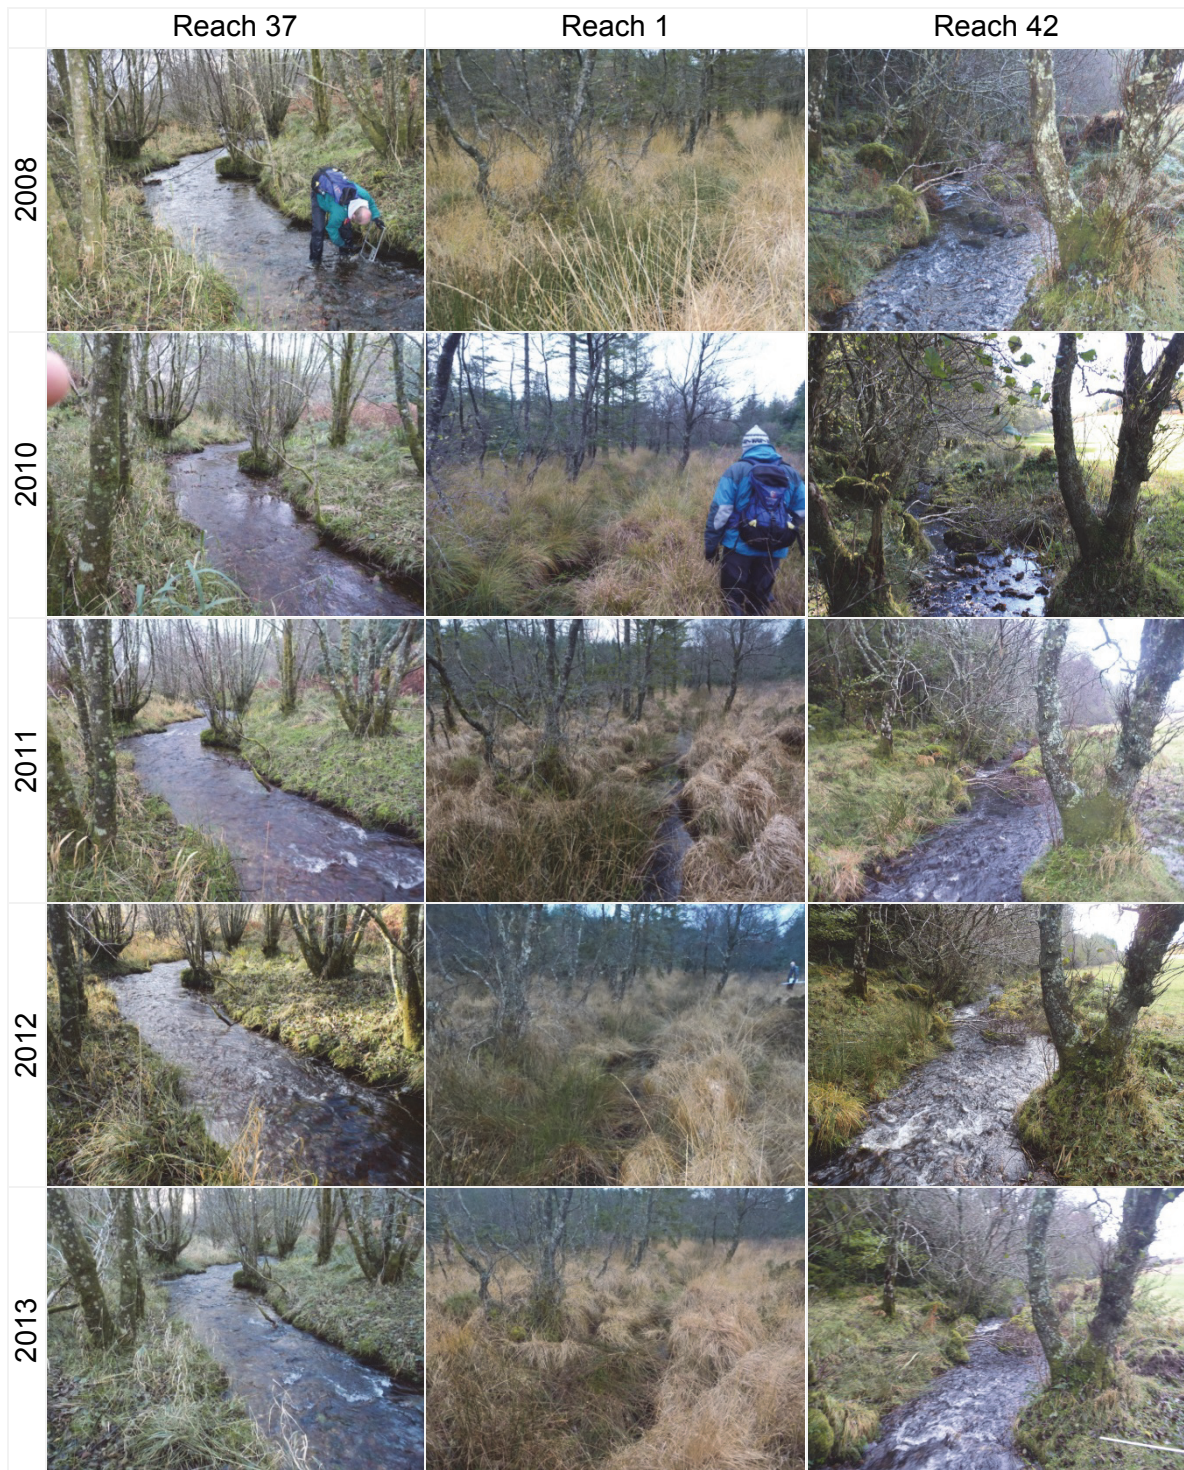
*Figure 3. A comparison of stream habitat at locations fixed for the duration of the trial.*

Riparian habitats were also documented using photography. A large library of photographs was compiled, a selection of which is presented in Figure 3. They show typical reaches typical of streams across the area and illustrate the stability of habitat structure including riparian vegetation and instream features.

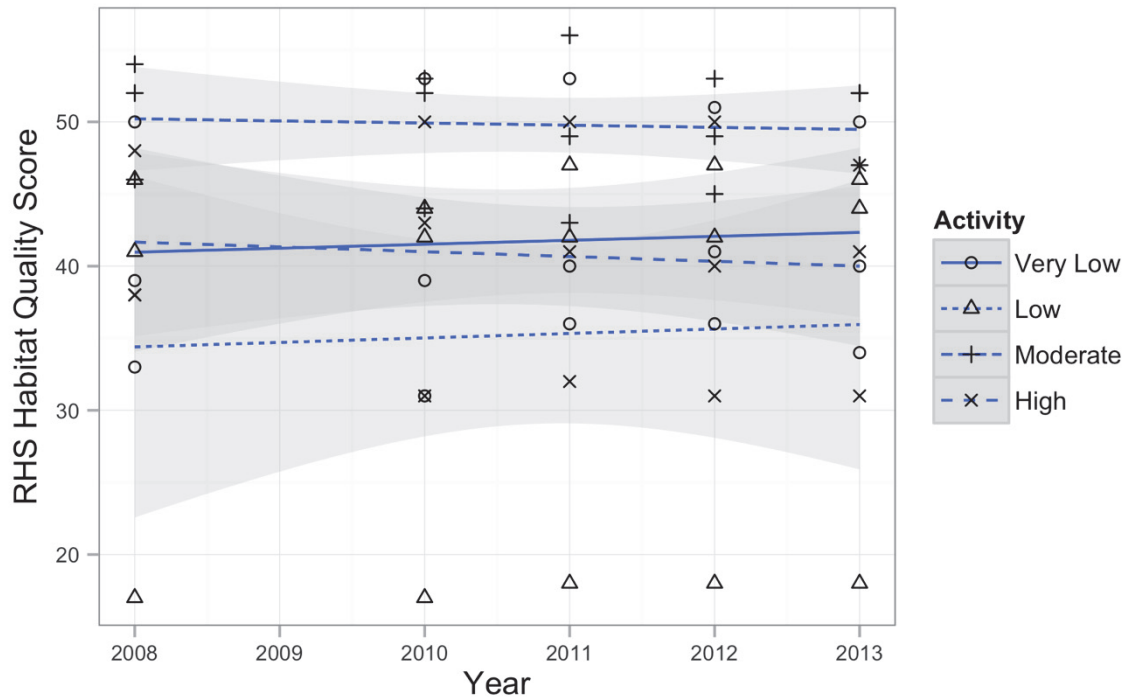
Figure 4. Relationship between Habitat Quality Scores for different levels of beaver activity over the course of the Scottish Beaver Trial

As described above, no individual reaches suggest a change in habitat quality over time as described by the HQS based on RHS data. The same is true when the data are grouped by beaver activity level (Figure 4).

To provide statistical support to the inference drawn from Figure 4, a linear mixed-effects model was fitted to the data. The model incorporated a correlation structure to account for the fact that the same reaches were surveyed repeatedly over the course of the trial. The output from the model is presented in Figure 5. The non-significance of the interaction terms between activity levels and time in the output indicates that there is no detectable effect of beaver activity on the Habitat Quality Scores, based on the data available. The analysis was done using the nlme package (version 3.1-117) in R (version 3.1.0).

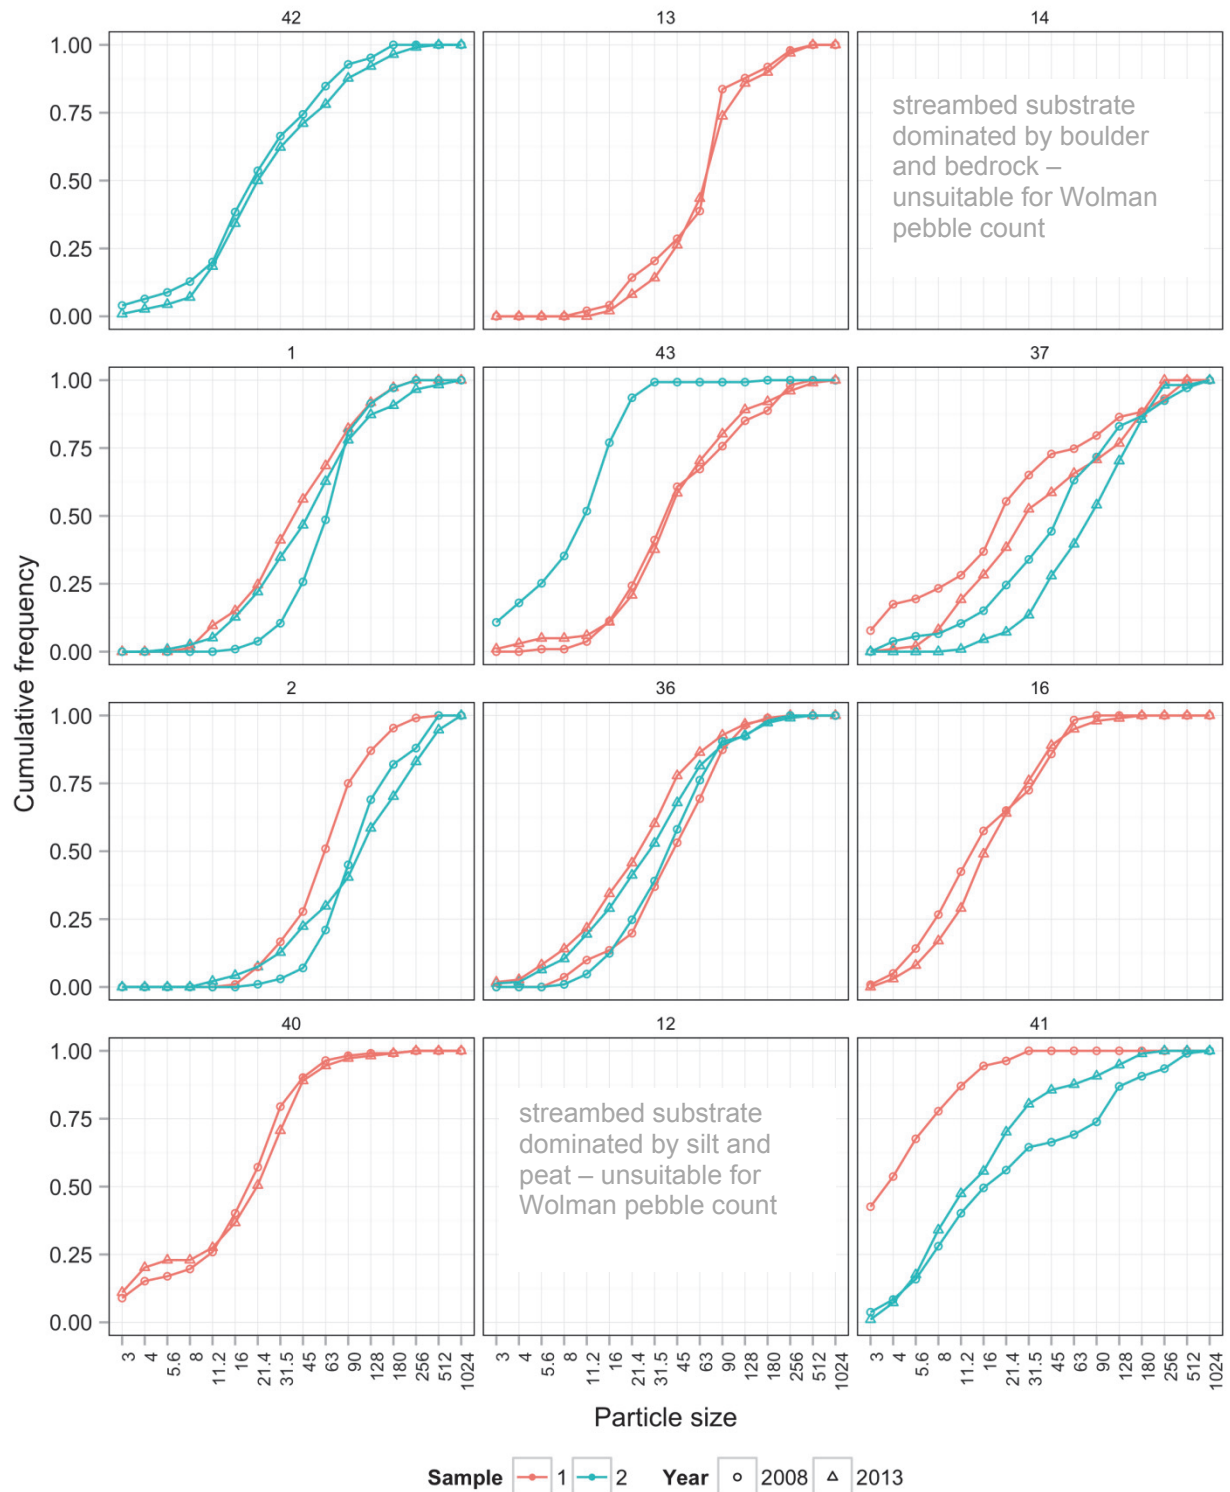
Figure 6. Cumulative frequency plots for the pebble count data collected at fixed locations on the reaches within the area of the Knapdale trial. Note: Surveys were undertaken at the start (2008, pre beaver) and end (2013) of the trial. Only one pebble count was undertaken in some reaches, either because the reach was shorter than 10 spot-checks or because gravel habitat was only present on a proportion of the reach. Not all pebble count locations were resurveyed in 2013.

The pebble count data collected from fixed locations on reaches within the area of the beaver trial are presented in Figure 6. The data show very little change in the composition of bed substrate, indicating no major shift in substrate type. No consistent siltation or coarsening of bed sediments are indicated by the profile graphs. This is most obvious for reaches that are relatively uniform such as 42, 13, 36 and 16. A few reaches, e.g. reach 37, appear to show a difference between 2008 and 2013 for one or both samples. This can be explained by the high diversity of bed substrates and features present at these locations meaning that slight differences in the spatial extent of the pebble count can lead to a change in the profile.

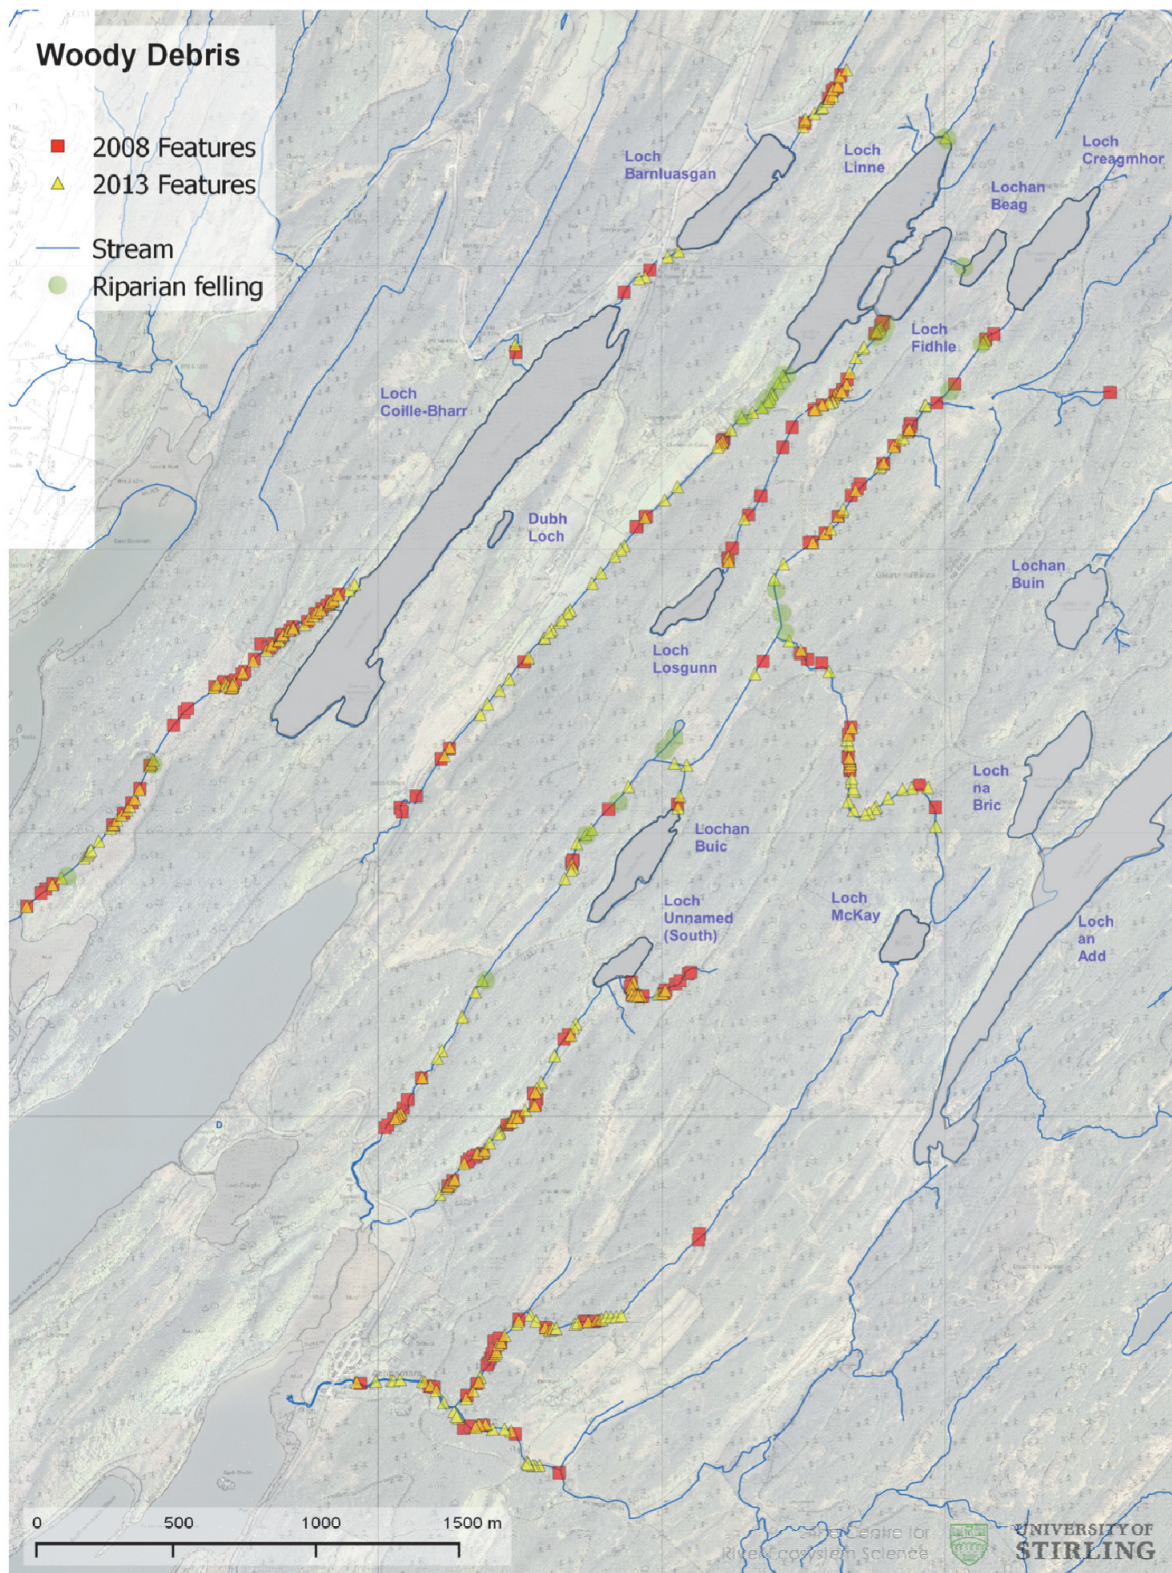
Figure 8. The location and number of woody debris features recorded in 2008 and 2013. Mapping data reproduced by permission of Ordnance Survey on behalf of HMSO. © Crown Copyright. All rights reserved.

Figure 8 illustrates the location and number of woody debris features recorded in the re-surveyed reaches at the beginning and end of the trial. The spatial extent of the features was broadly equal, although the density increased in some reaches. There was an increase in the total number of features recorded from 186 in 2008 to 313 in 2013. In particular there was an increase in the number of records of woody debris downstream of Loch Linne where some riparian felling occurred close to the loch outlet.

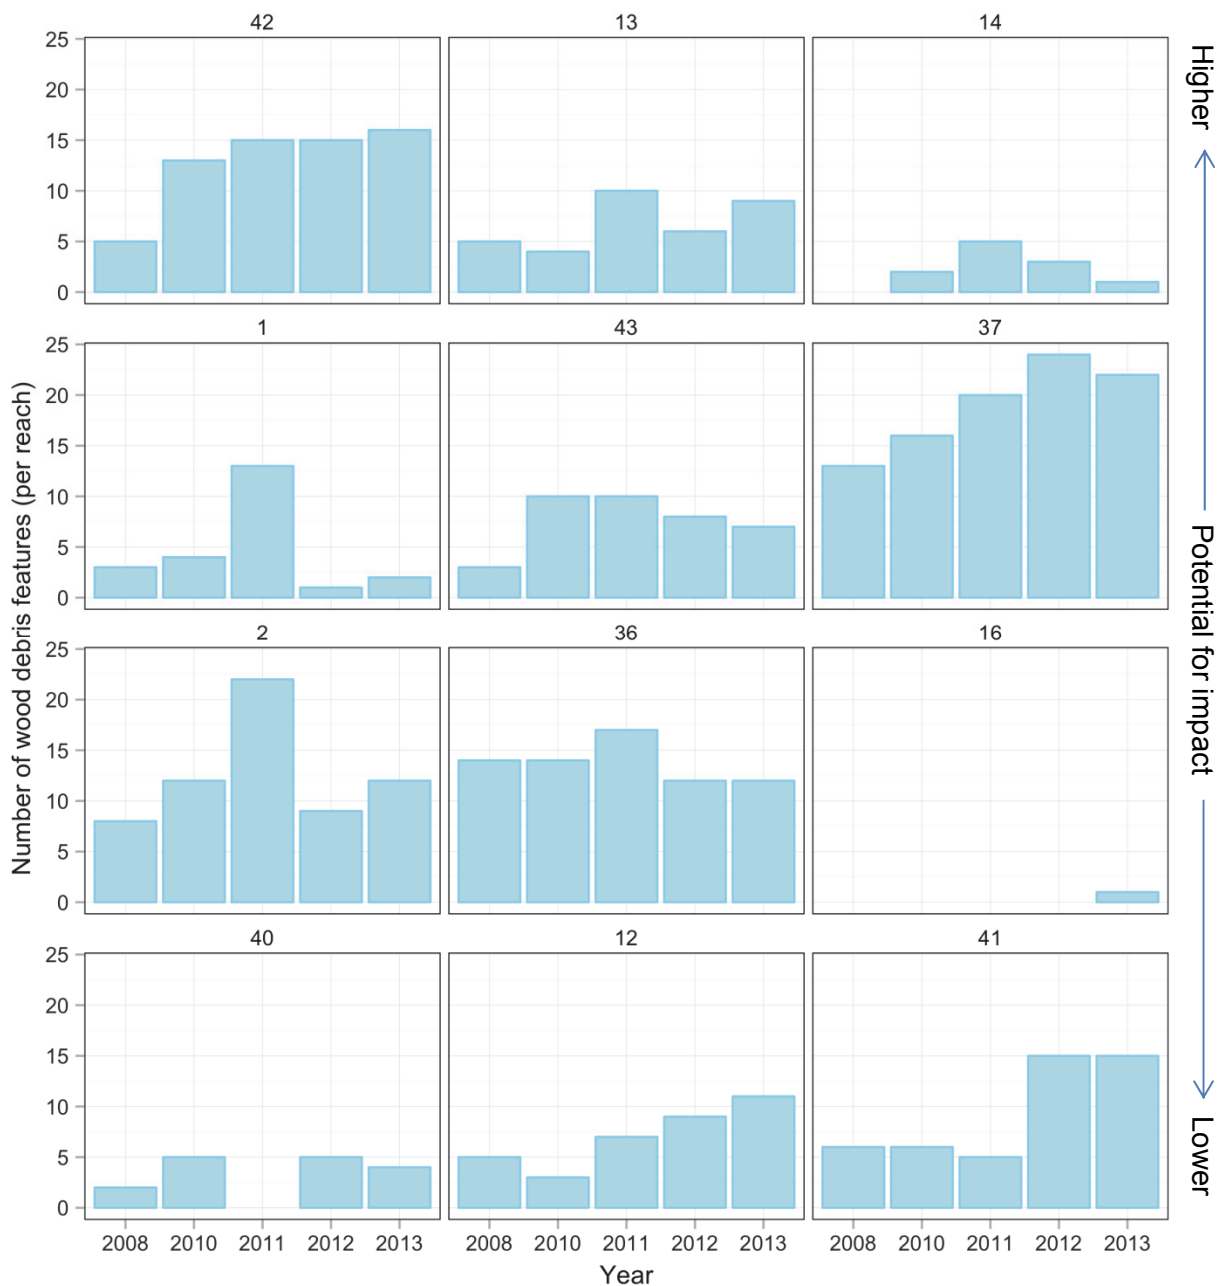
Figure 9. The number of woody debris features recorded for each of the reaches surveyed annually between 2008 and 2013

The number of woody debris features present over the course of the trial varied strongly at some sites but was largely stable at others. Those recorded were a mixture of consolidated features, accumulations of loose and more transient material, and individual items. The change in the number of woody debris features over the course of the trial can be seen in Figure 9.

The trend in the number of woody debris features through time varies from reach to reach. There was an increase in the number of features recorded in some reaches, e.g. 12, 16, 42, but this was not apparent in all reaches. Moreover, obviously cut beaver wood was rarely observed outwith the beaver dams. To compare reaches directly and assess whether changes in the occurrence of features could be attributed to the potential impact of beavers, the number of features were converted to a score of density per 100 m. When the reaches were then grouped according to the level of beaver activity, the general trend (apart from 'low' beaver activity) was for an increase in the density of features, although there was variability amongst the reaches within each group (Figure 10). The fact that reaches assigned to very low, moderate and high levels of activity all showed a similar average trend suggests that any apparent trend was unrelated to beaver activity. This most likely reflected the general influence of major storms in winter and spring of 2012 whose influence was potentially greater due to the weakening of branches by unusually high snow accumulation in the winters of 2009/10 and 2010/11.

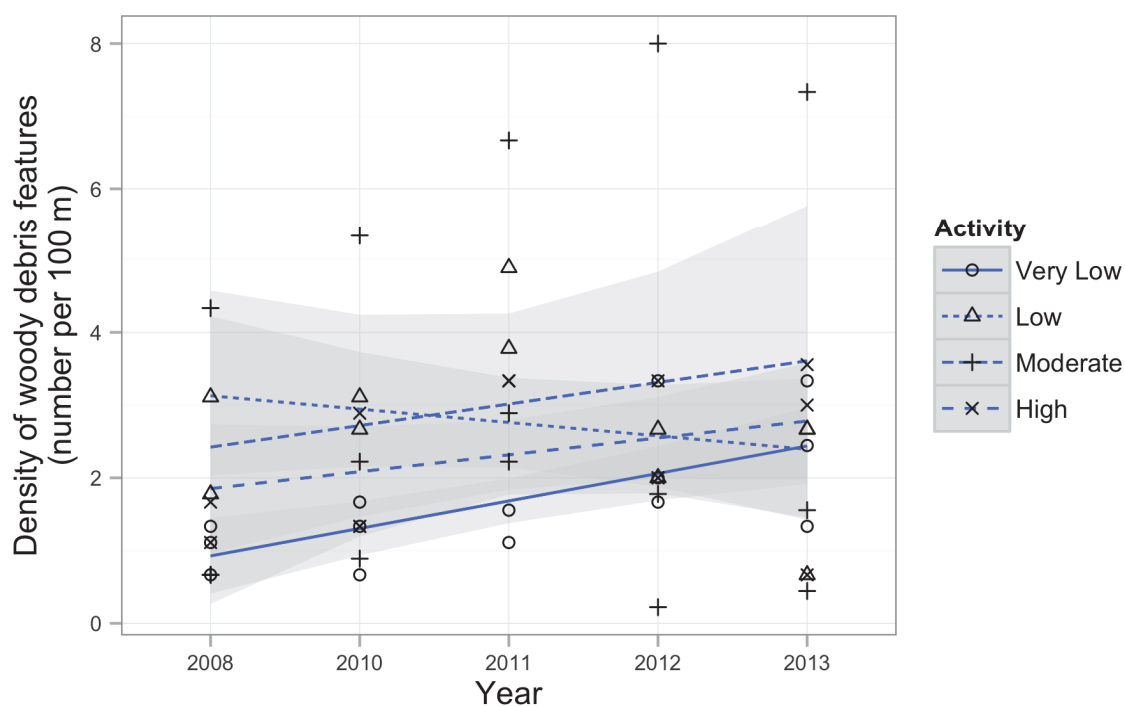
Figure 10. The trend in number of woody debris features over the duration of the trial. The data suggest a slight overall increase, but due to high variability amongst the reaches the effect is not statistically significant

To test the statistical significance of the trend and, more specifically, to test for a difference in the rate of increase in the presence of features between different activity levels, a linear mixed-effects model was fitted to the data. To account for the fact that reaches were repeatedly surveyed over the course of the trial, a correlation structure was incorporated into the model. The output is given in Figure 11. The model suggests that, based on the data available, it is not possible to confirm that the observed trend represents a true increase, although this trend would be significant at a threshold of  $p = 0.1$ . Perhaps more importantly, there is no statistical evidence that any of the different beaver activity levels responded differently through time.

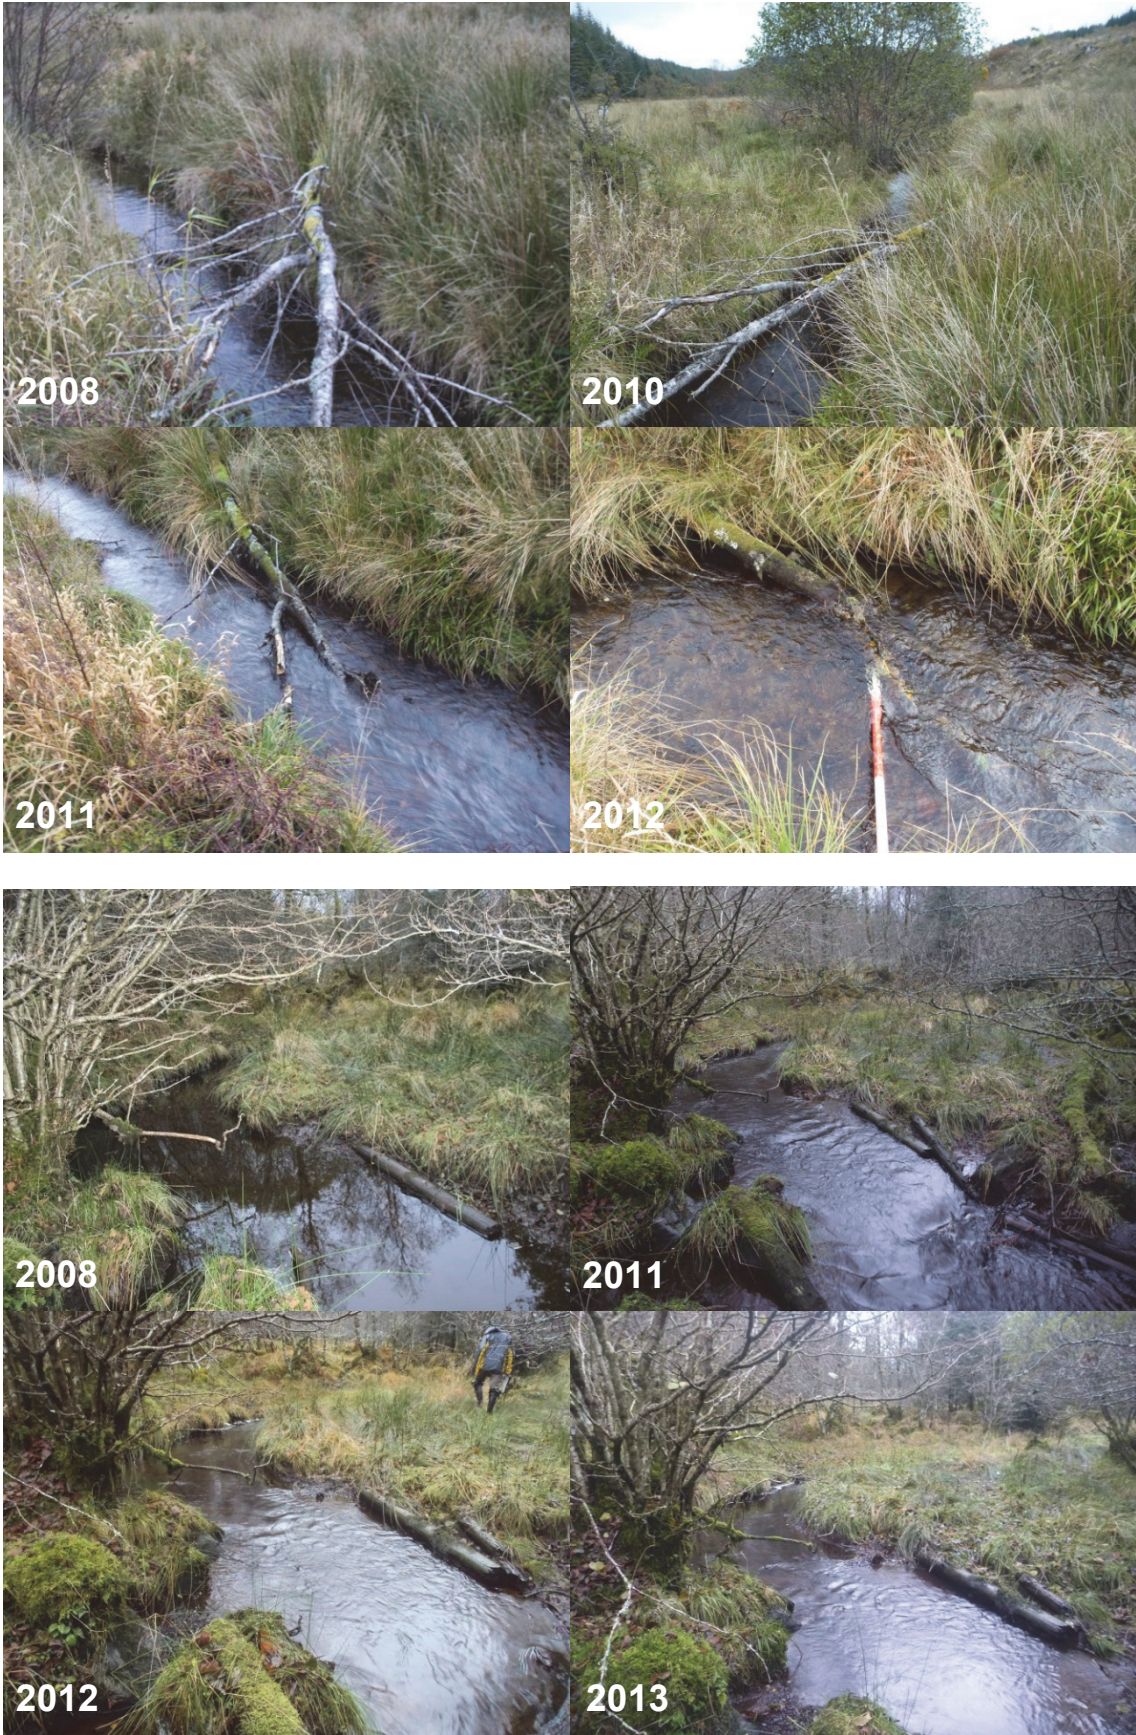
Figure 12. Fixed point photography showing the relative stability of woody debris. The upper panel is from reach 36 and the lower from reach 2.

Field observations indicated that, although features can be relatively transient, most notably smaller loose accumulations of twigs and leaves, for the relatively low energy Knapdale streams, larger features and individual pieces can remain *in situ* for a number of years ( Figure 12). Additionally, even where there is a turnover of material, features persist at some locations.

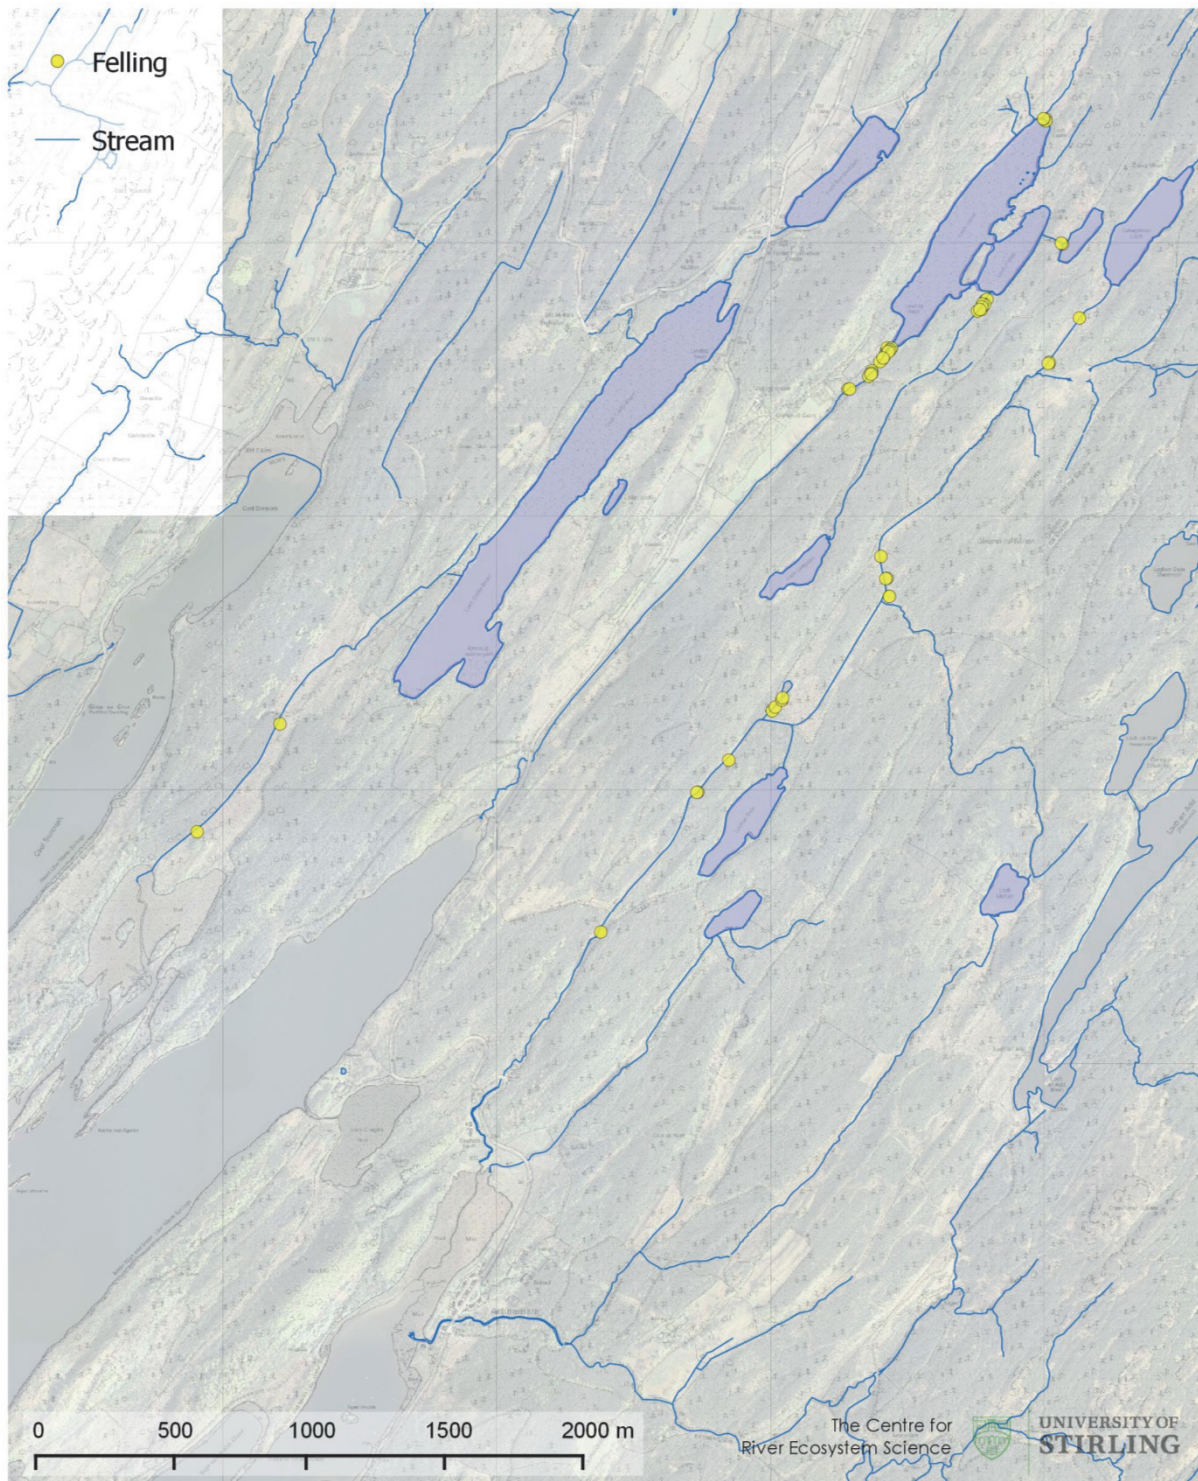
*Figure 13. The location of observed riparian felling on the stream network in the Scottish Beaver Trial area*

In addition to monitoring the potential effects of beaver activity on stream morphology and habitat, data on riparian felling and dam construction by beaver were collected. The recorded instances of riparian felling are shown in Figure 13. Other than near the shoreline of Loch Linne and Loch Fidhle, and on the outflow of Un-named Loch (North), symbols indicate the felling of single stems or small trees.

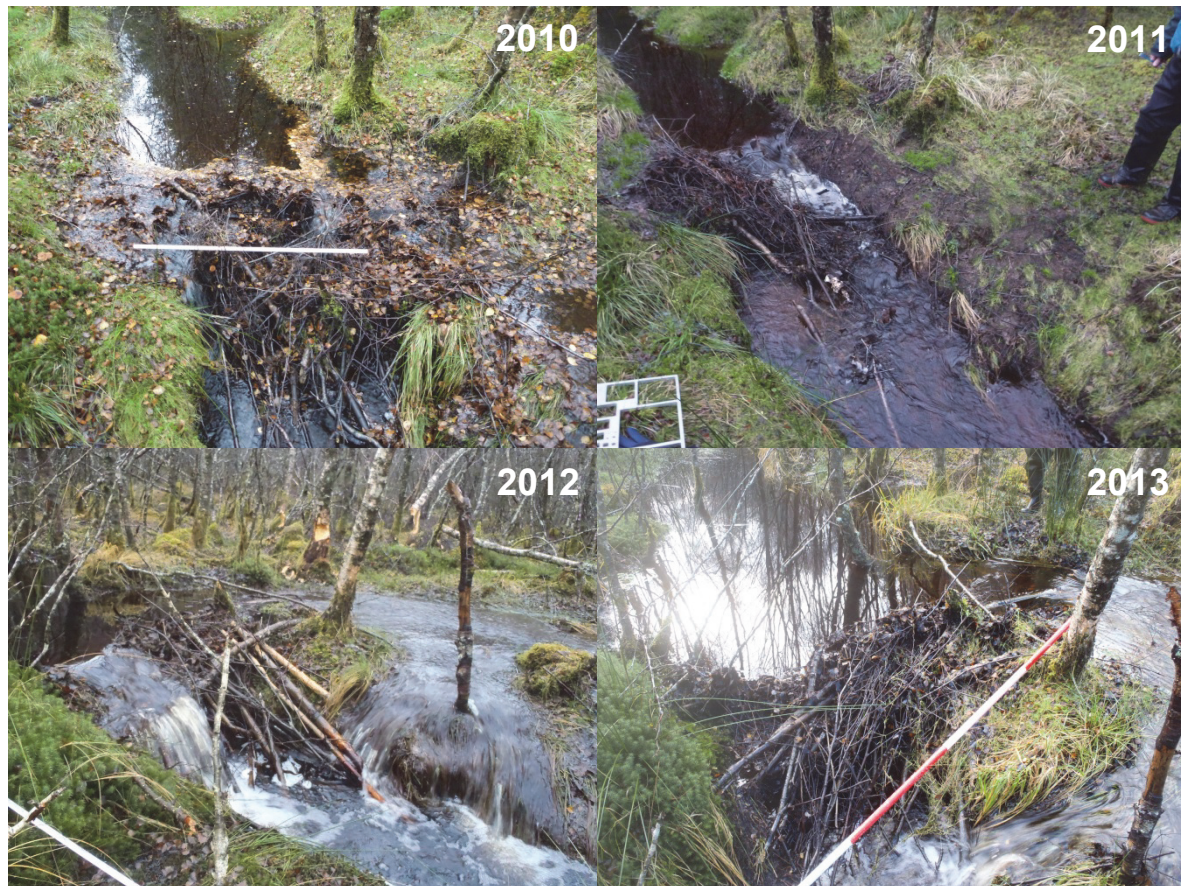
*Figure 14. Fixed point photography of dam constructed on the inflow to Loch Fidhle (reach 13)*

Three dams were constructed on survey reaches within the area of the trial. The beginnings of a dam on the outflow of Loch Linne were removed by Scottish Beaver Trial field staff early in the trial to comply with the conditions of the release licence. A dam at the outflow of Un-named Loch (North) was constructed at the start of a small stream that connects the Loch with Loch Fidhle over a distance of approximately 150 m. The proximity of the dam to the loch shore and the small size of the stream meant that this dam had very little measurable effect on the stream. The third dam, constructed on the inflow to Loch Fidhle (reach 13), had measurable but localised effects on the stream. In November 2013, the dam was 60 cm high and ponded water behind it for 55 m upstream. The phases of dam construction are shown in Figure 14.

The dam was constructed on a sluggish, slow flowing section of channel near the outflow of Loch Fidhle. Although there was a build-up of leaf litter, the already fine substrate did not accumulate and is unlikely to change dramatically.

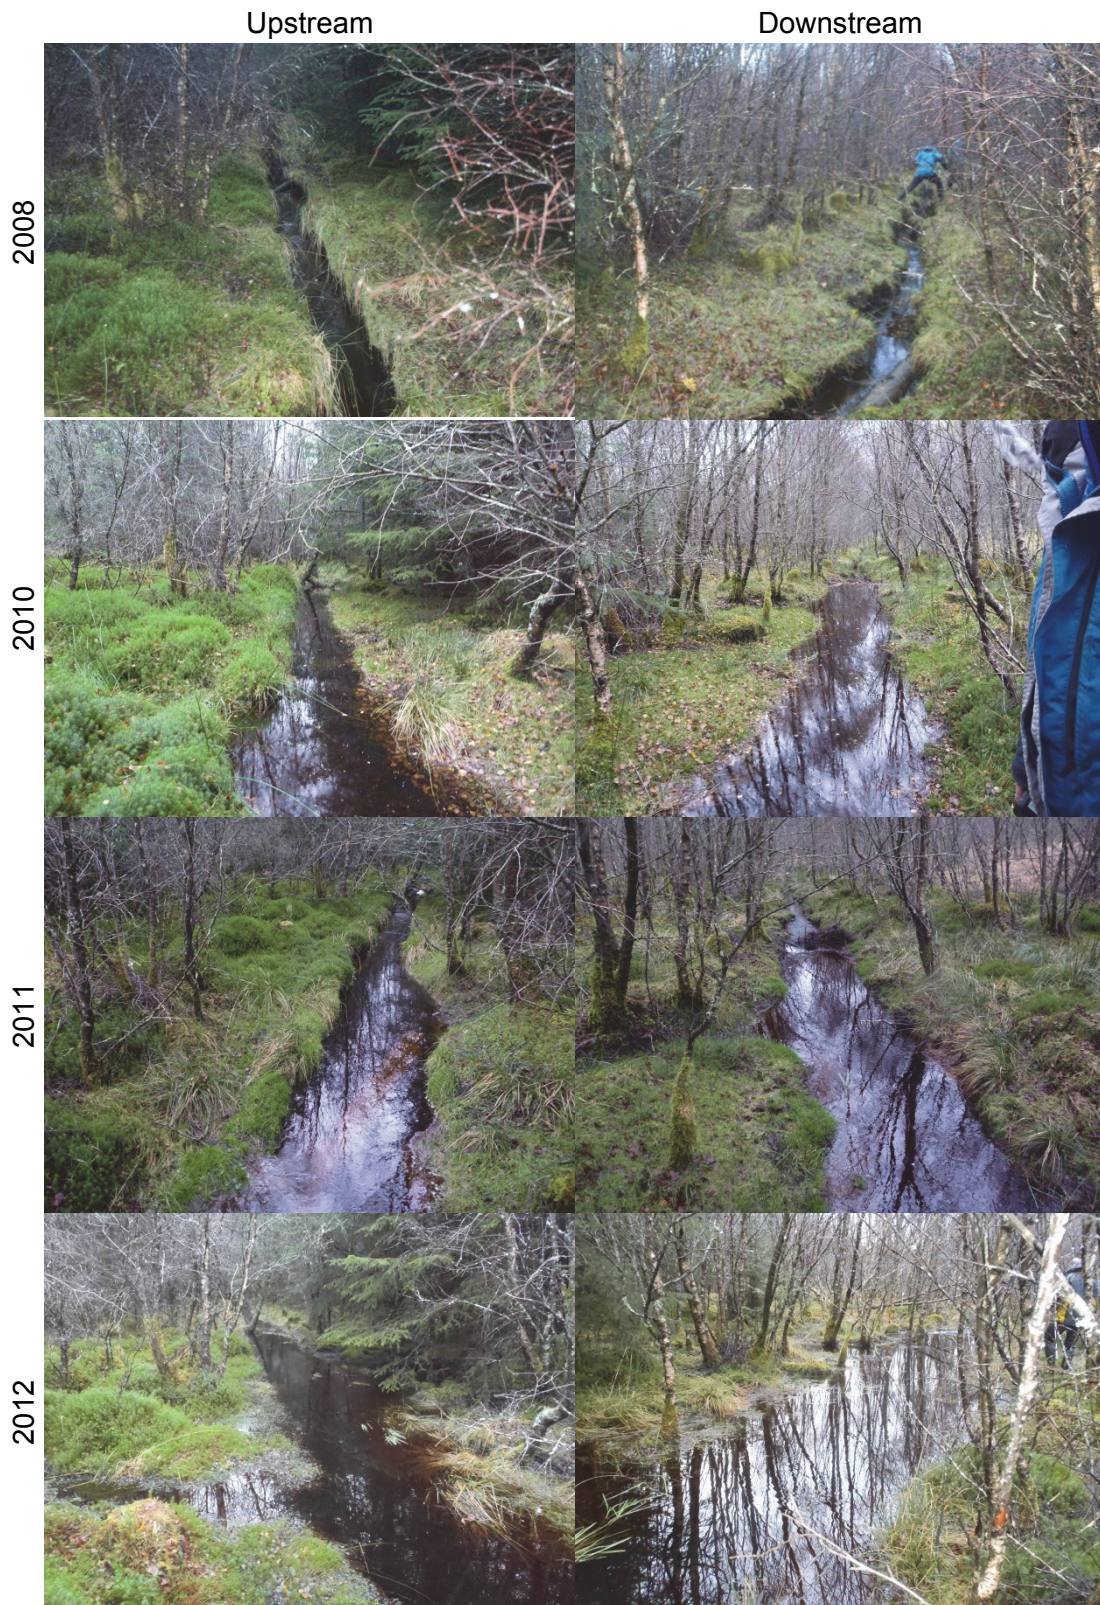
Figure 15. The impact of dam construction on stream habitat of inflow to Loch Fidle (reach 13).

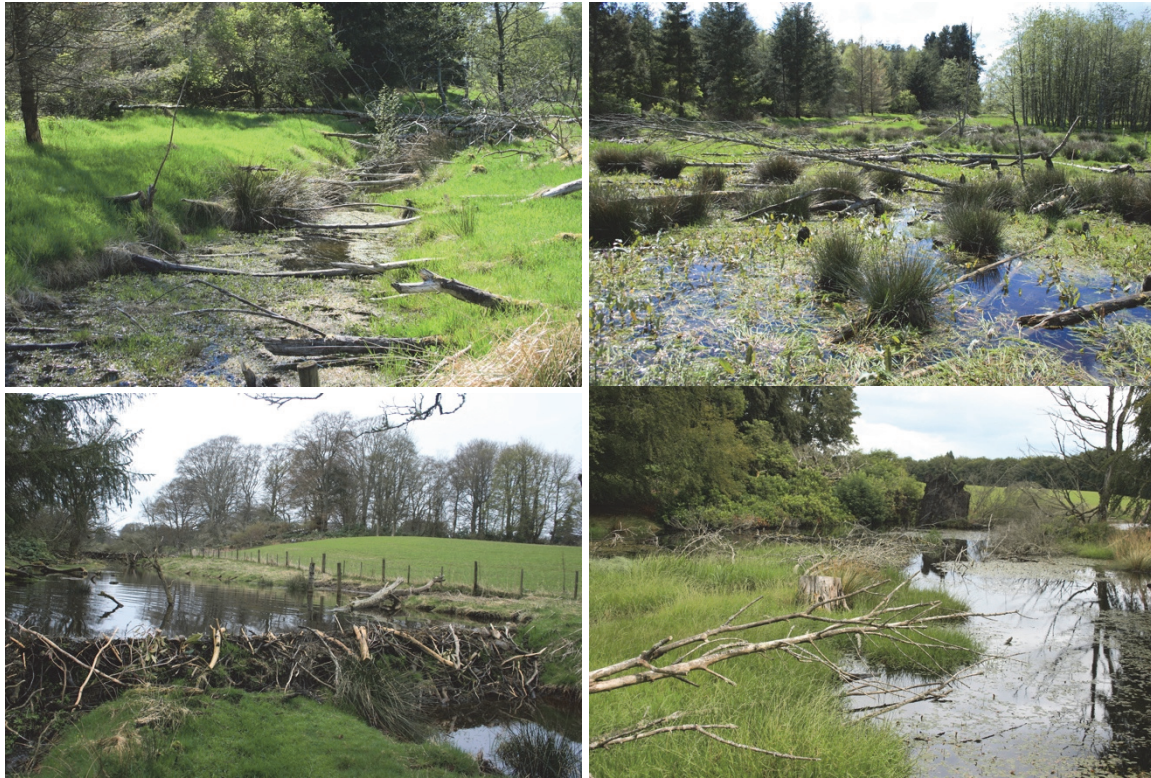
*Figure 16. Examples of modification of stream habitat on Tayside associated with dam building by beavers. All pictures from Bamff Estate near Alyth. Clockwise from top left: woody debris input to stream prior to dam building; creation of shallow water wetland through low 100 m long dam on stream headwater; mature (7 year old) pond formed on a cascade dam system on steeper gradient channel; three year old dam on cascade system reinforced after flood damage. All pictures © Nigel Willby.*

Figure 16 illustrates changes to small headwater agricultural streams at a site on Tayside associated with extensive felling and dam building by beavers and monitored over a 12 year period. Here there have been major changes in the riparian habitat and distribution of flow types, the retention of coarse and fine organic matter and fine sediment, and landscape scale changes in physical habitat heterogeneity (Law & Willby, *subm*). In this case the animals occurred at high densities due to partial containment, had limited access to larger areas of standing water, and tree felling by beavers was the major agent of wood input to watercourses. The use of RHS in this situation would, without question, have registered major changes in fluvial geomorphology.
