# Investigation of Standing Water and Wetland SSSIs thought to be under Diffuse Pollution Pressure: Ardblair and Myreside Fens

**Commissioned Report No. 713**

## **Investigation of Standing Water and Wetland SSSIs thought to be under Diffuse Pollution Pressure: Ardblair and Myreside Fens**

**Commissioned Report No. 713**  
**Project No: 13700**  
**Contractor: EnviroCentre Ltd.**  
**Year of publication: 2015**

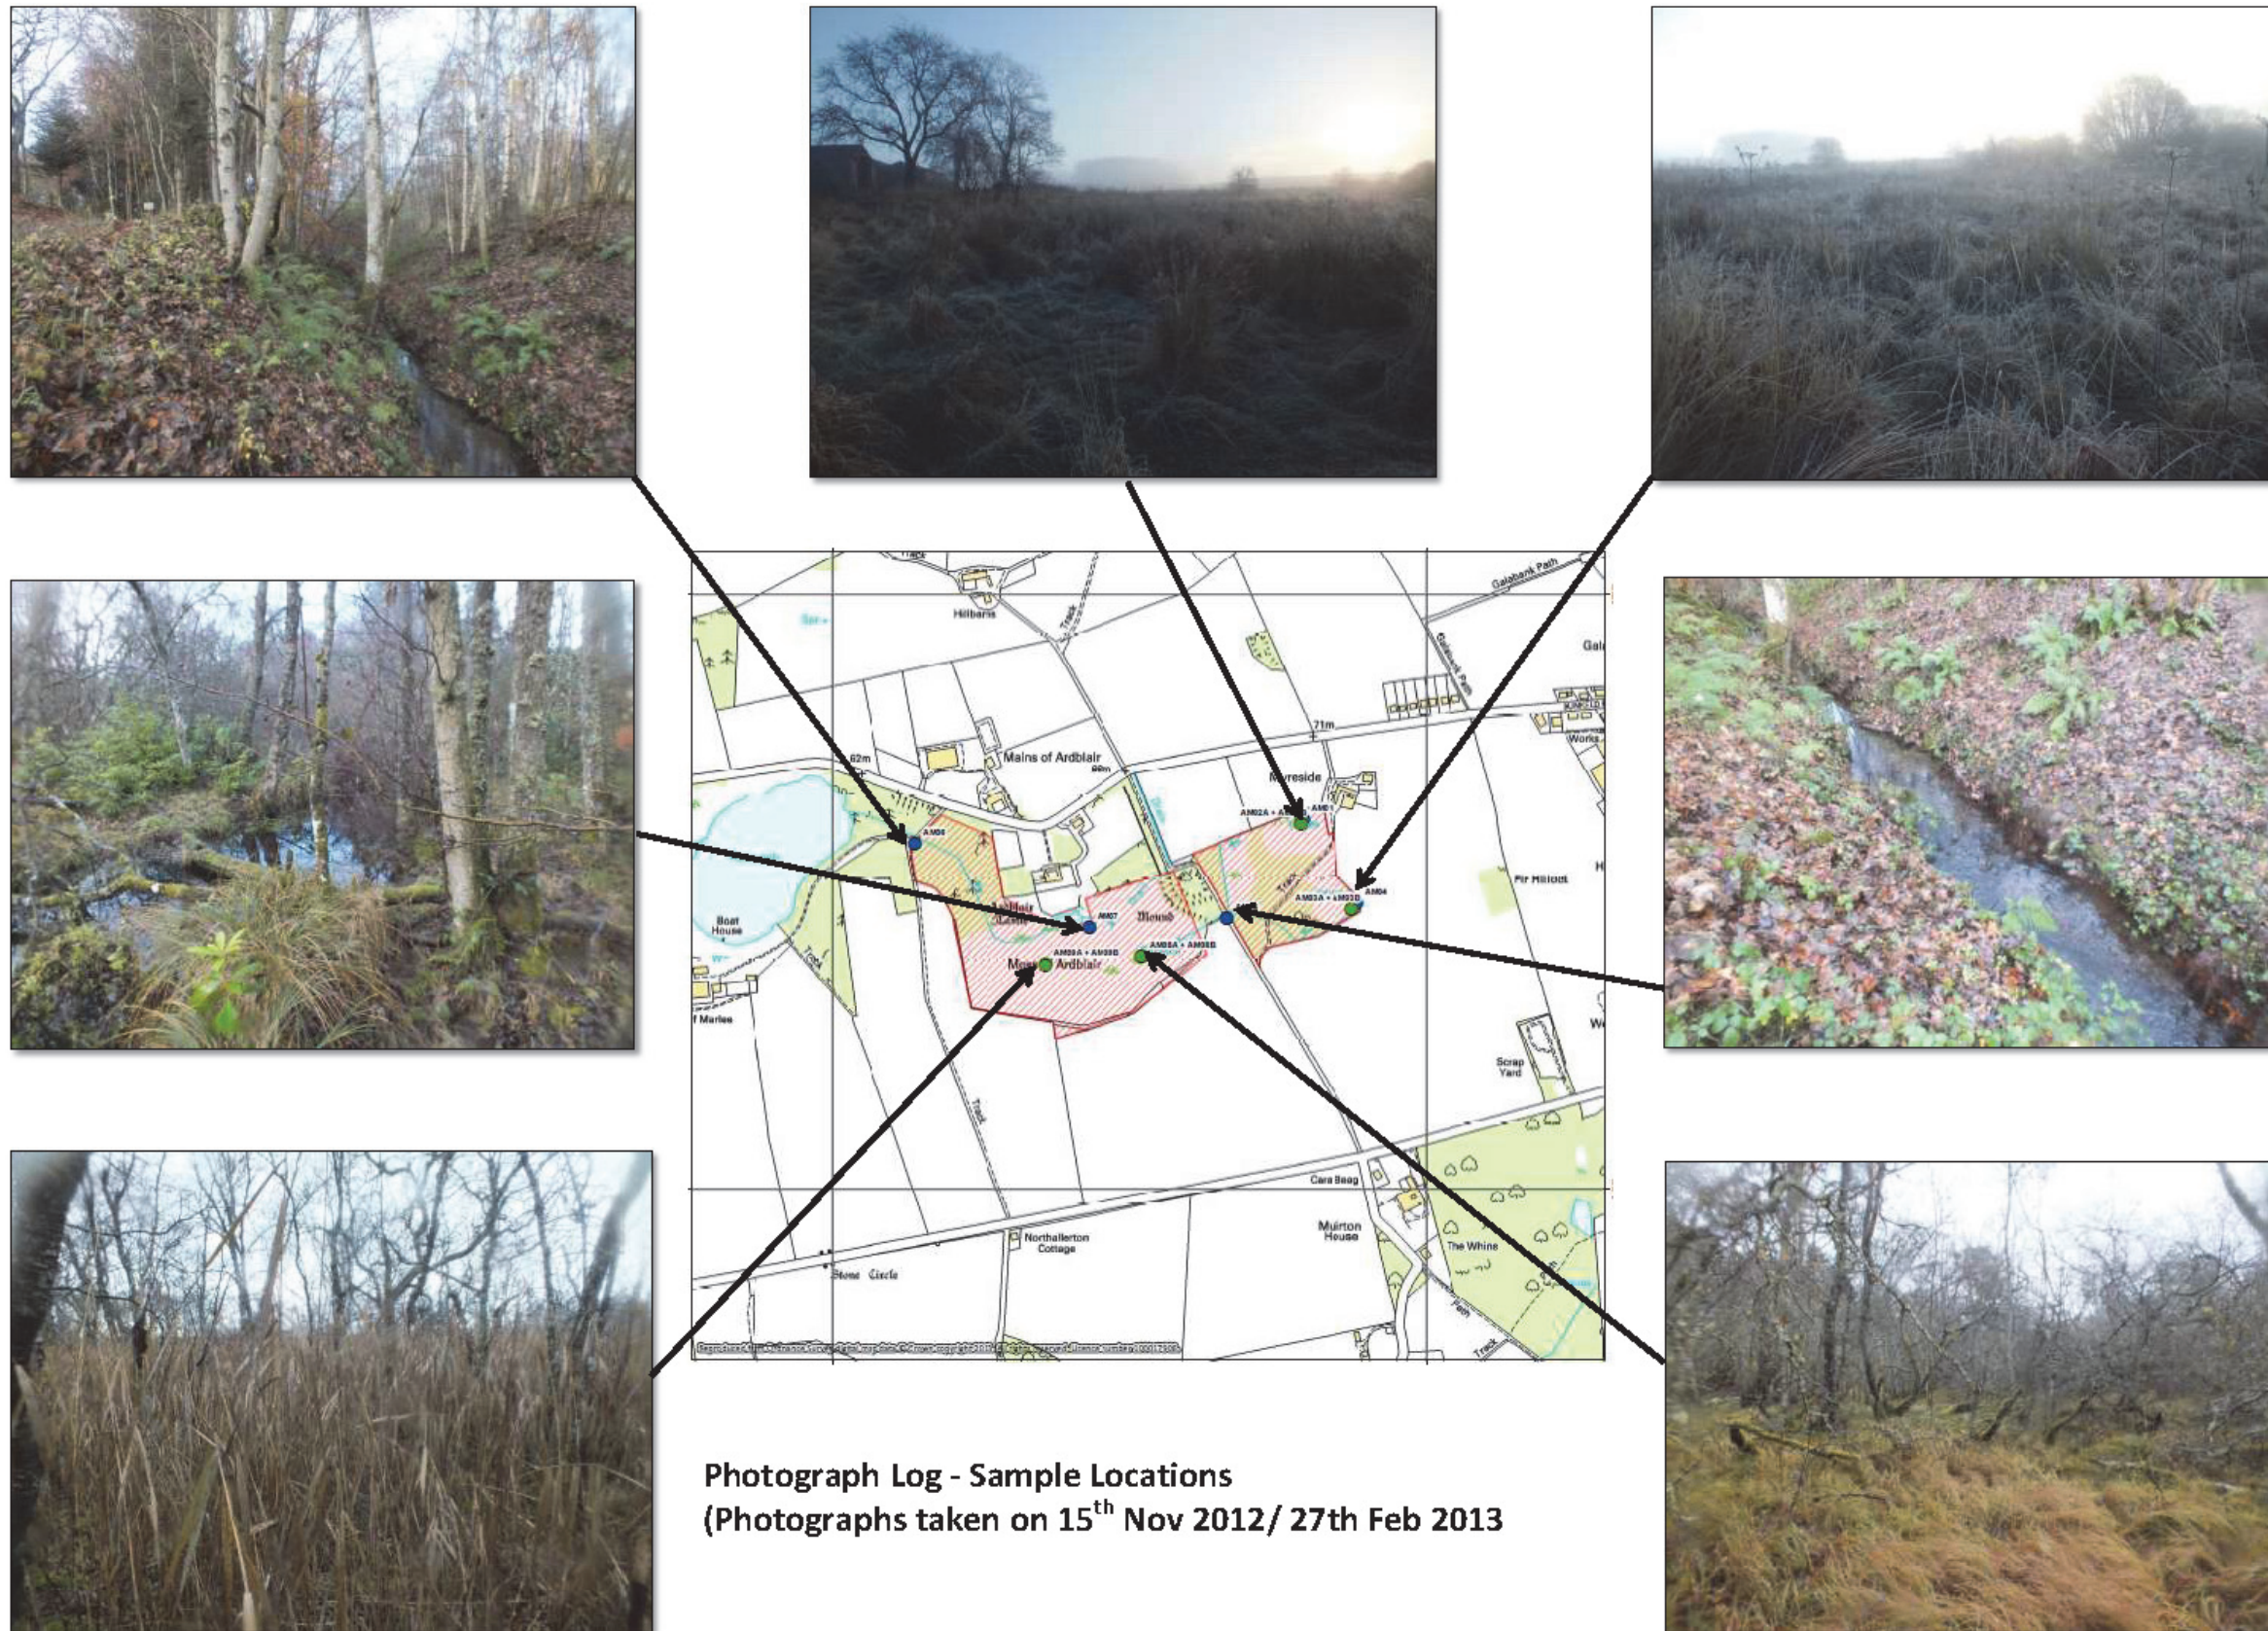
Figure 2.3: Photographs of each Sampling Location

All sampling methods were carried out by trained personnel. Photographs of each sampling location were taken (see Figure 2.3 in Annex 1) and grid references for each location recorded.

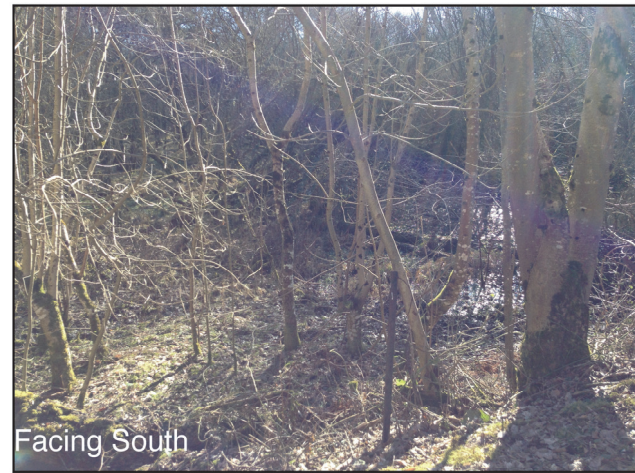
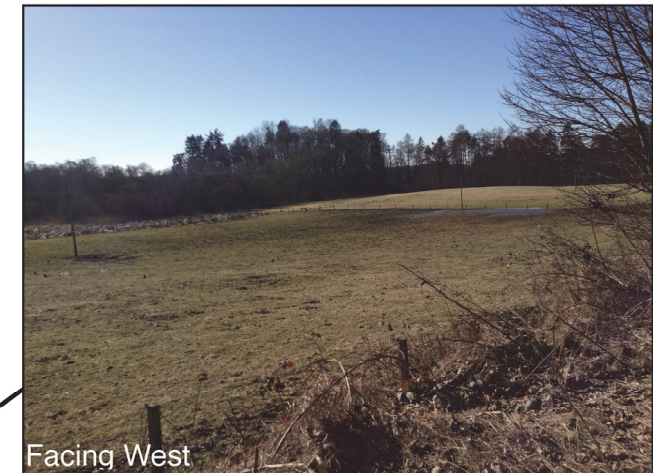
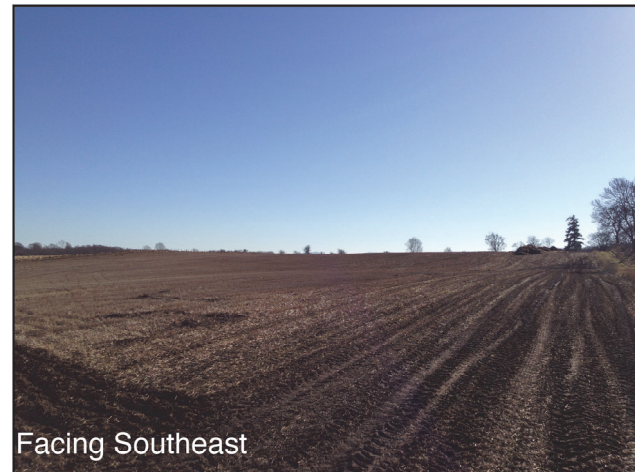
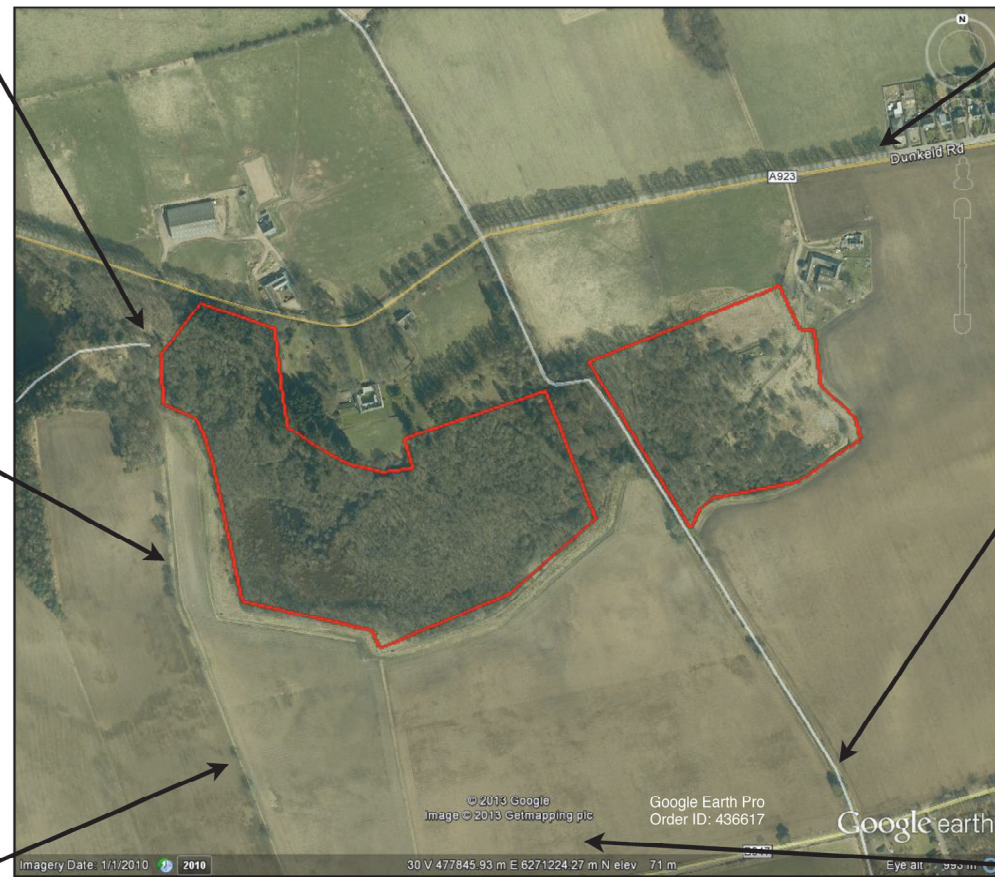
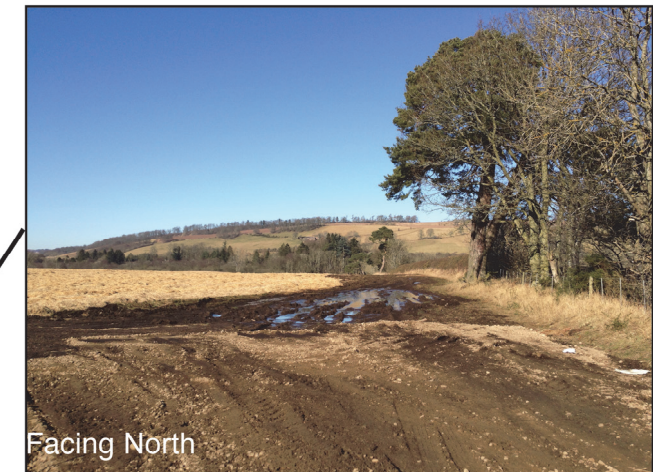
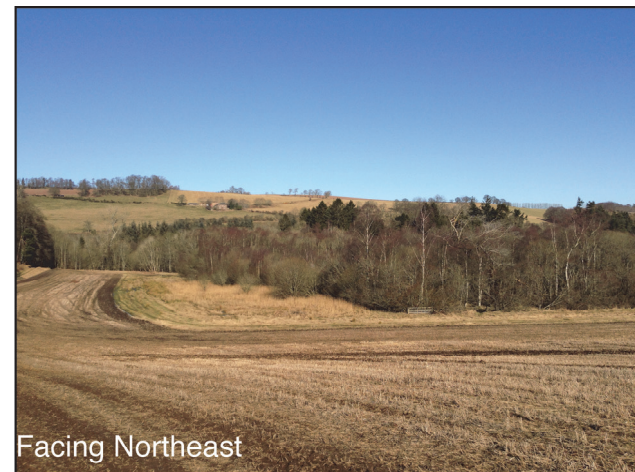
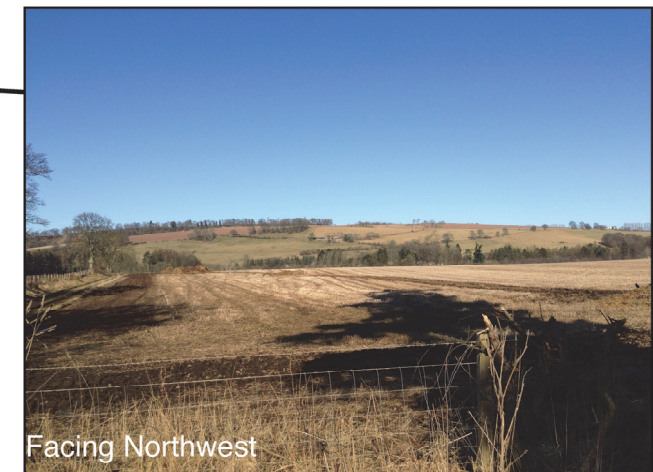
Figure 2.4: Photographs of Surrounding Land Use

- Geo-referenced photograph locations of surrounding land use (refer to Figure 2.4 in Annex 1) ;
- Adjacent land use;
- Identified and potential pollution sources; and
- Atypical or unusual site features (e.g. fly tipping, vandalism, etc.).

- The sampling area was free of litter. No visible pollution sources were observed within the sampling area. Dumping of cut crops was observed at the western boundary of Moss of Ardblair.
- The fields surrounding the site comprise a mixture of grazed and arable land, generally to the north and south of the site respectively, with Rae Loch to the west

(downstream). Dung piles were observed in the fields to the south of Moss of Ardblair. A buffer zone was observed to the south of the site in this area.

- Field drains were observed around the site, including an open drain entering Moss of Ardblair at the north eastern corner.
- The site is fenced and there is no public access.
- There are three properties in close proximity of the site (Ardblair Castle, Mains of Ardblair and Myreside) and several other properties were observed within 500m of the site. It is understood that these properties have septic tanks but this has not been confirmed.
- The town of Blairgowrie (including industrial works) is within ~500m of the site.
- Open drains traverse the site, particularly Moss of Ardblair.

Photograph Log- Surrounding Catchment  
Photographs taken on the 27th February 2013
