# Investigation of Standing Water and Wetland SSSIs thought to be under Diffuse Pollution Pressure: Auchrochar Wetlands

**Commissioned Report No. 714**

## **Investigation of Standing Water and Wetland SSSIs thought to be under Diffuse Pollution Pressure: Auchrochar Wetlands**

**Contractor: EnviroCentre Ltd.**

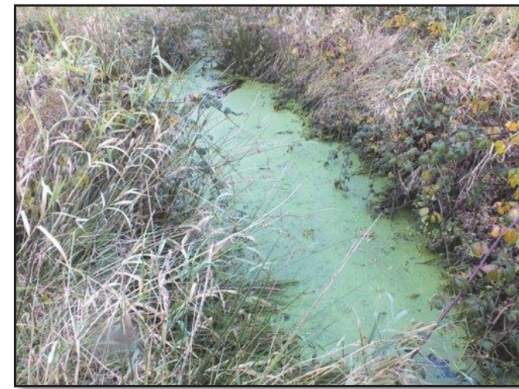
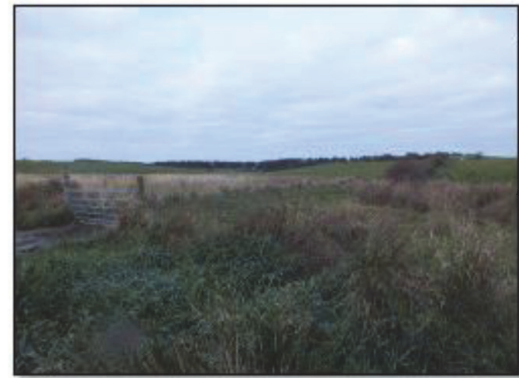
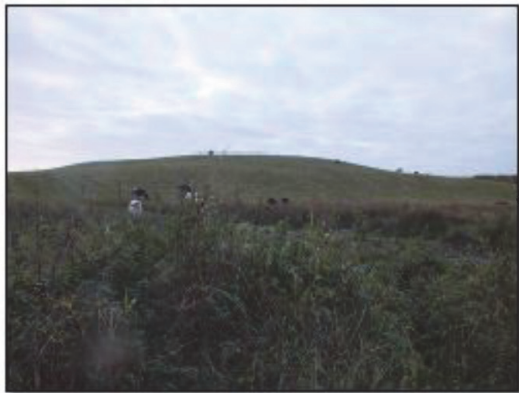
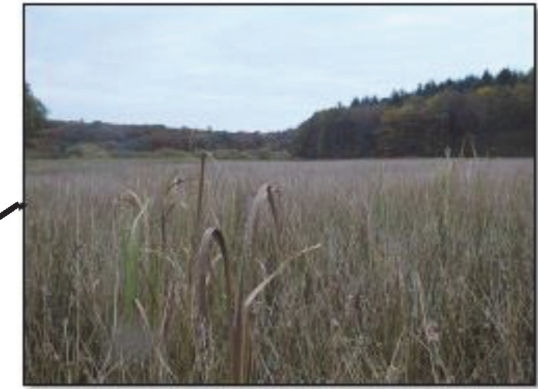
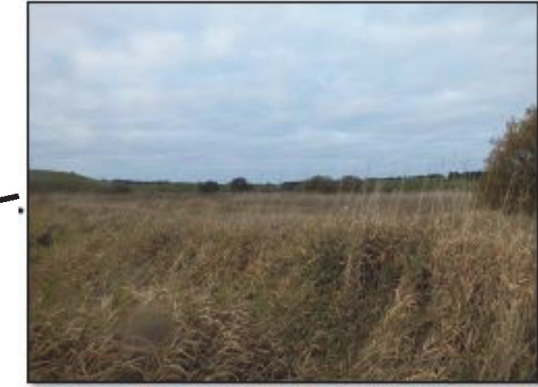
*Figure 2.3: Photographs of each Sampling Location*

All sampling methods were carried out by trained personnel. Photographs of each sampling location were taken (see Figure 2.3 in Annex 1) and grid references for each location recorded.

- With the exception of total iron, all of the laboratory results for AW06 were elevated – particularly for ammonia (with a very high result of 29.2mg/l recorded). The sample comprised an atypical green/brown colouration and was observed to have a strong

farm effluent odour. As this sample is an inflow to the site and collected immediately down gradient of the dairy farm, it is considered to be indicative of contaminated runoff from the farm. In direct contrast to the aforementioned ammonia result (which may have been further elevated by degradation taking place post-sampling/during transit to the lab), it should however be noted that the dissolved oxygen level in this sample is at 85.9%. This value is significantly higher than would be expected of pollutants (e.g. slurry) and/or organic enrichment – with the proposed explanation being that the inflow was very recent and the oxygen level not fully used up at the point the sample was collected. No evidence of slurry spreading was observed in this area.

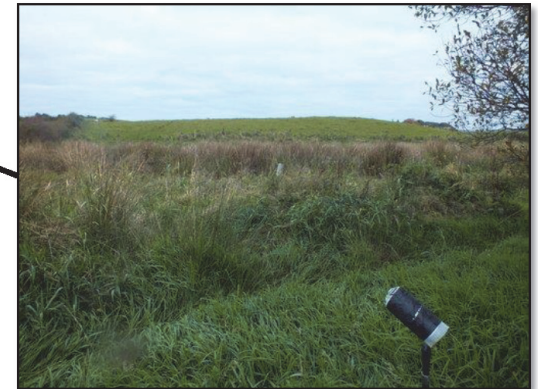
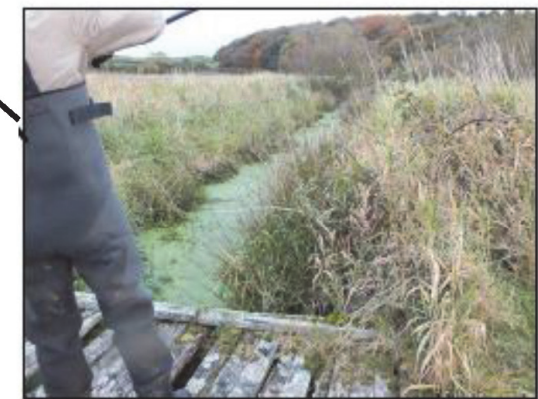
**Photograph Log - Sample Locations**  
**(Photographs taken on 26<sup>th</sup> October 2012/ 19th February 2013)**

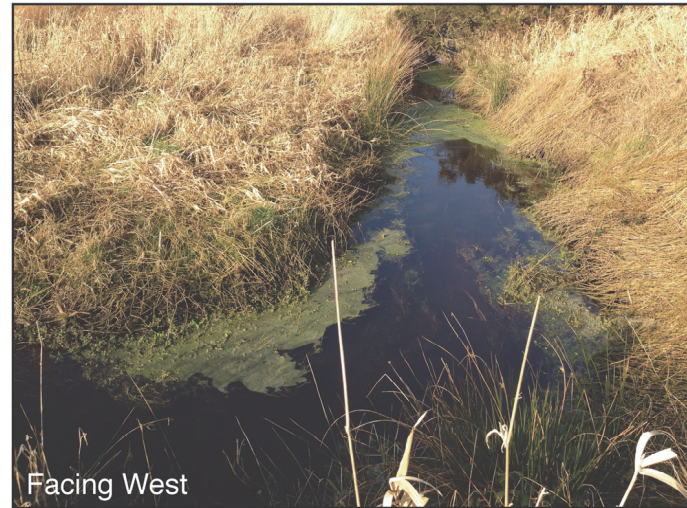
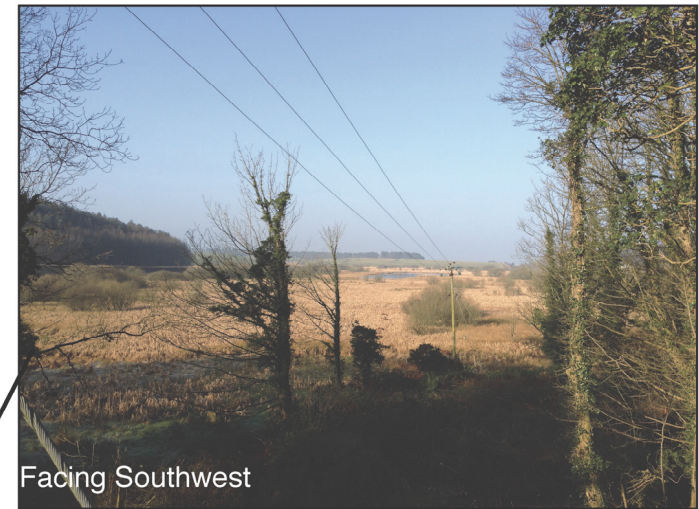
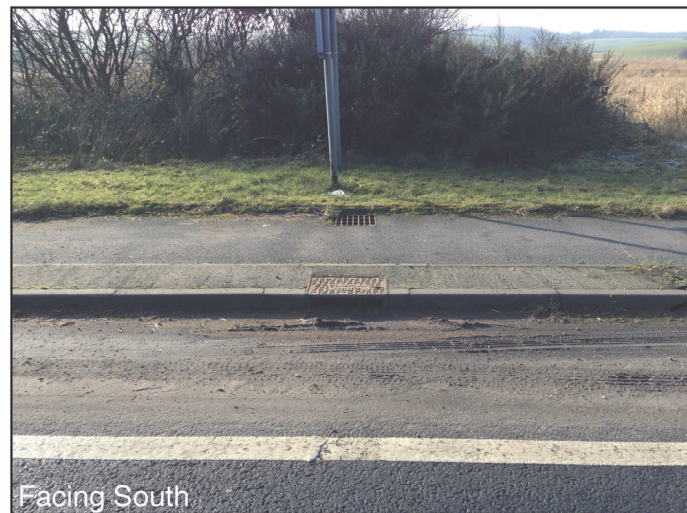
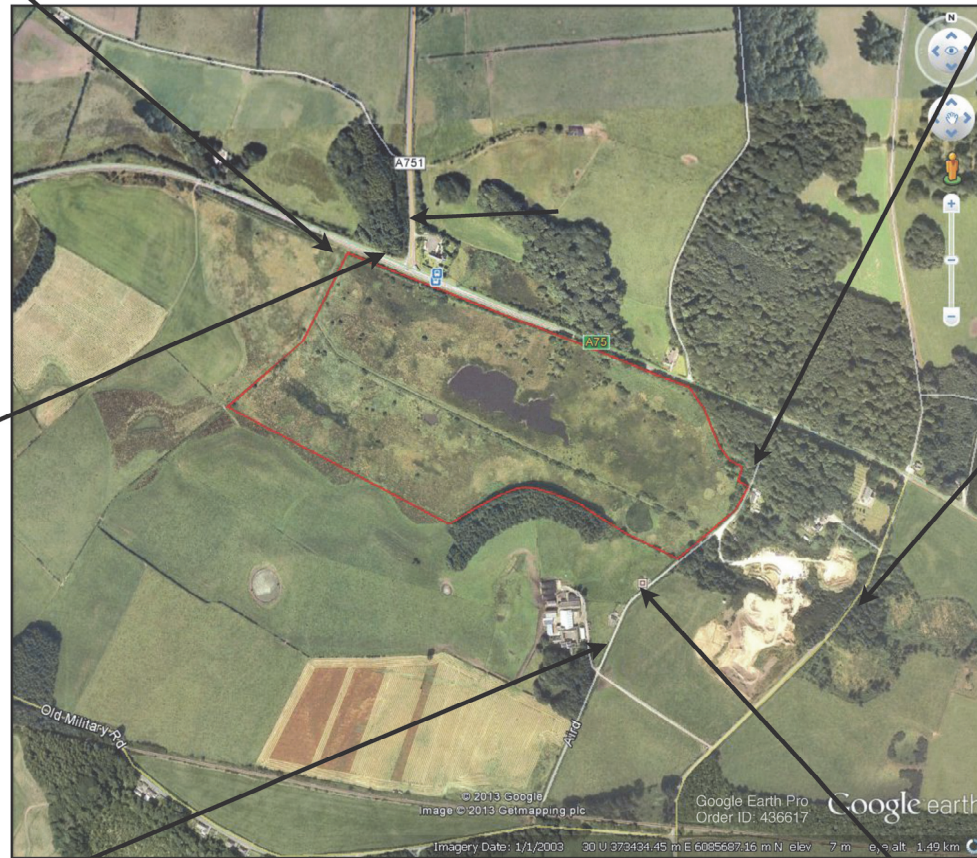
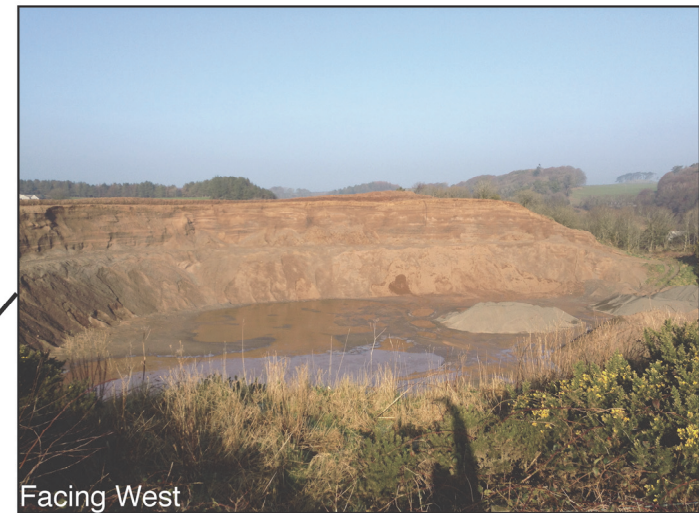
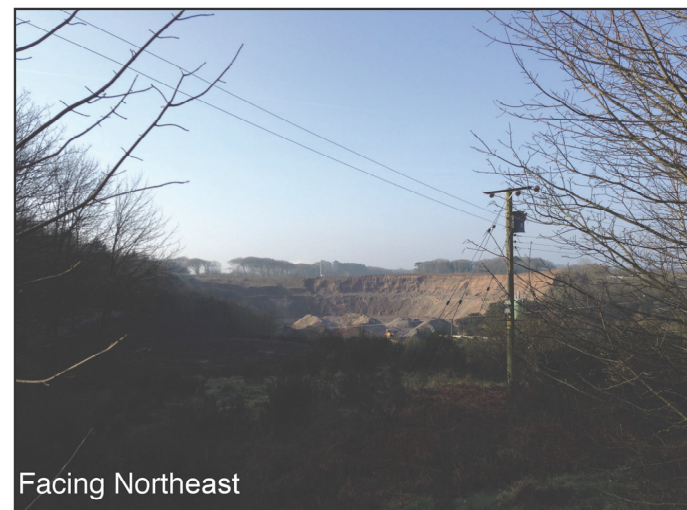
Figure 2.4: Photographs of Surrounding Land Use

- The site was free of litter. No visible pollution sources were observed within the site boundary.
- There is an access track through the middle of the site (the man-made causeway). It was considered that the track is suitable for vehicle access.
- A dairy farm is situated on the south boundary of the site. This comprises a sizeable operational facility.

- To the south and west of the site were grazed fields associated with the adjacent dairy farm. None of the fields were noted to have buffer strips or reduced margins where they border the SSSI site.

- ix. Review the use of fertilisers and soil conditioning applications within the landholding immediately adjacent to the site boundary, as well as the management of the dairy steading.

- xii. Proactively engage with dairy steading to understand current management and address potential pollution issues.
- xiii. Proactively engage with catchment landowners to understand the historical land use practices to determine changes which are likely to have influenced the site. This should include the now derelict buildings on the north eastern boundary and an appraisal of how the operations therein may have influenced conditions at the site.

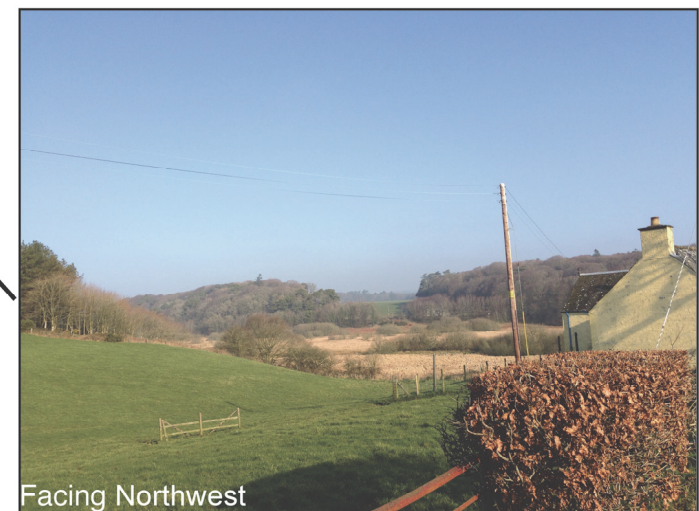
- Geo-referenced photograph locations of surrounding land-use (see Figure 2.4 in Annex 1);
- Adjacent land use;
- Identified and potential pollution sources; and
- Atypical or unusual site features (e.g. fly tipping, vandalism, etc.).

Photograph Log- Surrounding Catchment  
Photograph Taken 19th February 2013
