Investigation of Standing Water and Wetland SSSIs thought to be under Diffuse Pollution Pressure: Camilla Loch

Commissioned Report No. 716

Commissioned Report No. 716
Project No: 13700
Contractor: EnviroCentre Ltd.
Year of publication: 2015

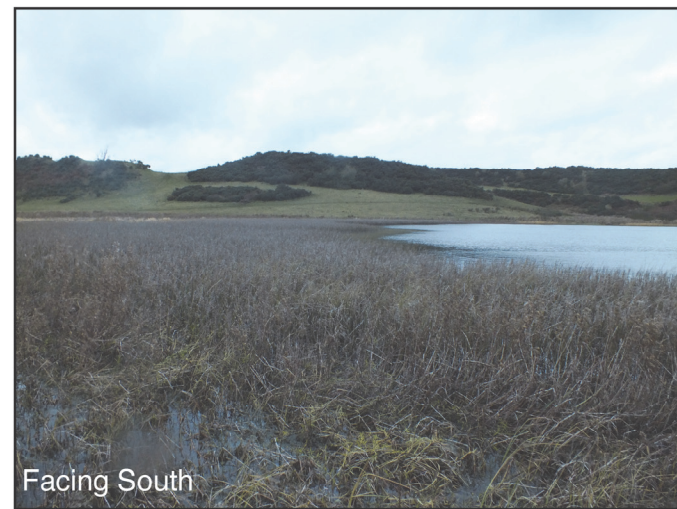
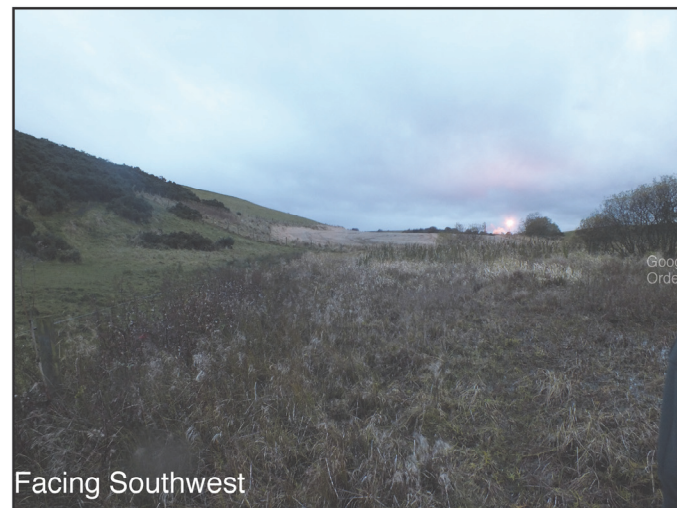
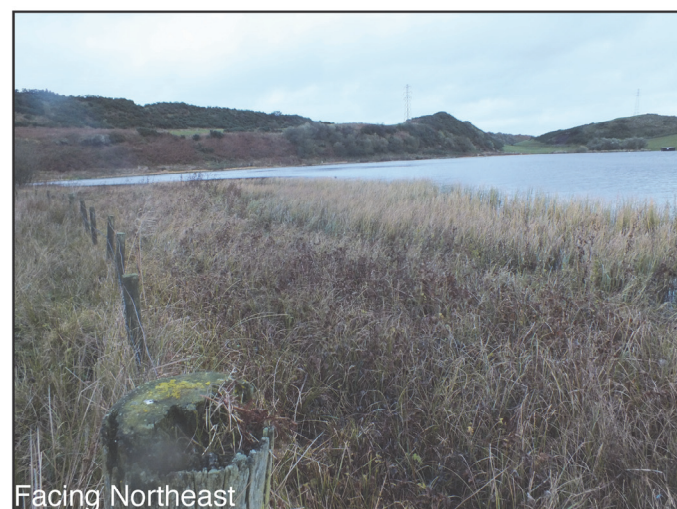
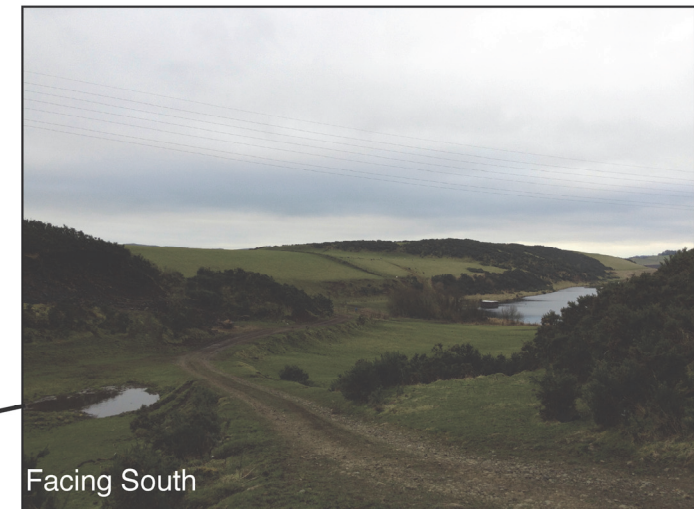
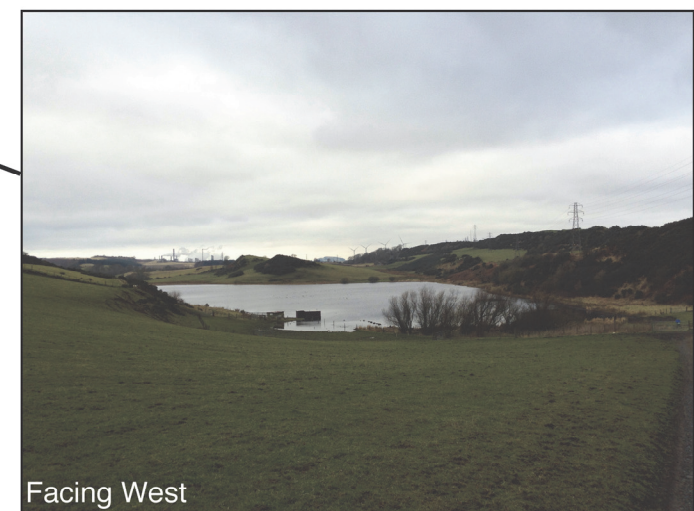
Figure 2.4: Surrounding Land Use Photographs

Photograph Log- Surrounding Catchment
Photographs taken on 20th February 2013
