Investigation of Standing Water and Wetland SSSIs thought to be under Diffuse Pollution Pressure: Carriston Reservoir

Commissioned Report No. 718

Commissioned Report No. 718
Project No: 13700
Contractor: EnviroCentre Ltd.
Year of publication: 2015

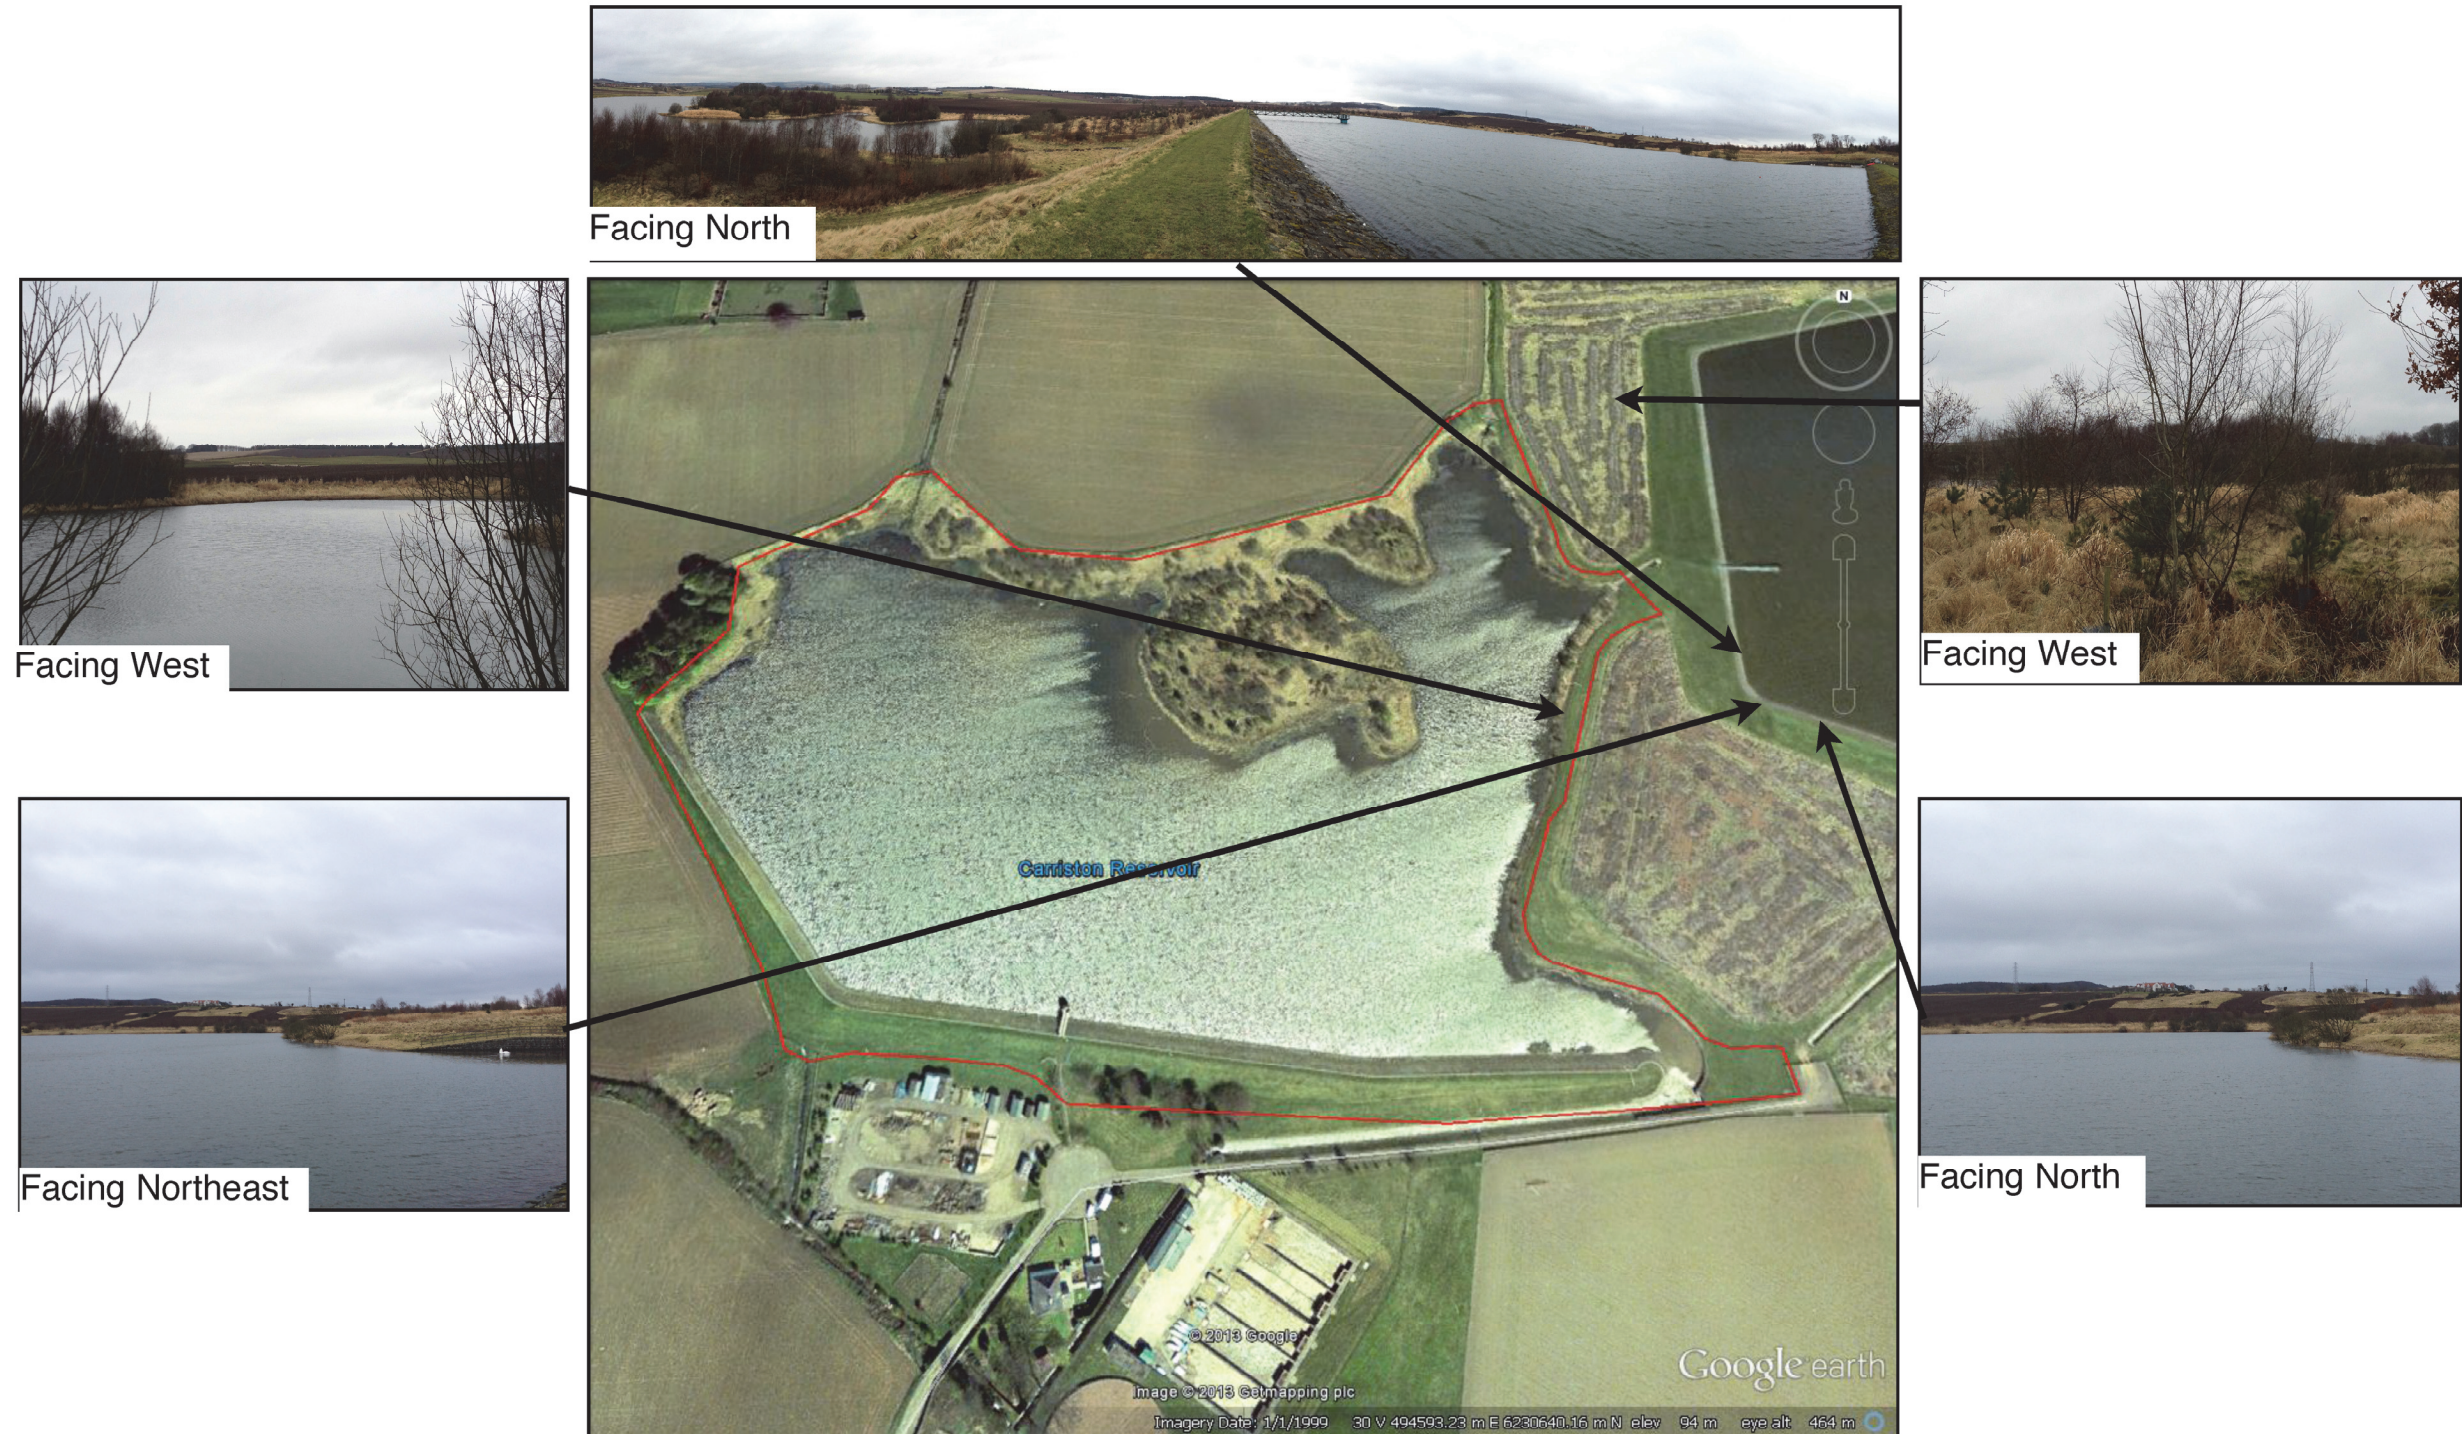
Figure 2.4: Surrounding Land Use Photographs

- The site was free of litter. No visible pollution sources were observed within the site boundary.
- Agricultural land bounding the site was ploughed at the time of the site visit. No clear buffer zones were observed along the northern perimeter of the site.
- The wider catchment comprises extensive areas of agricultural land. The upper catchment is connected to the site by the unnamed burn and this provides hydraulic connectivity with the SSSI. The land management practices and residential sewage provision in the upstream catchment are likely to have a direct influence on the quality and quantity of flows in the unnamed burn.

- An active quarry is operating in the catchment to the north of the site. This appears to be of a reasonable scale and may directly influence groundwater quality and/or the quantity/quality of the flows in the unnamed burn.

Photograph Log- Surrounding Catchment
 Photographs taken 20th February 2013
