Investigation of Standing Water and Wetland SSSIs thought to be under Diffuse Pollution Pressure: Danskin Loch

Commissioned Report No. 721

Investigation of Standing Water and Wetland SSSIs thought to be under Diffuse Pollution Pressure: Danskine Loch

Contractor: EnviroCentre Ltd.

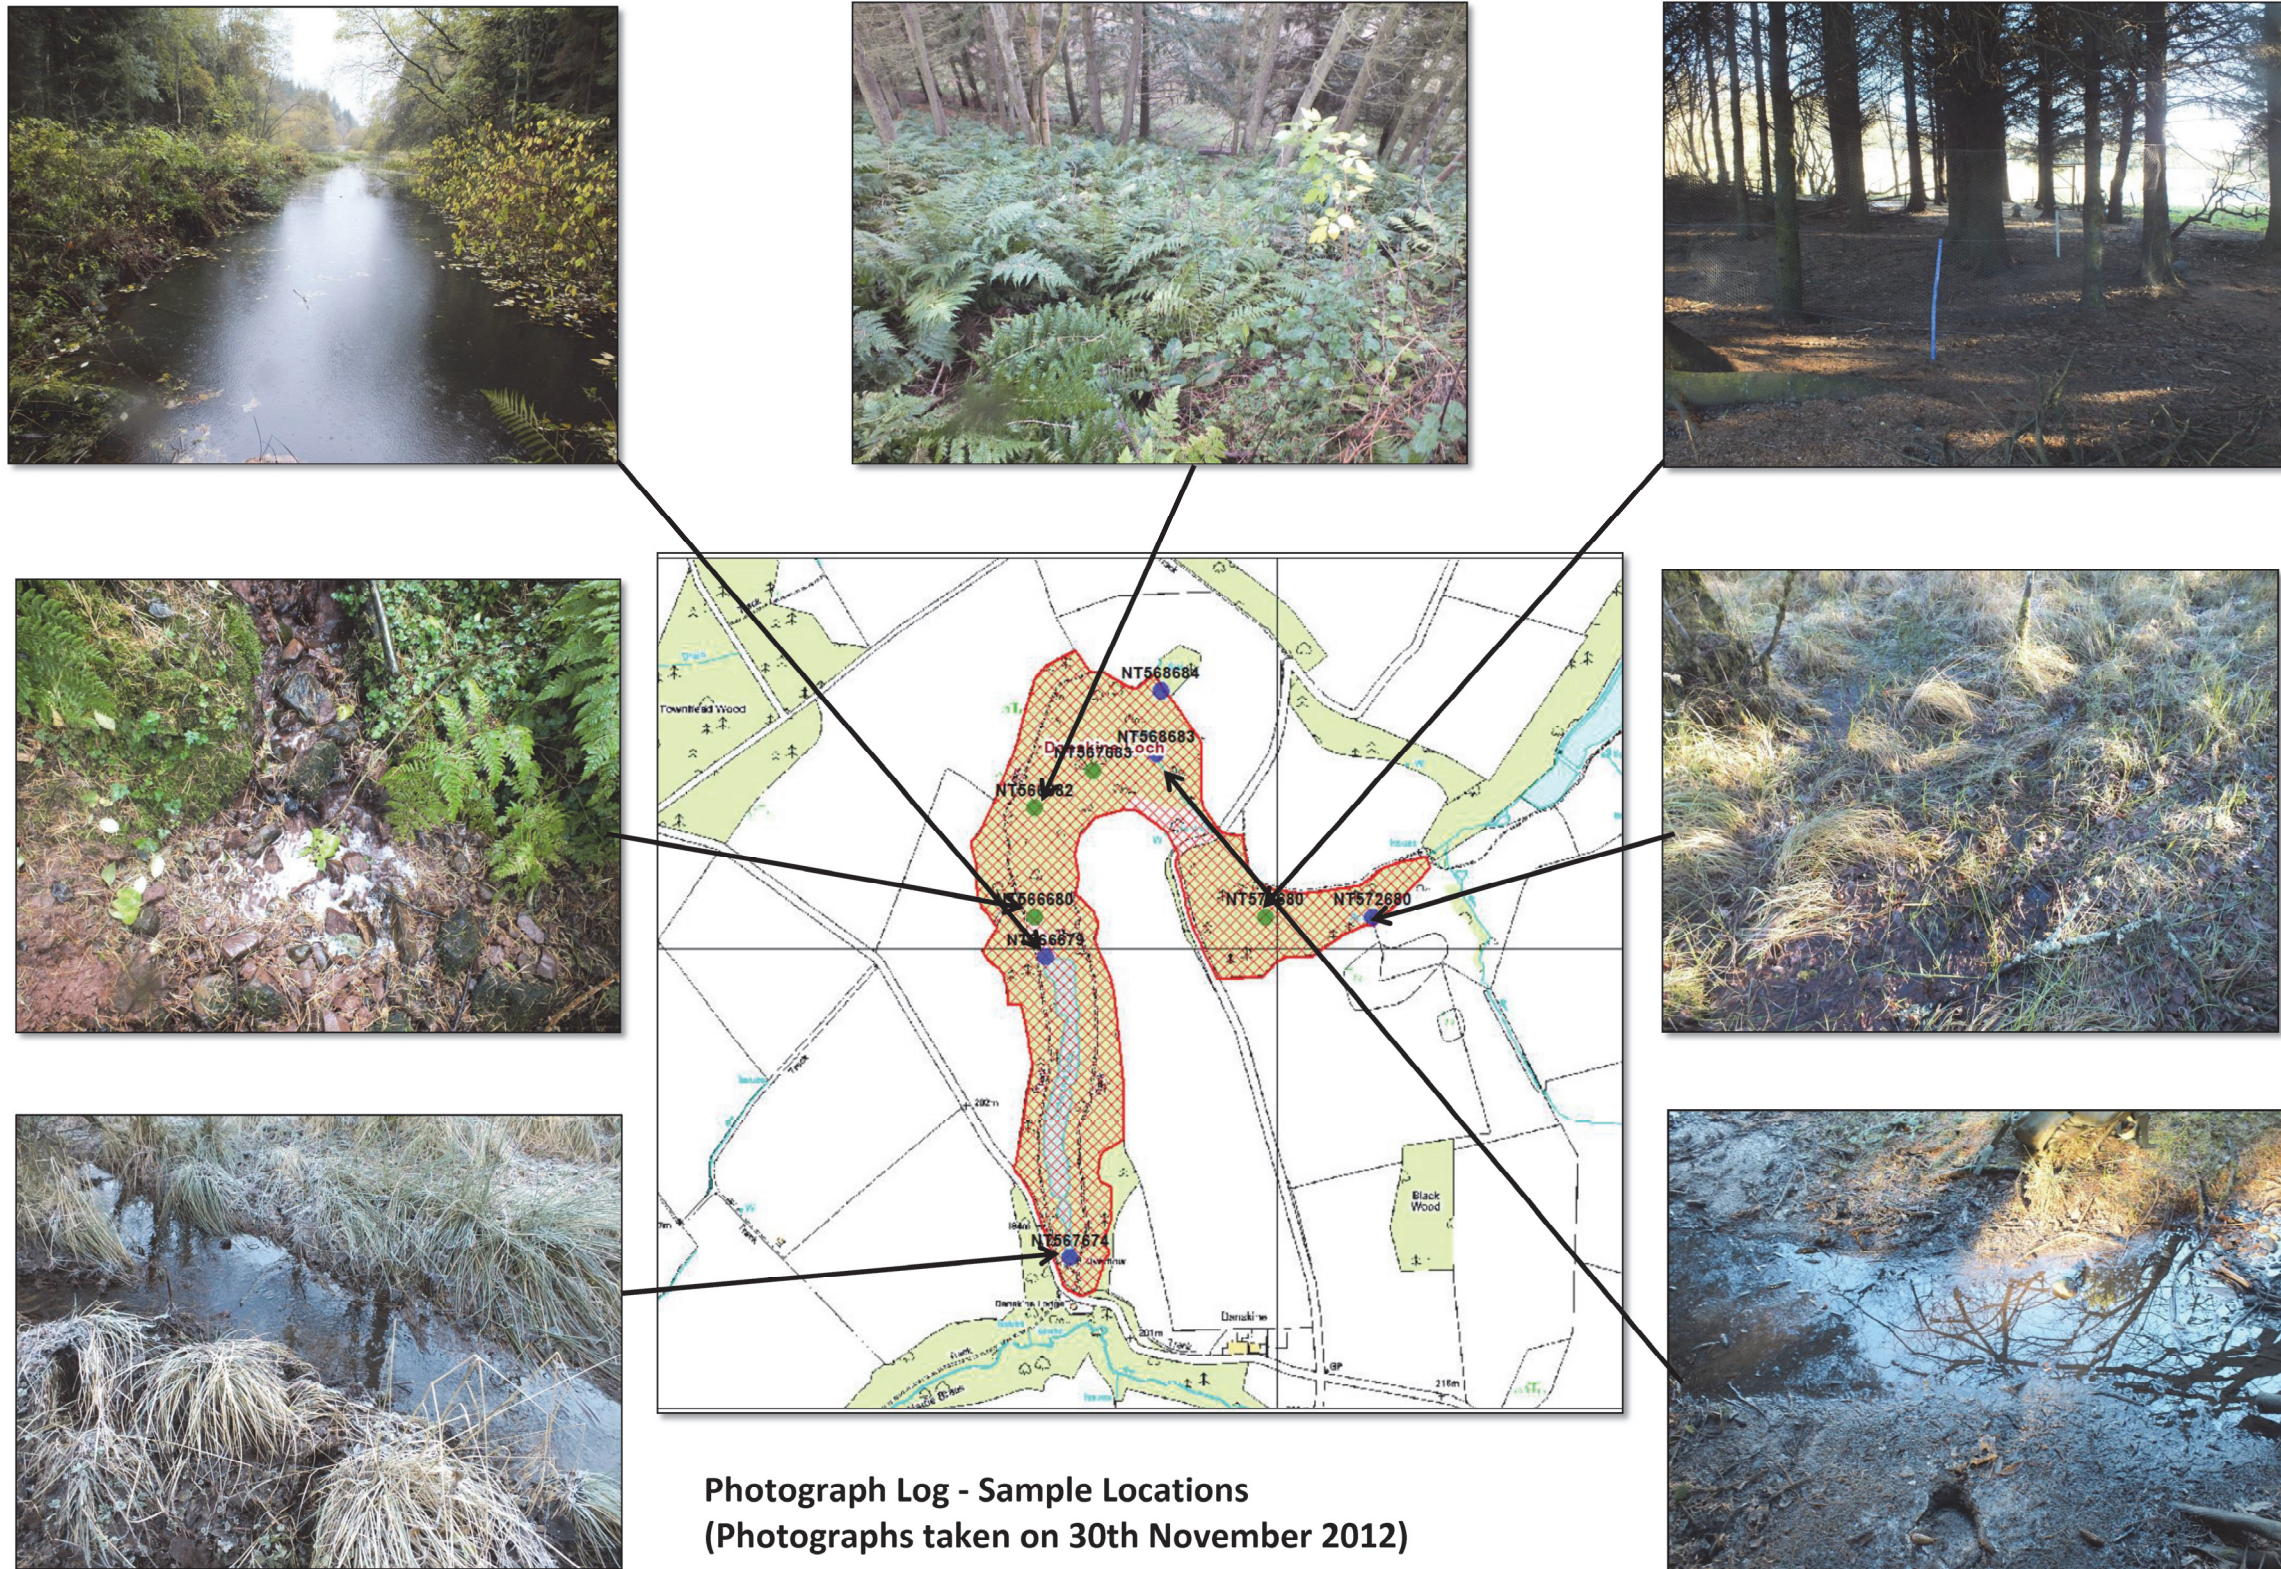
Figure 2.3: Sample Location Photographs

All sampling methods were carried out by trained personnel. Photographs of each sampling location were taken (see Figure 2.3 in Annex 1) and grid references for each location recorded.

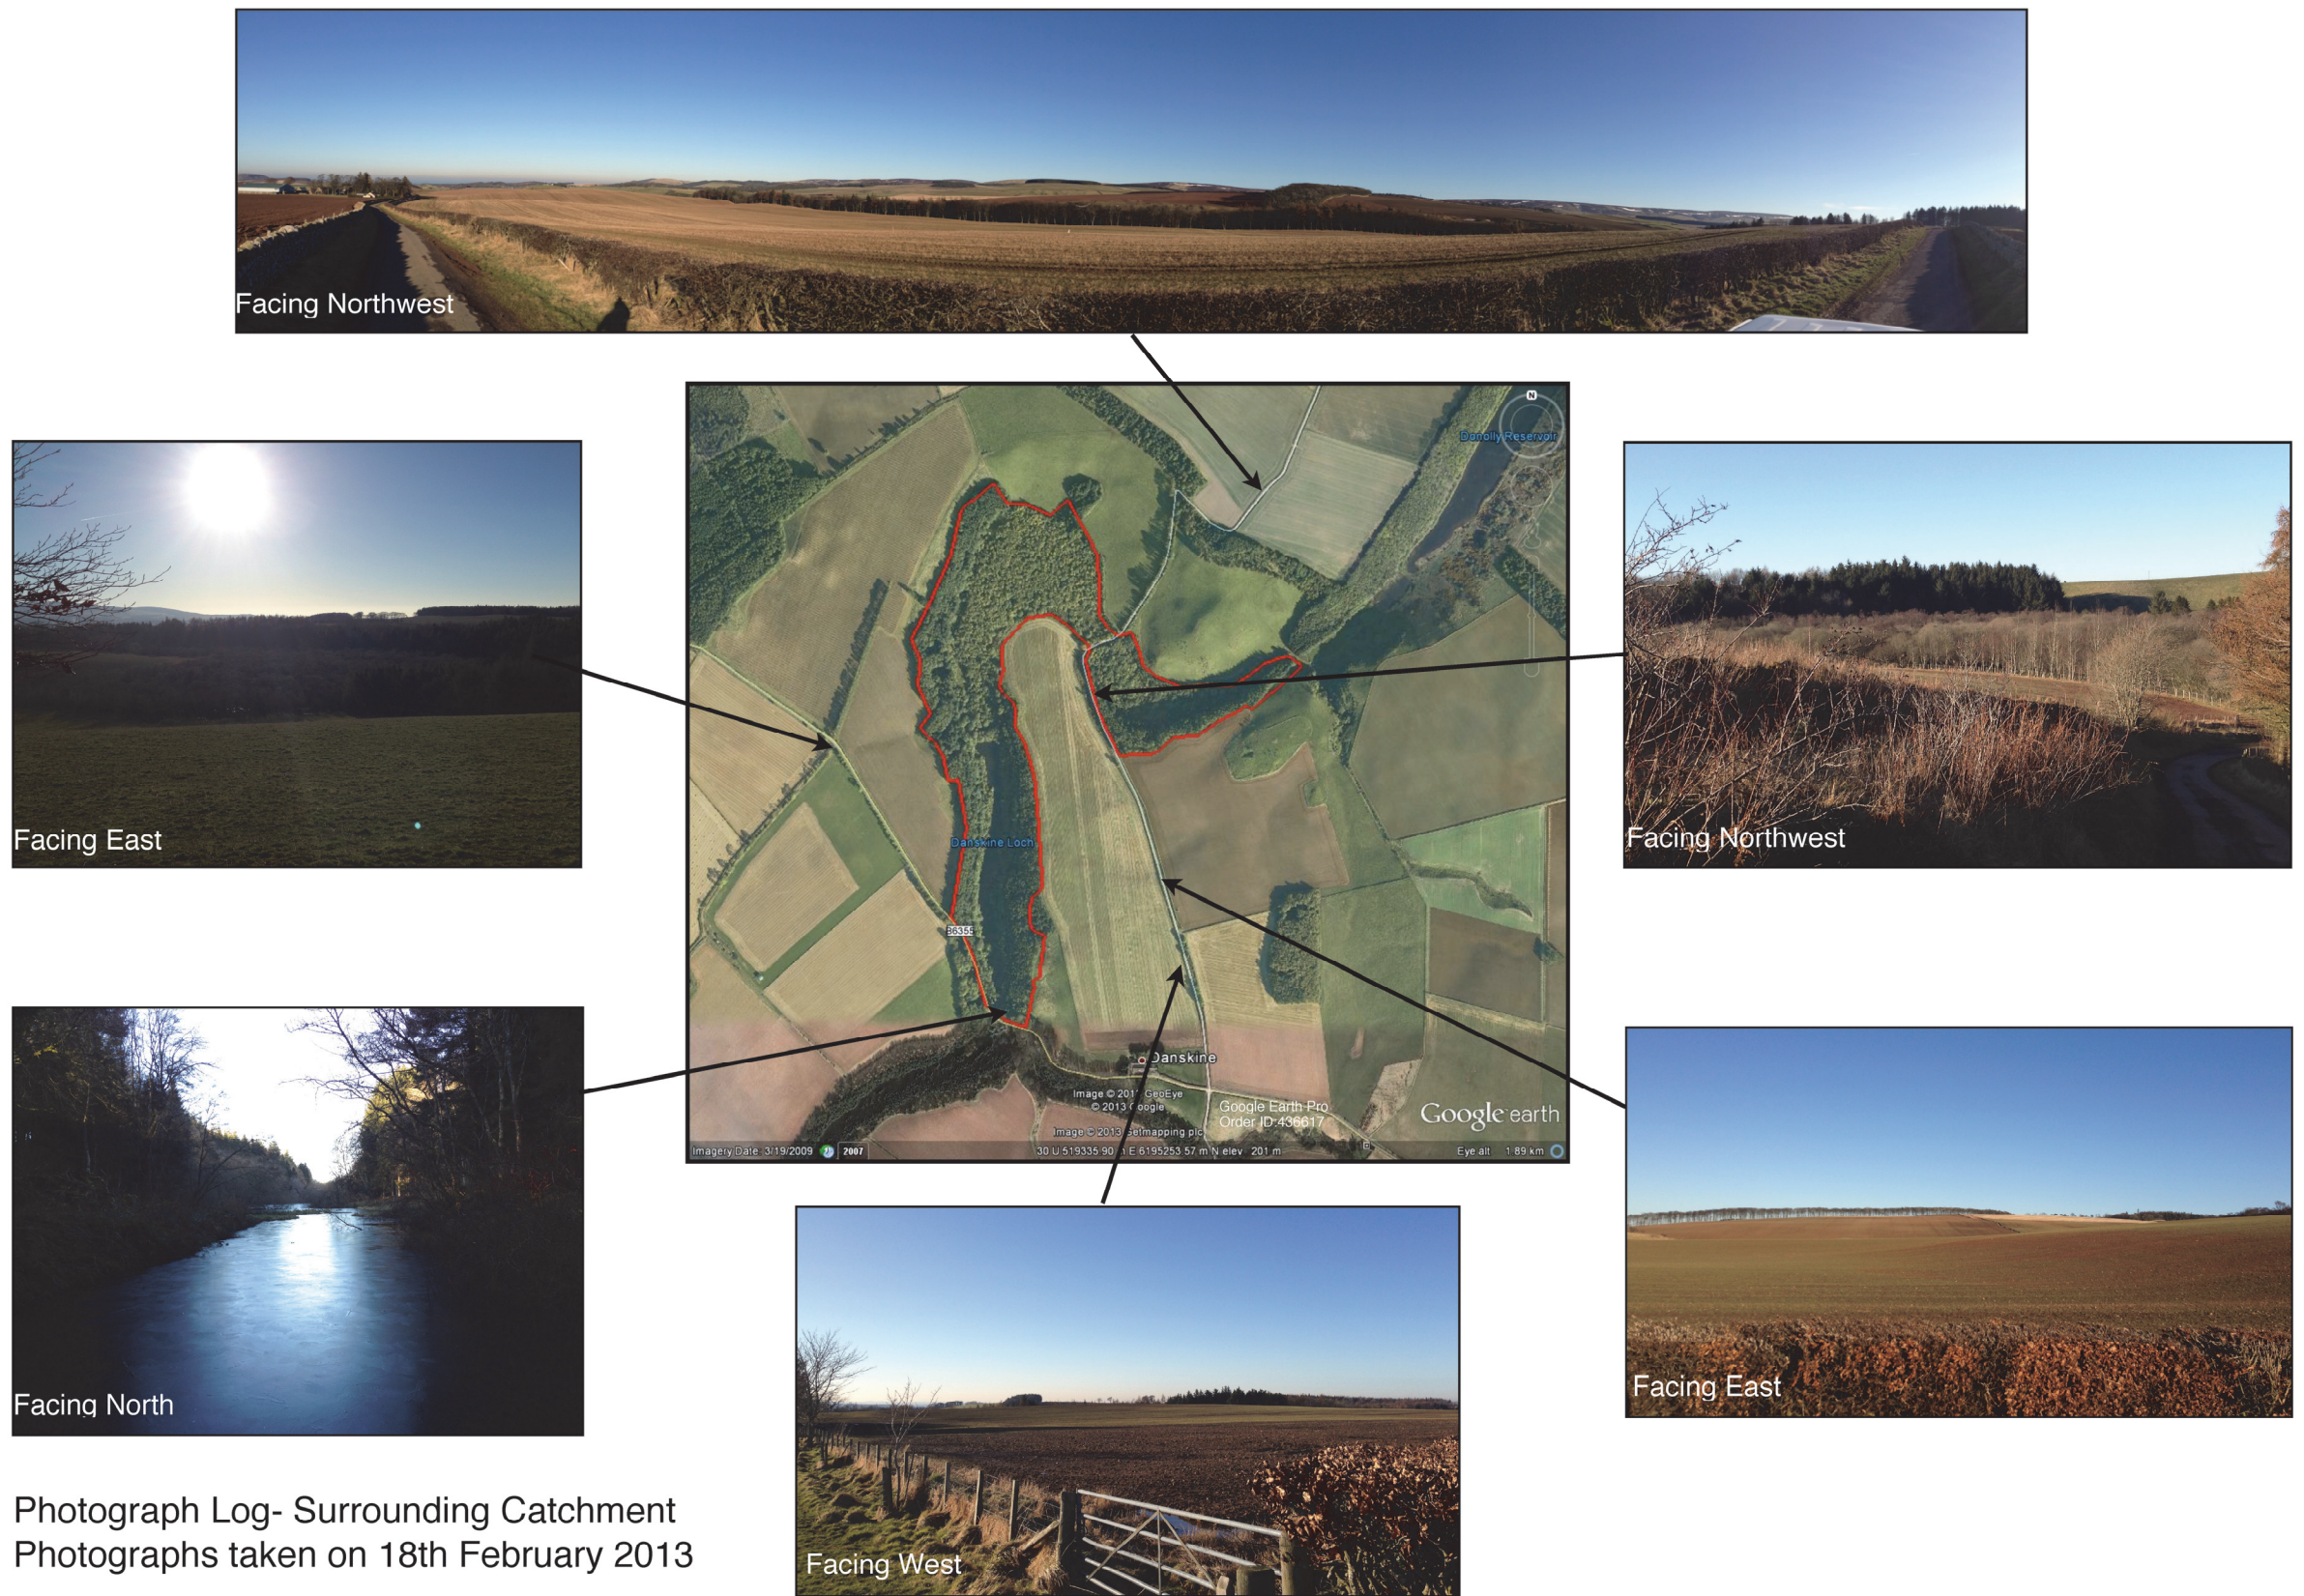
Figure 2.4: Surrounding Land Use Photographs

- Geo-referenced photograph locations of surrounding land use (refer to Figure 2.4 in Annex 1);
- Adjacent land use;
- Identified and potential pollution sources; and
- Atypical or unusual site features (e.g. fly tipping, vandalism, etc.).

Photograph Log- Surrounding Catchment Photographs taken on 18th February 2013
