Investigation of Standing Water and Wetland SSSIs thought to be under Diffuse Pollution Pressure: Duddingston Loch

Commissioned Report No. 723

Commissioned Report No. 723
Project No: 13700
Contractor: EnviroCentre Ltd.
Year of publication: 2015

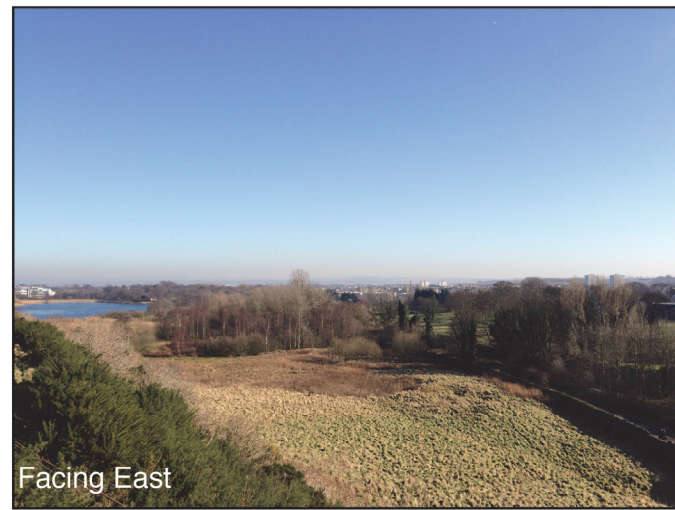
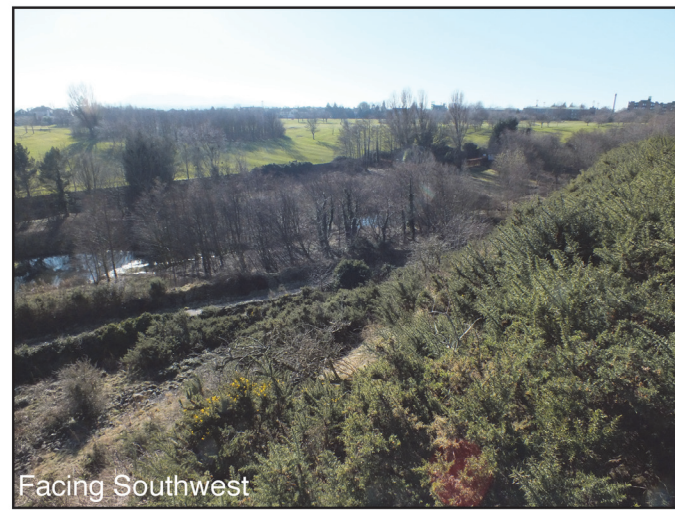
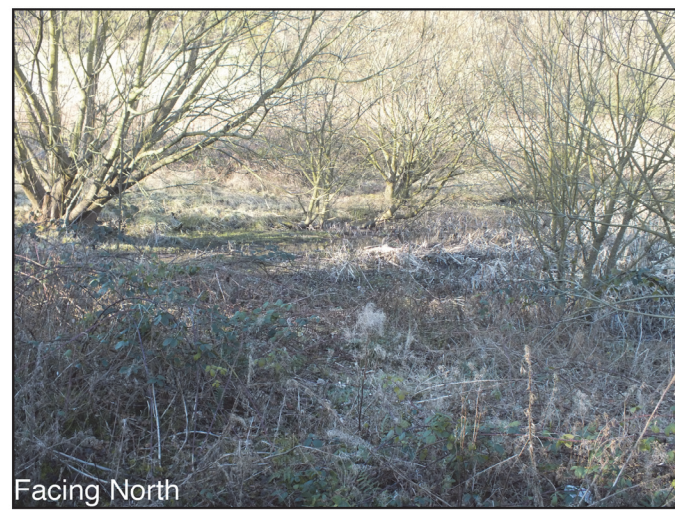
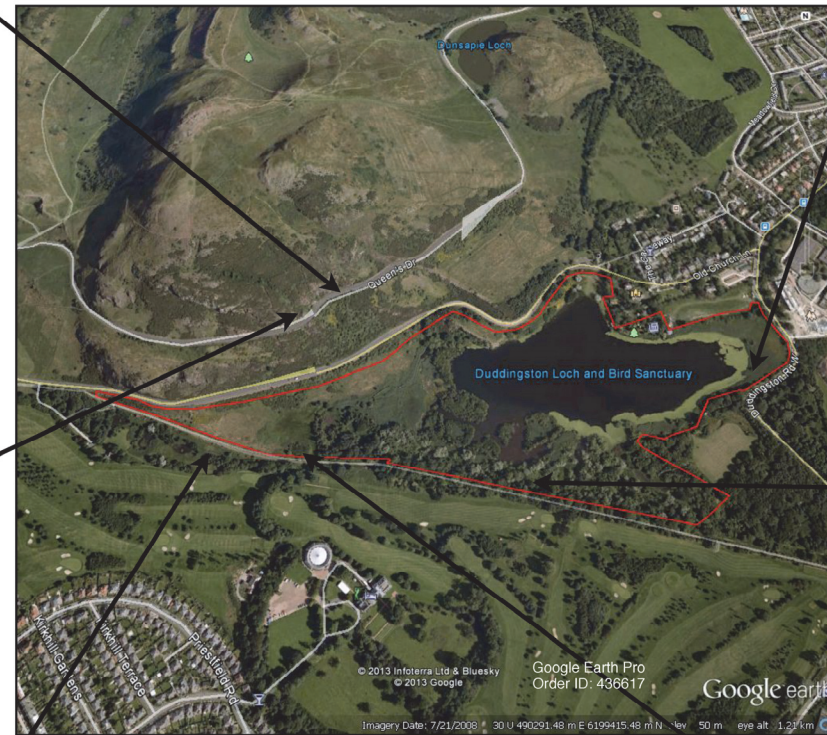
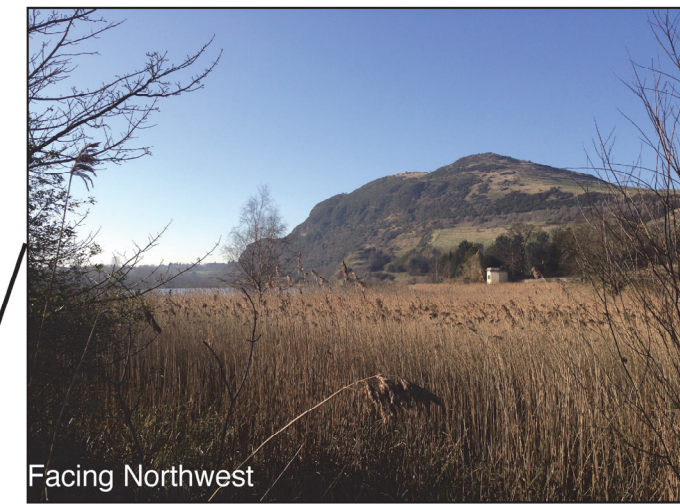
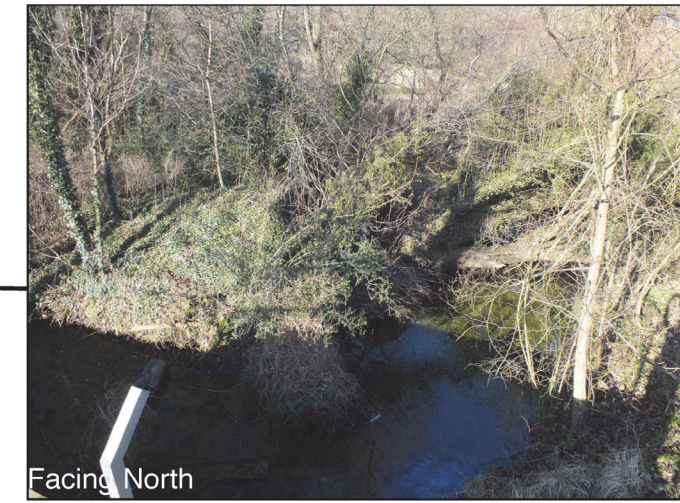
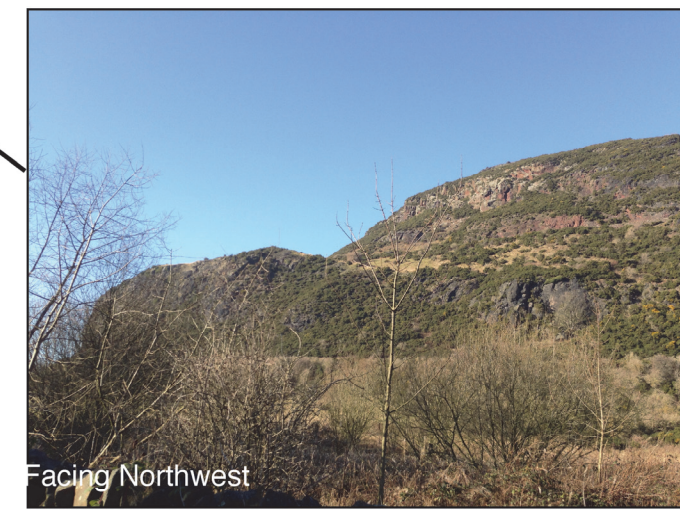
Figure 2.4: Surrounding Land Use Photographs

Photograph Log- Surrounding Catchment
Photographs taken 27th February 2013
