Investigation of Standing Water and Wetland SSSIs thought to be under Diffuse Pollution Pressure: Gattonside Moss

Commissioned Report No. 724

Commissioned Report No. 724
Project No: 13700
Contractor: EnviroCentre Ltd.
Year of publication: 2015

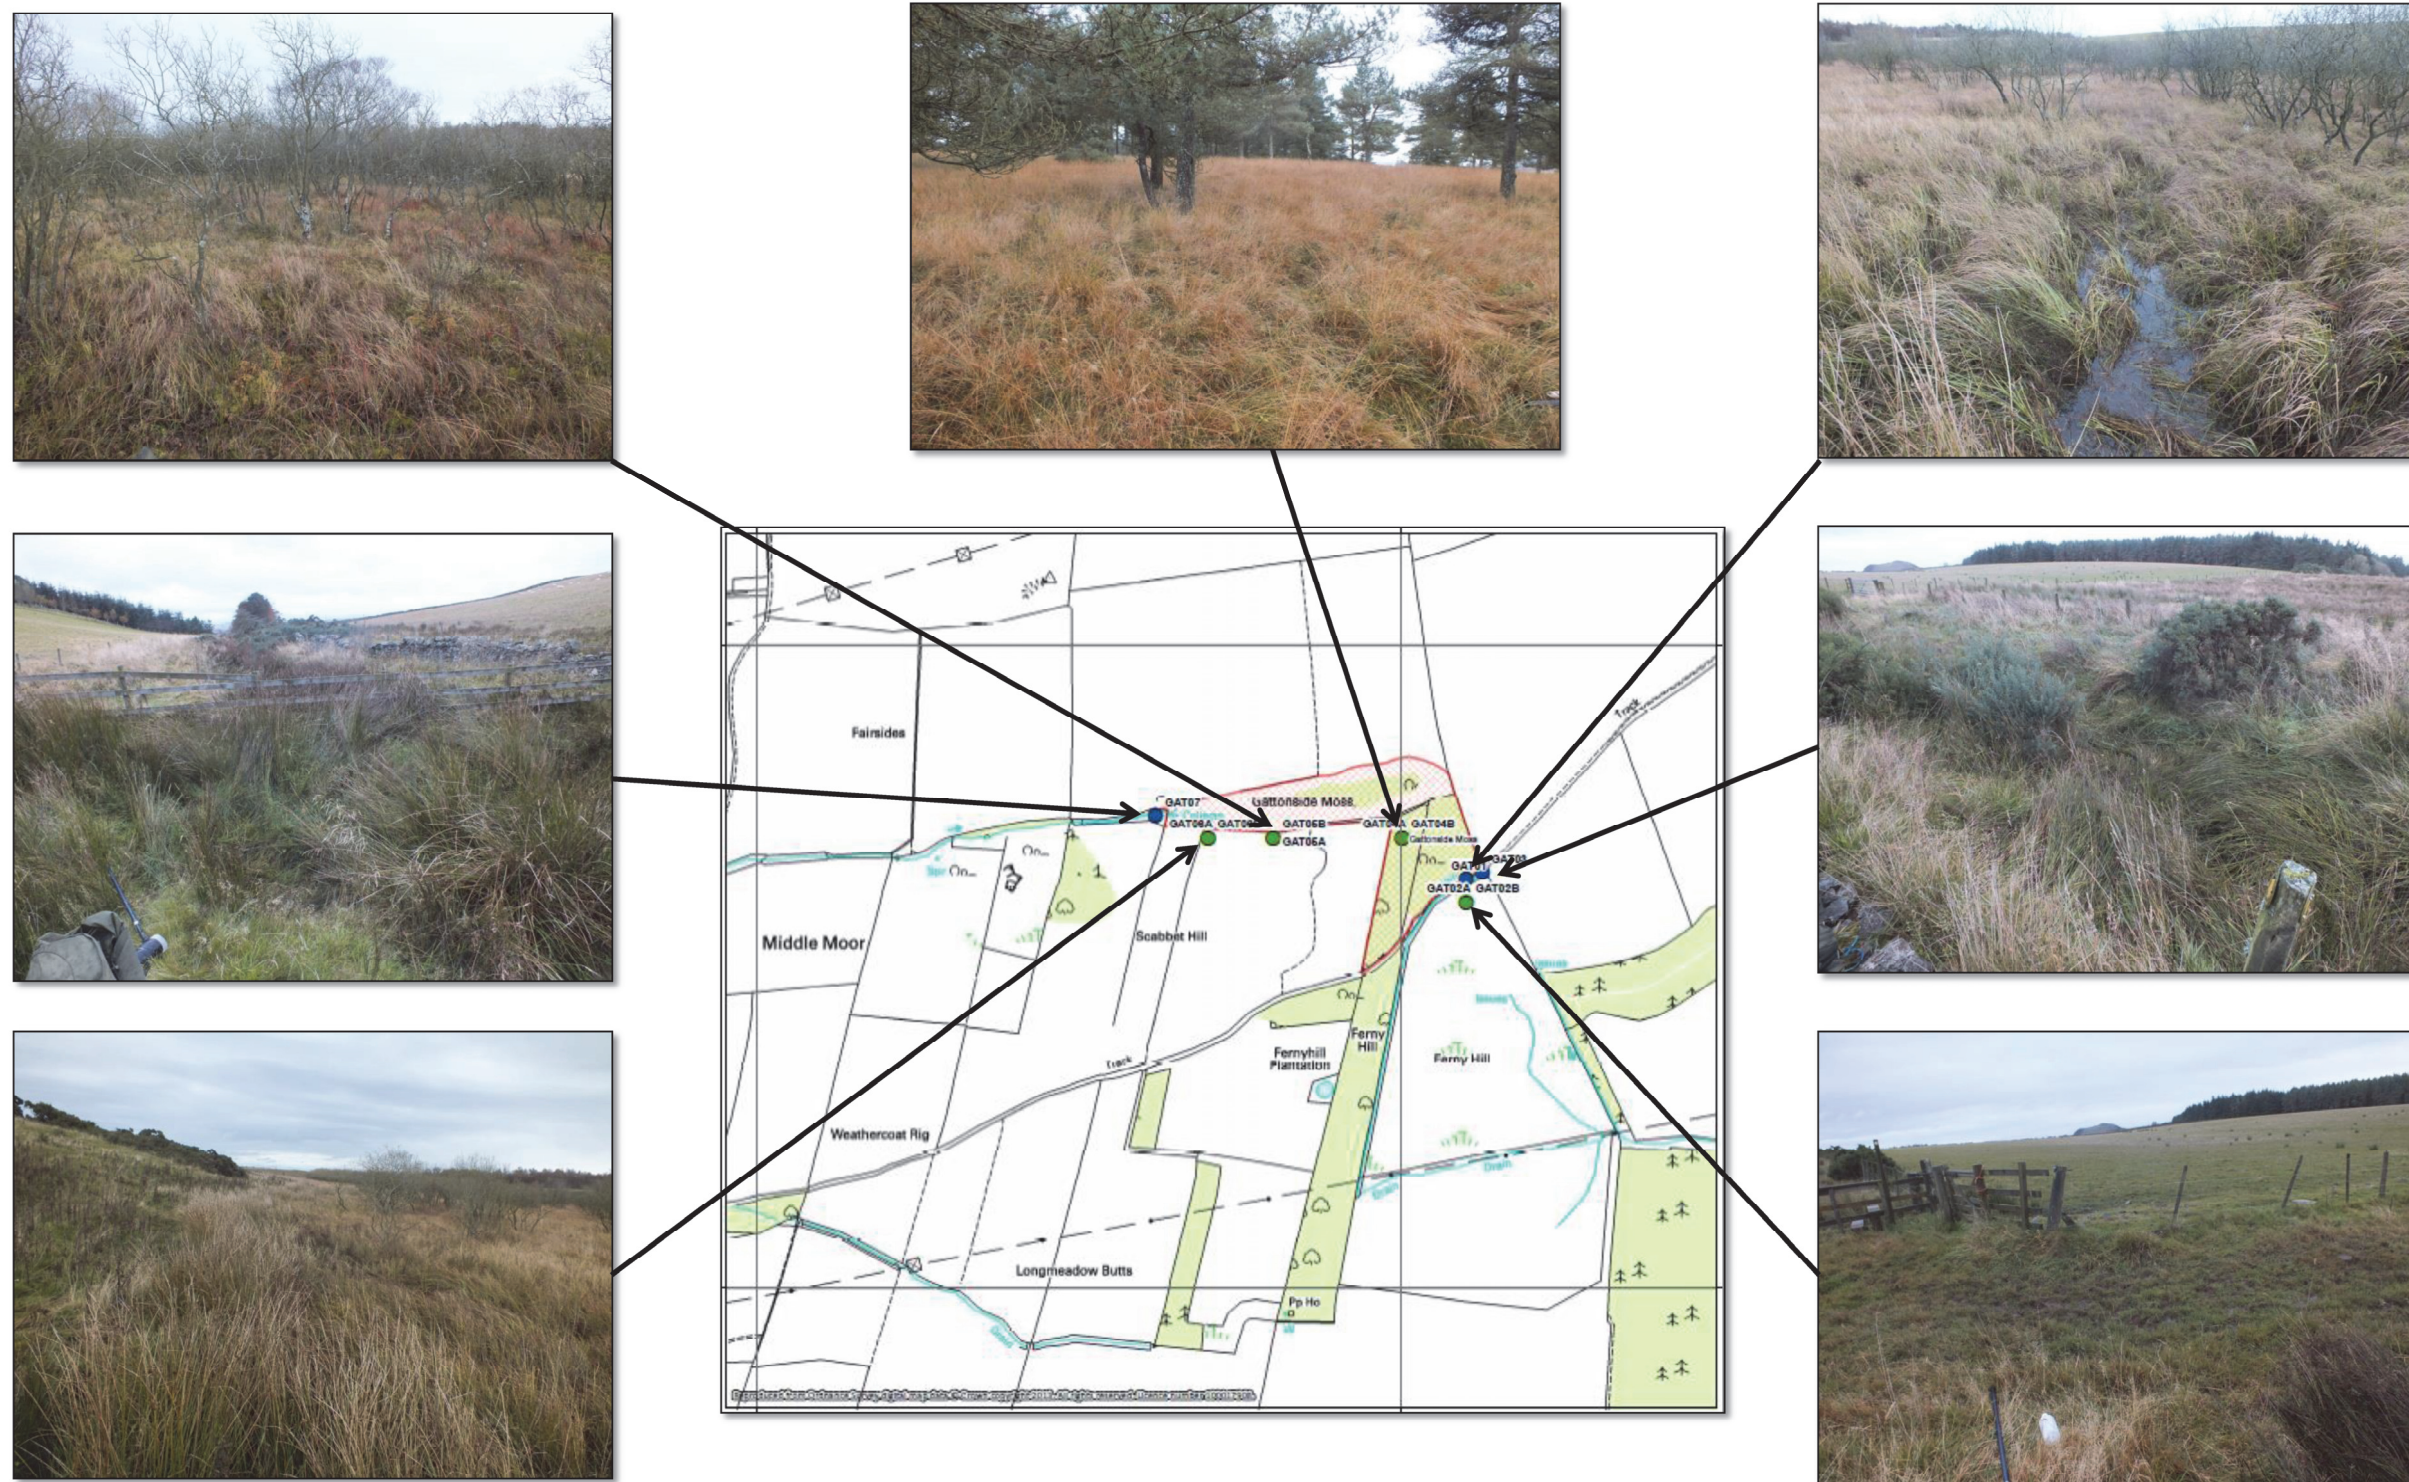
Figure 2.3: Sampling Location Photographs

All sampling methods were carried out by trained personnel. Photographs of each sampling location were taken (see Figure 2.3 in Annex 1) and grid references for each location recorded.

Photograph Log - Sample Locations
(Photographs taken on 6th November 2012)

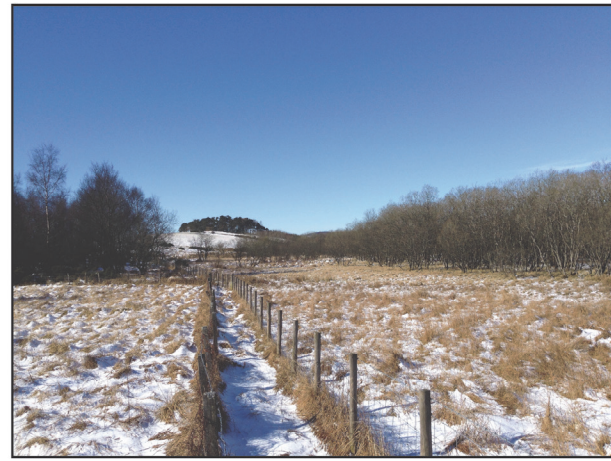
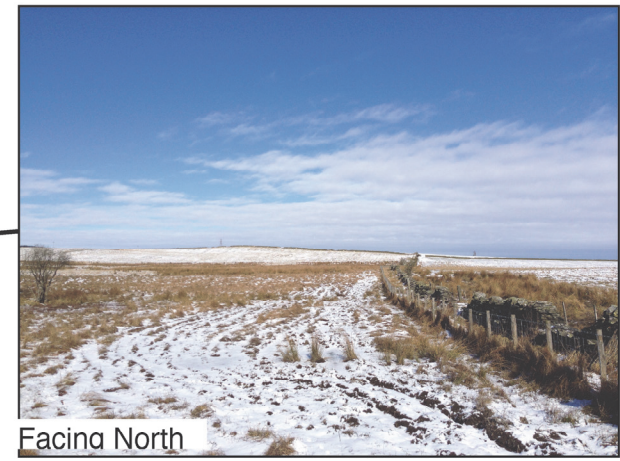
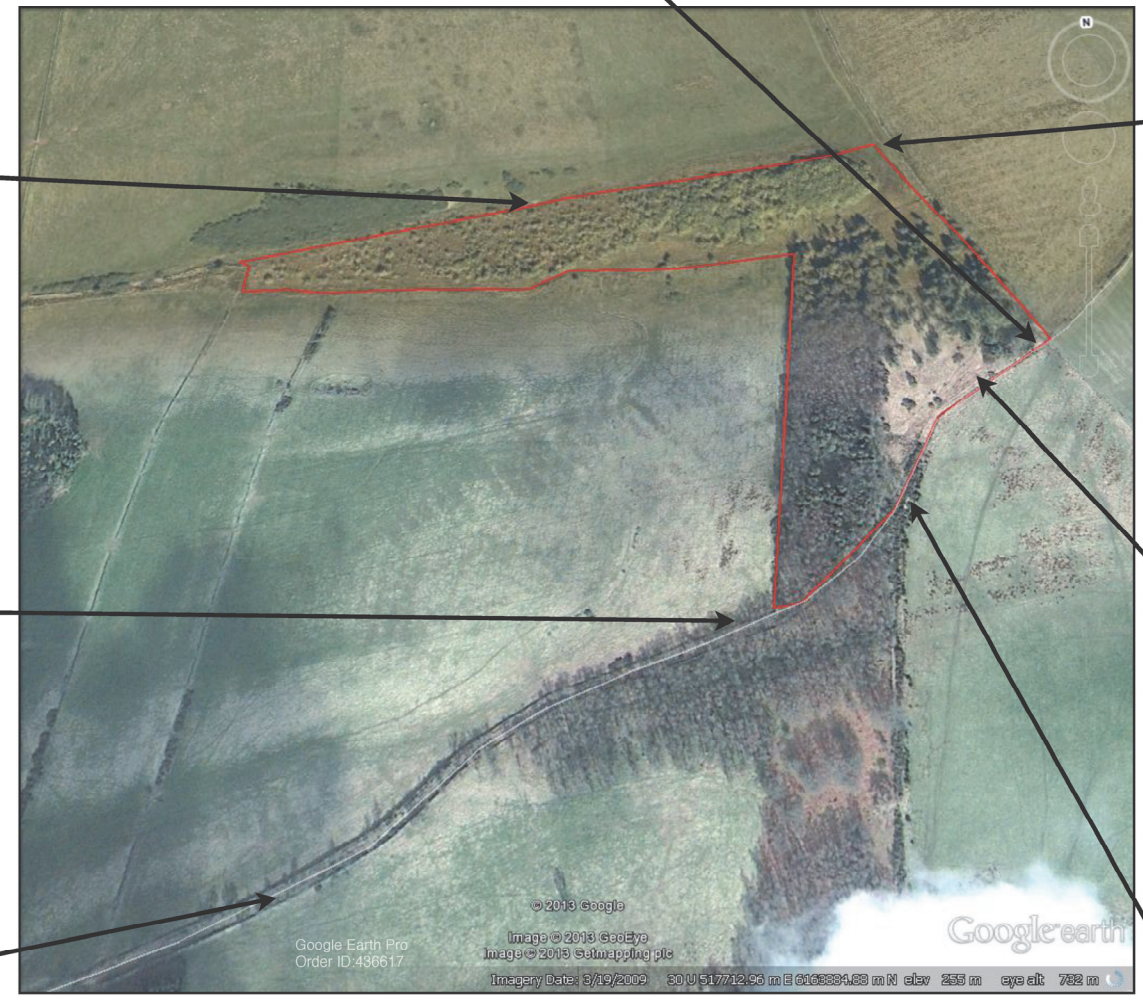
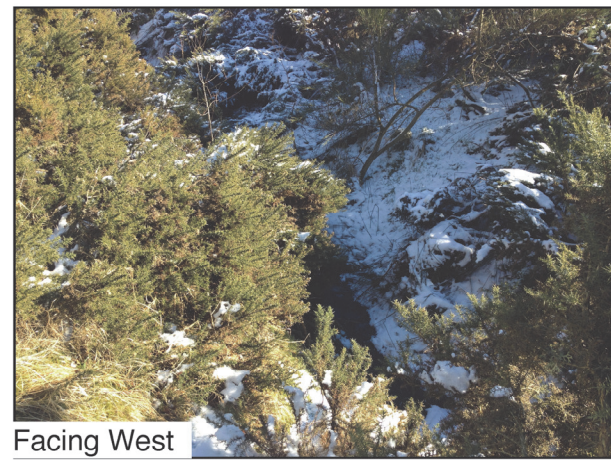
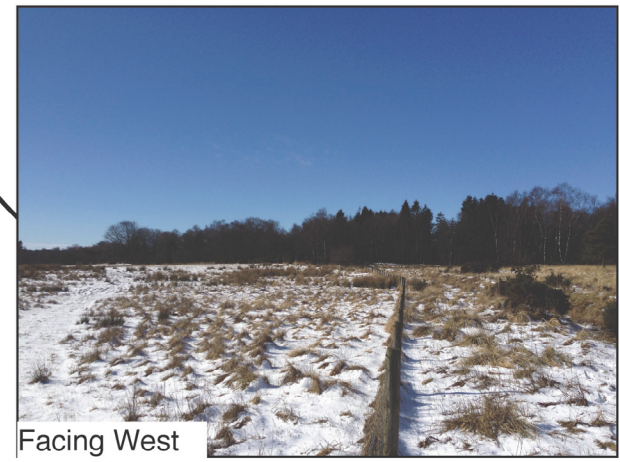
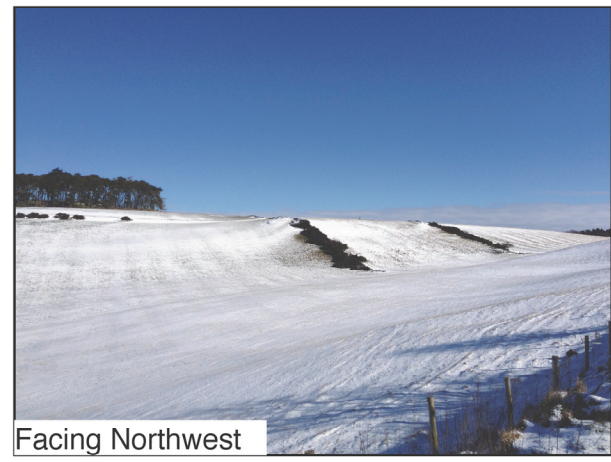
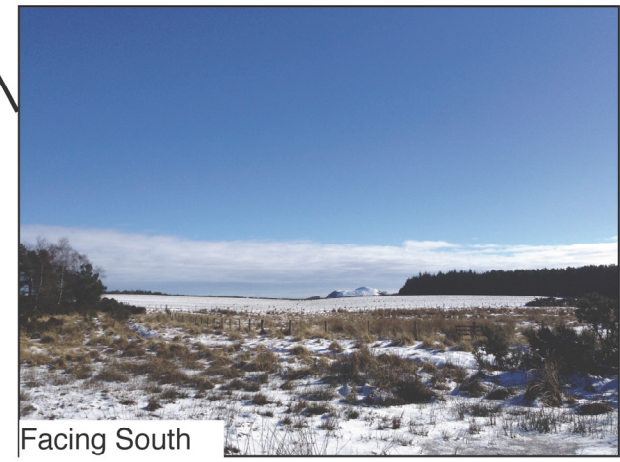
Figure 2.4: Surrounding Land Use Photographs

- Geo-referenced photograph locations of surrounding land use (refer to Figure 2.4 in Annex 1);
- Adjacent land;
- Identified and potential pollution sources; and
- Atypical or unusual site features (*e.g.* fly tipping, vandalism, *etc.*).

- The site was free of litter and no visible pollution sources were observed within the site boundary.
- The site sits in an upland location but is directly influenced by the surrounding topography which comprises hills to the north, west and south.
- The only locations of open water observed on site were in the northern valley fen section in areas close to the source of the springs. The southern part of the site largely comprised scrub vegetation including gorse and mature Scots Pine (*Pinus sylvestris*) trees.
- The northern part of the site was markedly drier than the southern area, with the latter being the wettest at the southern-most boundary.

- The immediate fields abutting the site to the north and east comprised improved pasture. No grazing was observed in the adjacent fields at the time of the visit. This may be due to the unfavourable weather conditions and presence of snow on the ground.

- Evidence of the immediate surrounding land having been improved for agricultural purposes. Evidence of muck spreading was observed as having recently taken place in the fields which lie immediately east and south of the site. This may also explain the absence of grazing stock. No buffer zones were observed to be in existence although the activities did not appear to have encroached onto the SSSI site.

- A man-made drainage ditch – believed to pass from Ferny Hill plantation (to the south west and hydrologically connected to the site) - is present along the southern boundary of the site. However it would appear that this has now been largely infilled through natural deposition and vegetation growth. The ground in this area was observed to be inundated with water.

- Man-made changes to the drains were considered to have been undertaken in the field abutting the northern boundary of the site. This would align with the landform and presence of the adjacent springs. It has been previously recorded that these flows are high in iron (see section 1.4) however, no orange-brown discolouration of flows was observed.

Photograph Log- Surrounding Catchment
Photographs taken 12th March 2013
