# Investigation of Standing Water and Wetland SSSIs thought to be under Diffuse Pollution Pressure: Loch Spynie

**Commissioned Report No. 726**

## **Investigation of Standing Water and Wetland SSSIs thought to be under Diffuse Pollution Pressure: Loch Spynie**

**Project No: 13700**

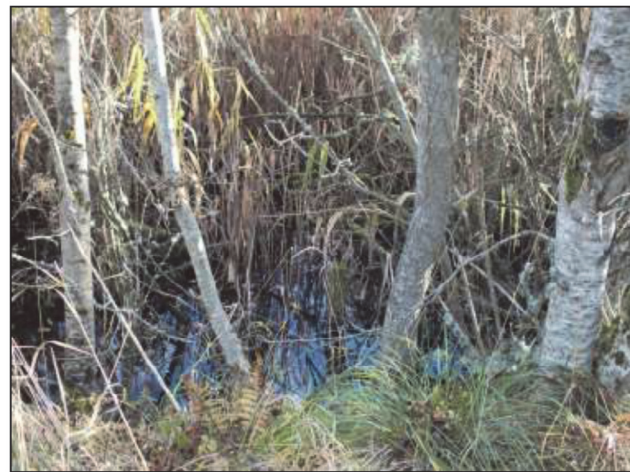
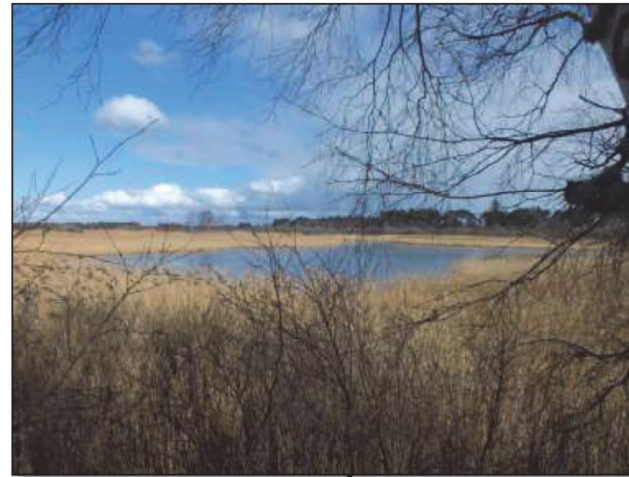
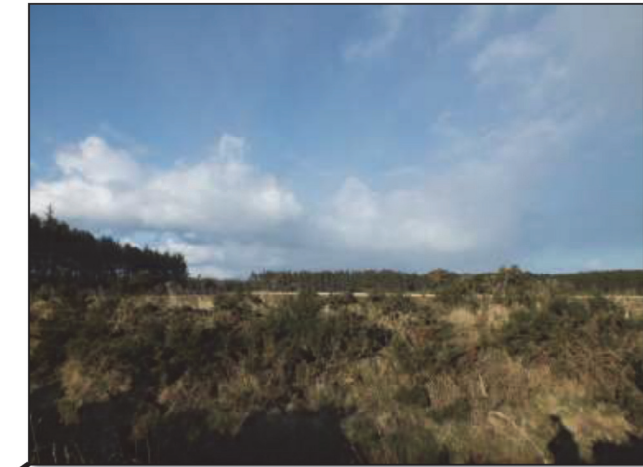
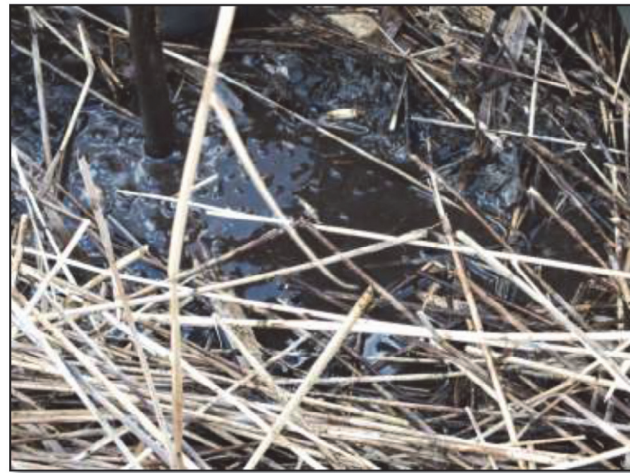
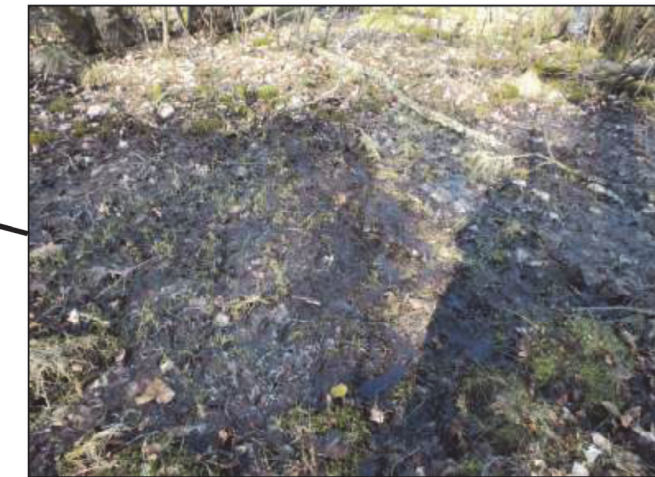
Figure 2.3: Sampling Location Photographs

**Photograph Log - Sample Locations**  
 (Photographs taken on 13<sup>th</sup> November 2012/26<sup>th</sup> February 2013)

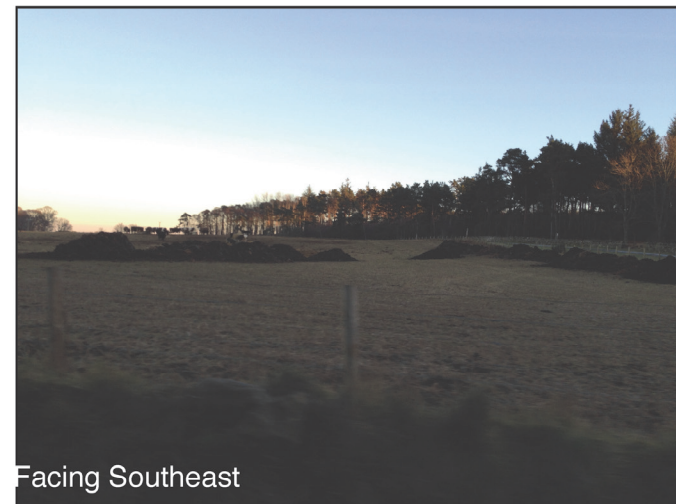
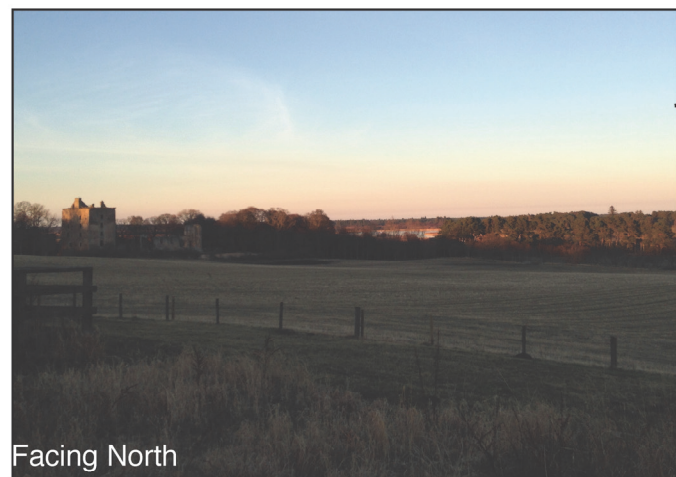
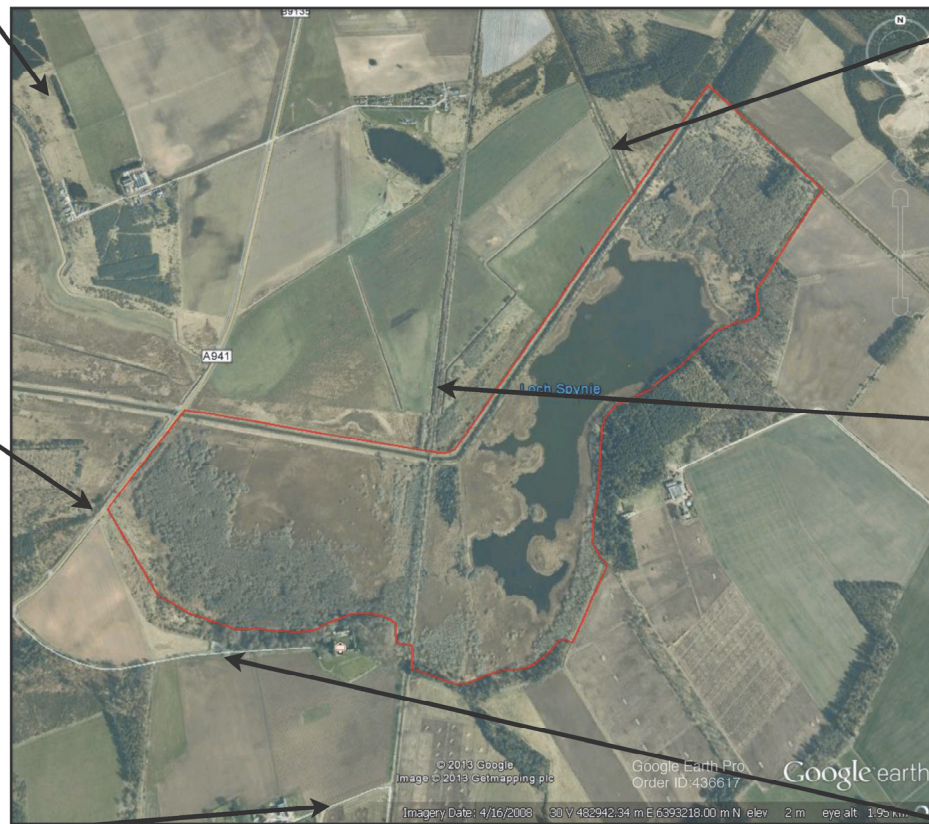
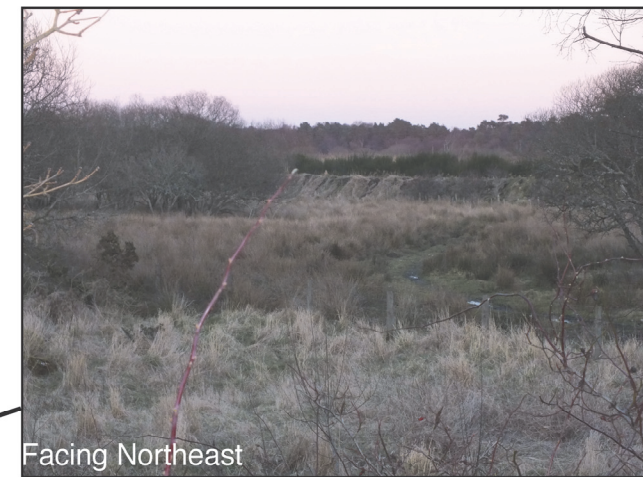
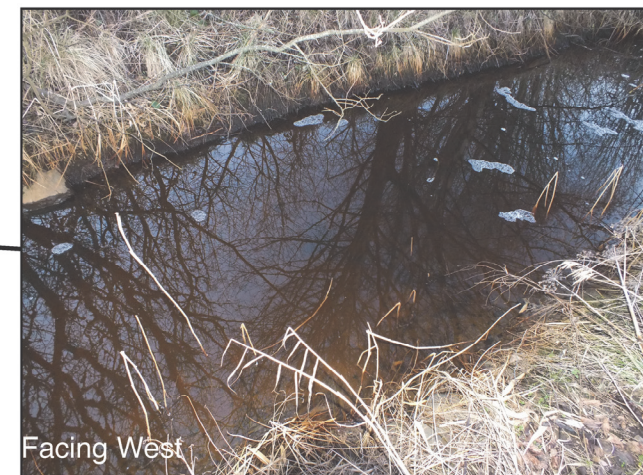
Figure 2.4: Surrounding Land Use Photographs

Photograph Log- Surrounding Catchment  
Photographs Taken 26th February 2013
