Investigation of Standing Water and Wetland SSSIs thought to be under Diffuse Pollution Pressure: Loch Watston

Commissioned Report No. 727

**Investigation of Standing Water and Wetland SSSIs
thought to be under Diffuse Pollution Pressure:
Loch Watston**

Commissioned Report No. 727
Project No: 13700
Contractor: EnviroCentre Ltd.
Year of publication: 2015

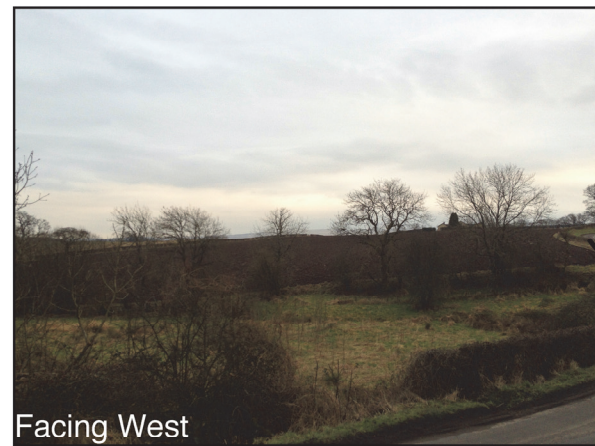
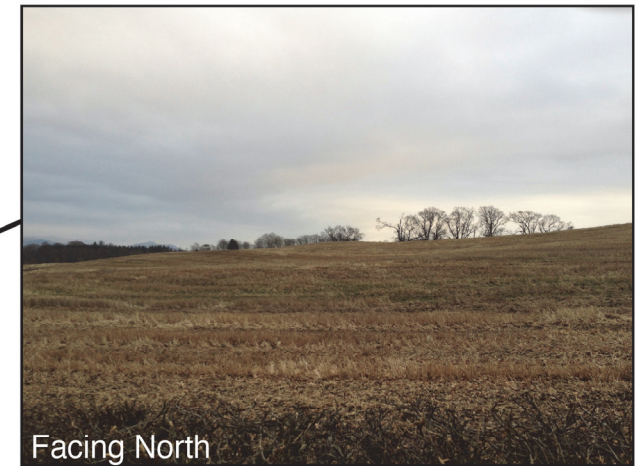
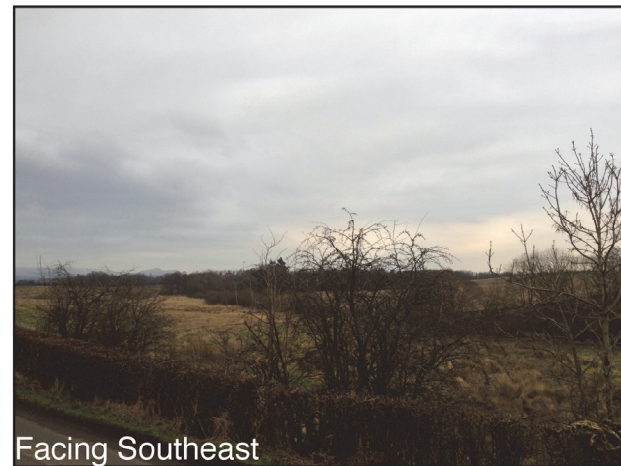
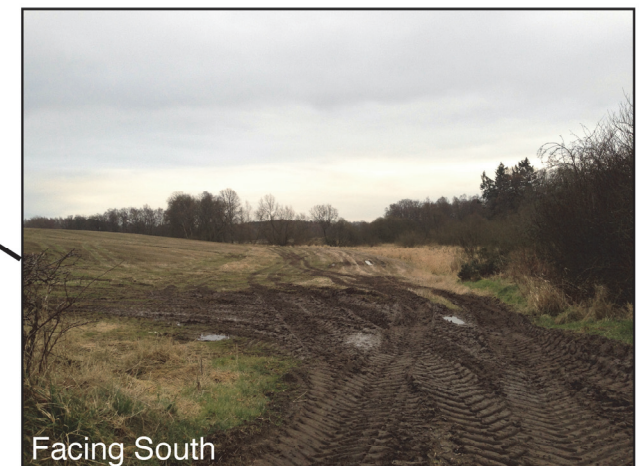
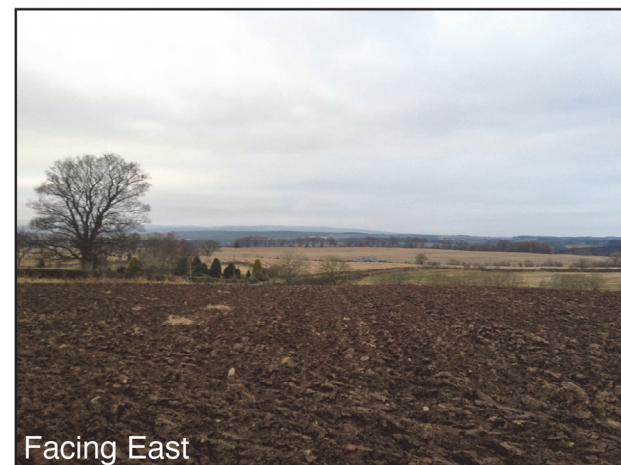
Figure 2.3: Sample Location Photographs

Photograph Log - Sample Locations
 (Photographs taken on 26th Nov 2012)

Facing West

Facing North

Facing Southeast

Facing South

Facing East

All sampling methods were carried out by trained personnel. Photographs of each sampling location were taken (see Figure 2.3 in Annex 1) and grid references for each location recorded.

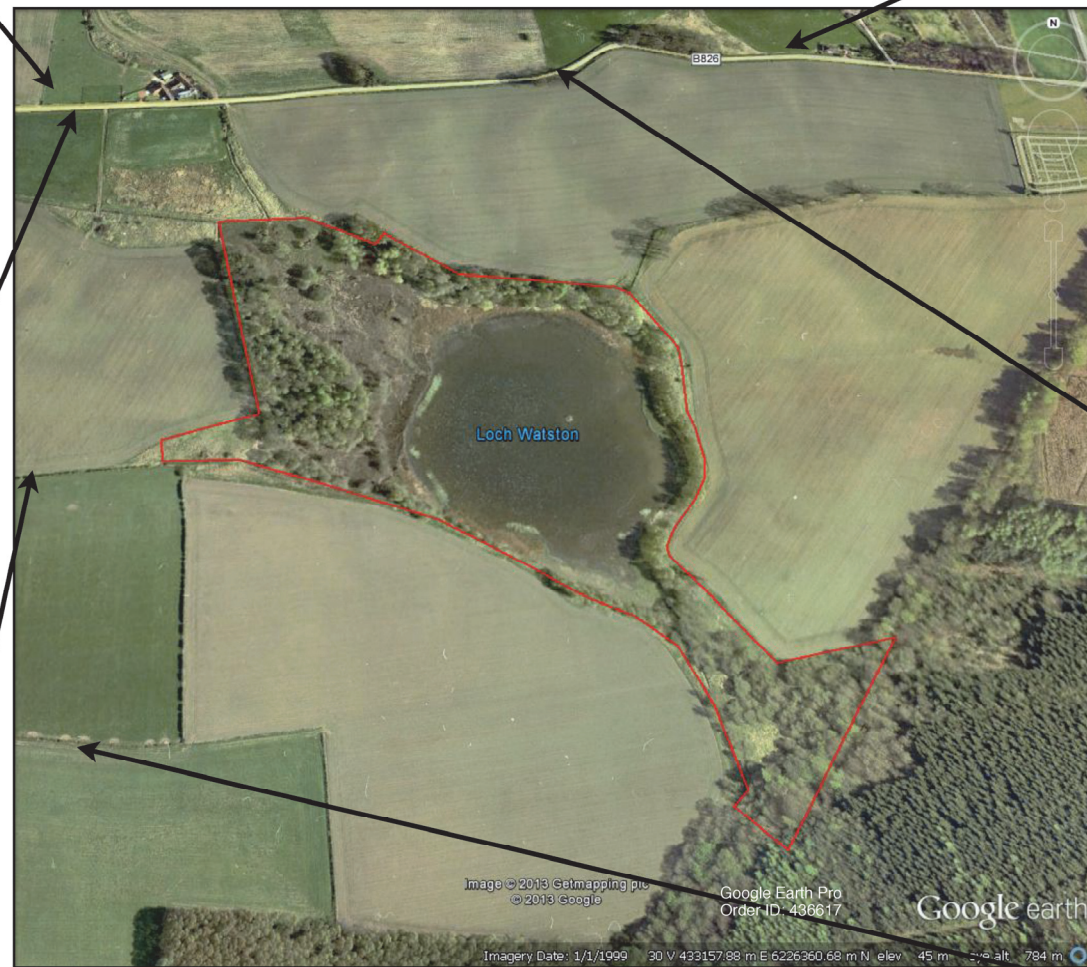
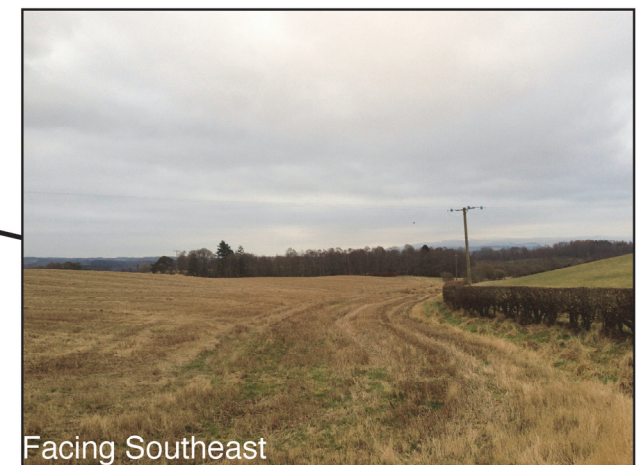
Figure 2.4: Surrounding Land Use Photographs

Photograph Log-Surrounding Land Use
Photographs taken 20th February 2013

Facing Southeast
