Investigation of Standing Water and Wetland SSSIs thought to be under Diffuse Pollution Pressure: Lochmill Loch

Commissioned Report No. 729

Project No: 13700

Contractor: EnviroCentre Ltd.

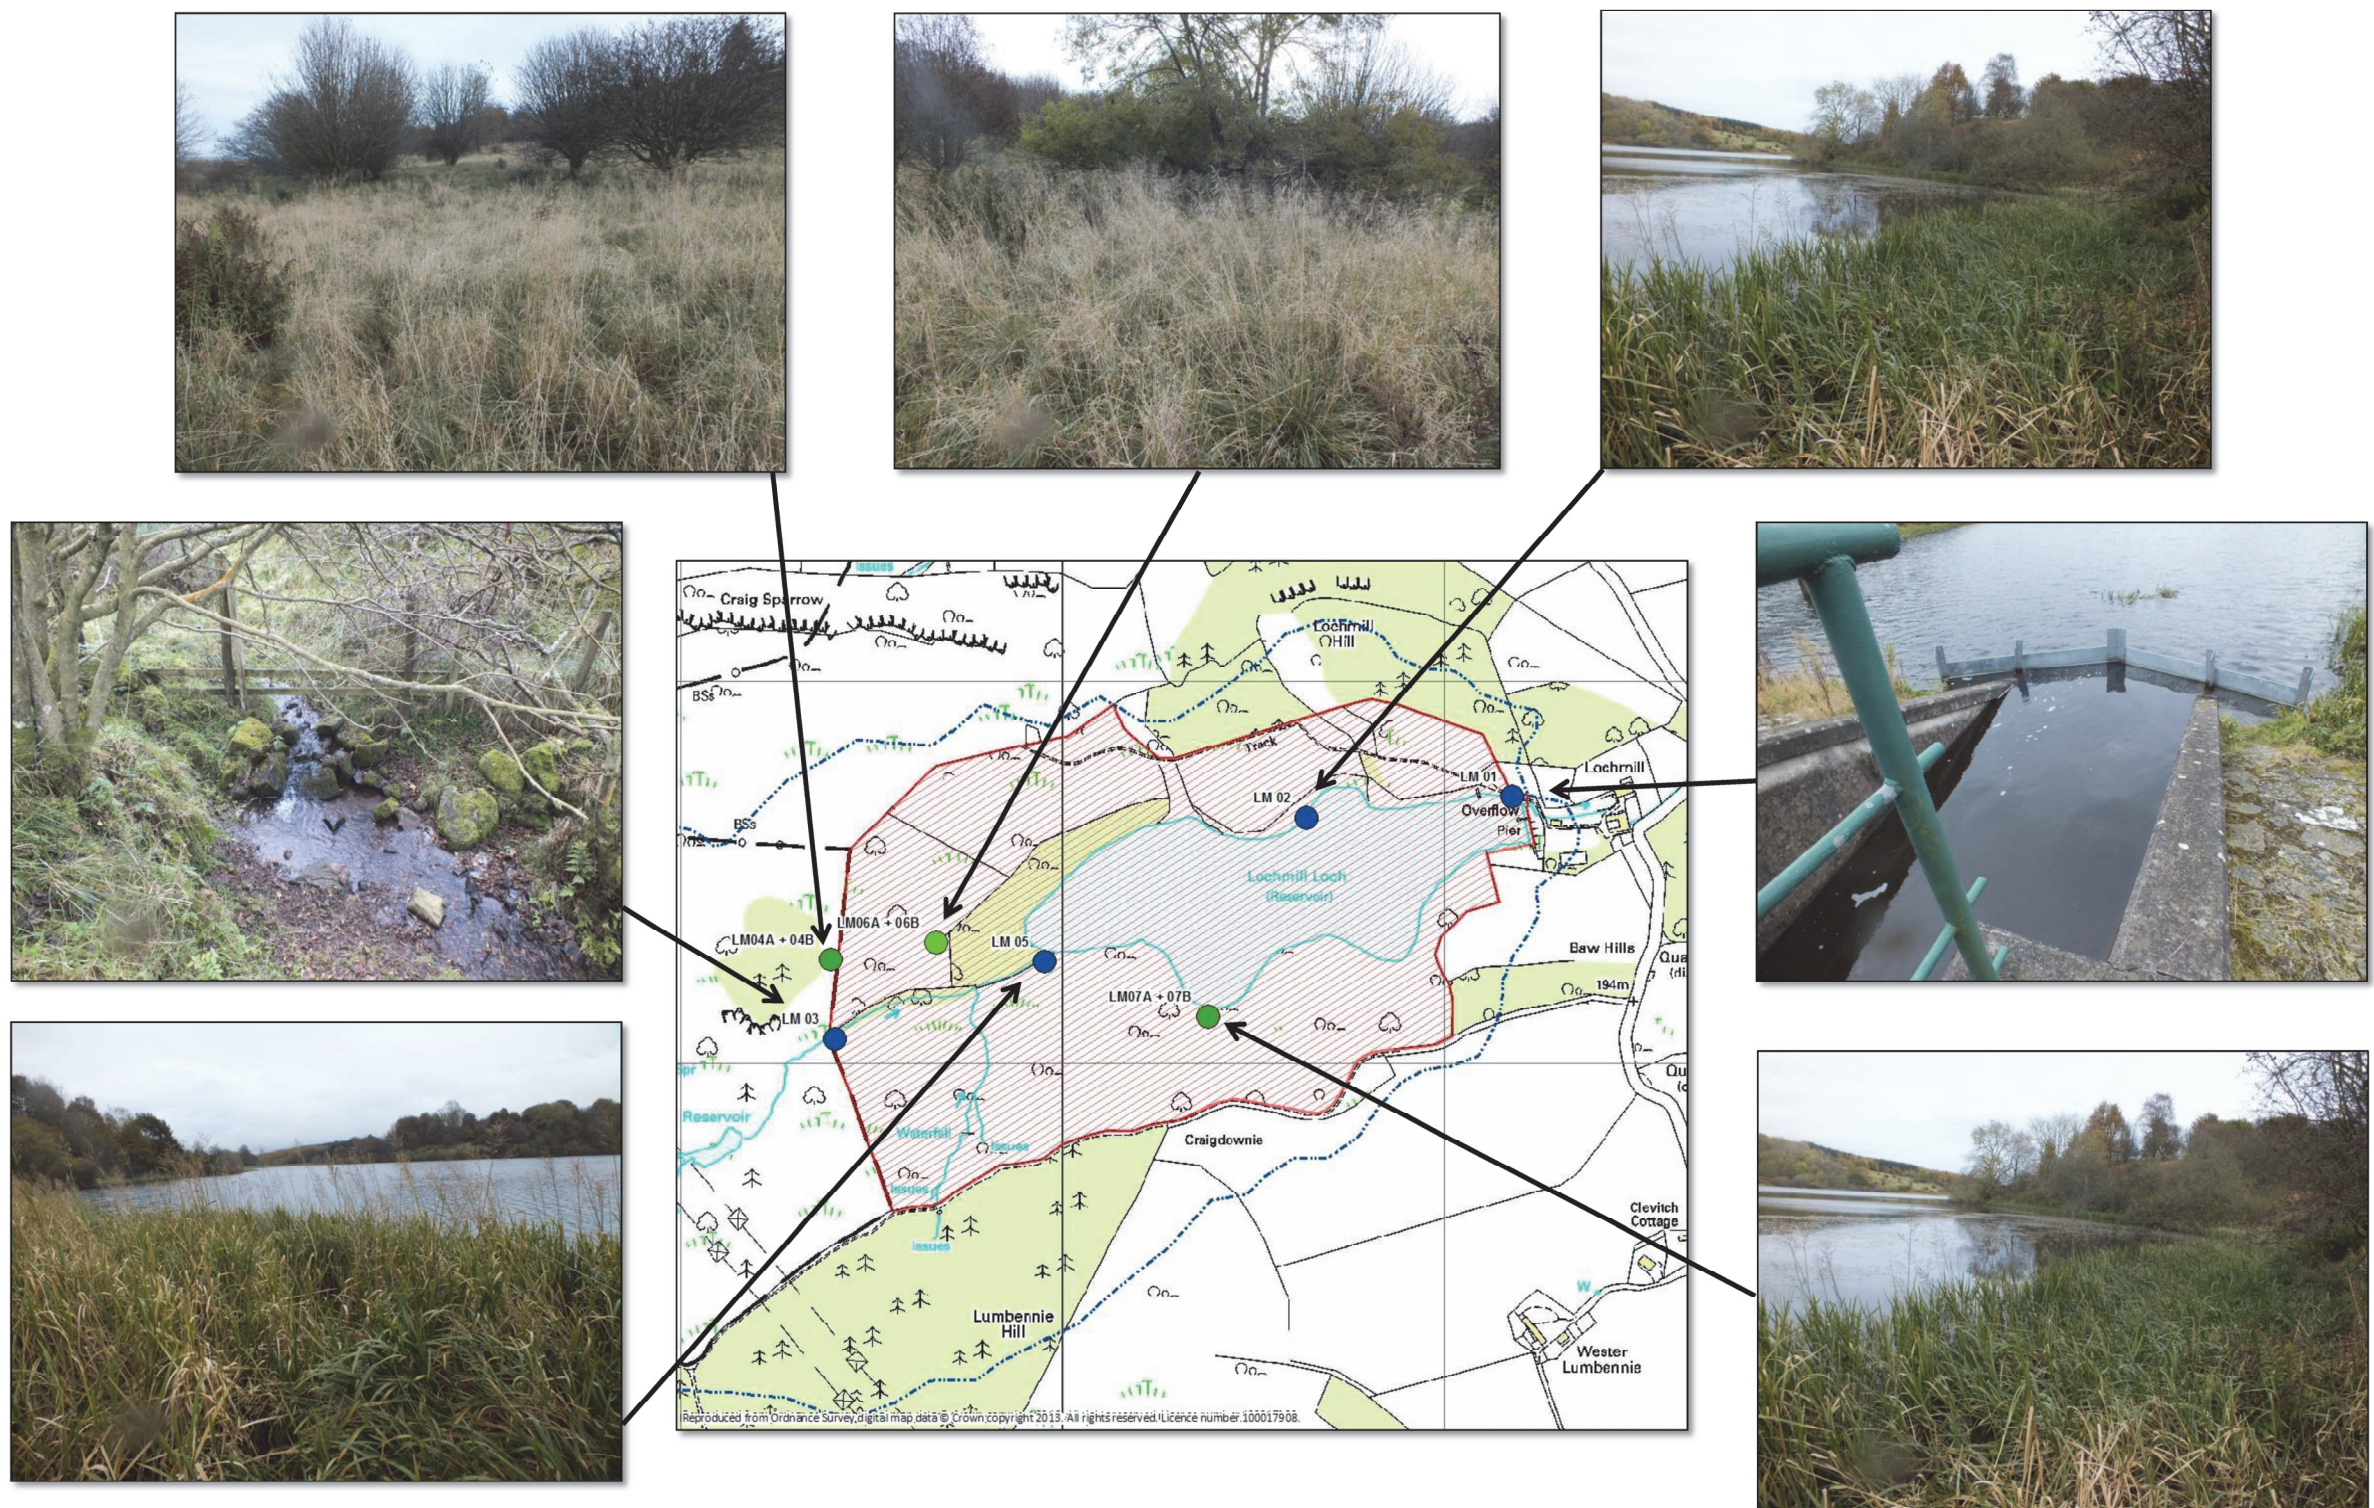
Figure 2.3: Sampling Location Photographs

Photograph Log - Sample Locations
 (Photographs taken on 30th October 2012)

All sampling methods were carried out by trained personnel. Photographs of each sampling location were taken (see Figure 2.3 in Annex 1) and grid references for each location recorded.

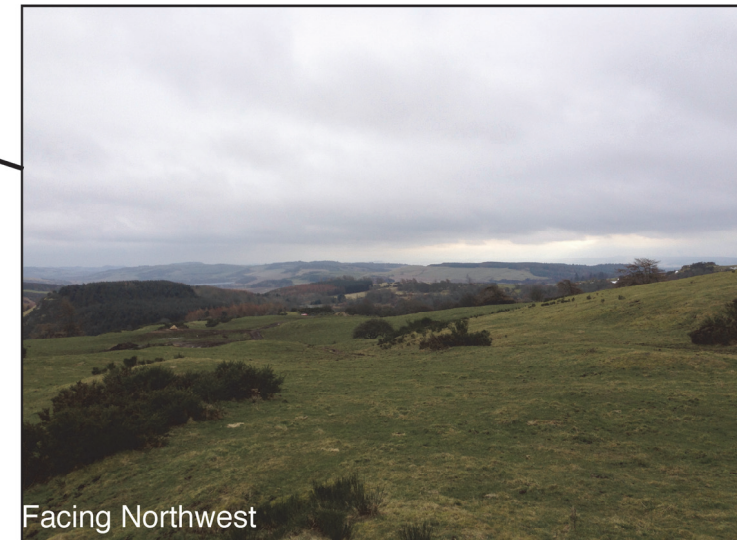
Figure 2.4: Surrounding Land-use Photographs

Photograph Log- Surrounding Catchment
Photographs taken 20th February 2013
