Commissioned Report No. 731

**Investigation of Standing Water and Wetland SSSIs
thought to be under Diffuse Pollution Pressure:
Moss of Kirkhill**

Commissioned Report No. 731
Project No: 13700
Contractor: EnviroCentre Ltd.
Year of publication: 2015

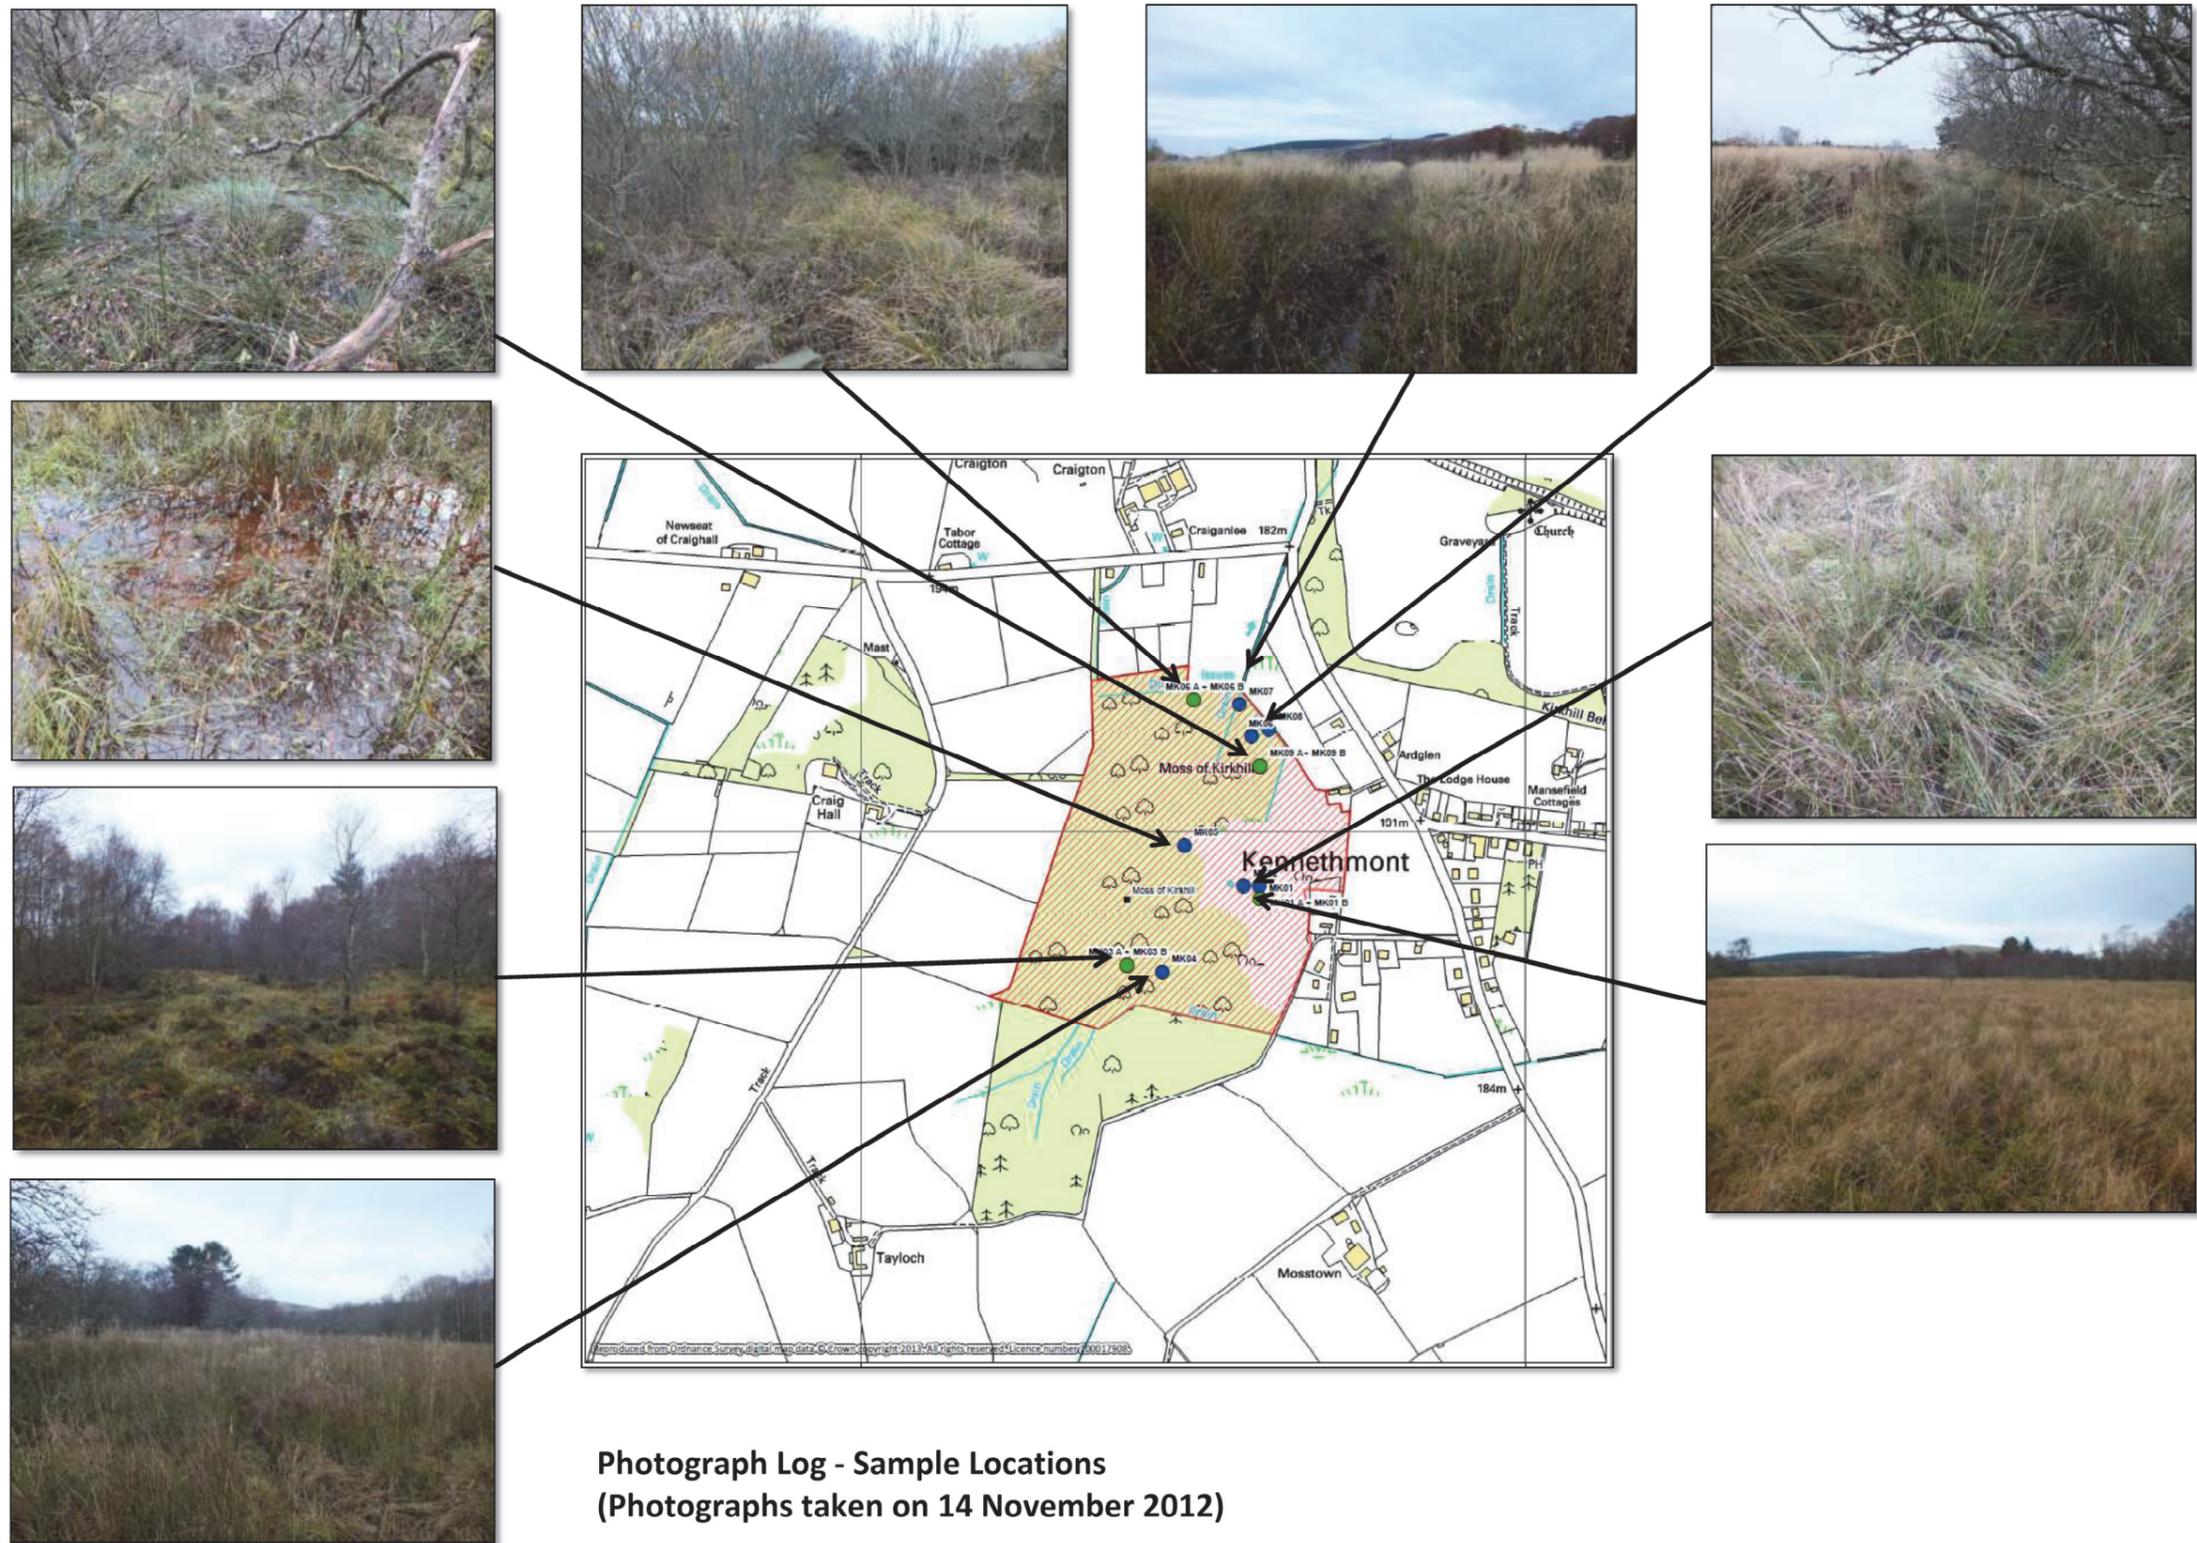
Figure 2.3: Photographs of each Sampling Location

All sampling methods were carried out by trained personnel. Photographs of each sampling location were taken (see Figure 2.3 in Annex 1) and grid references for each location recorded.
