Investigation of Standing Water and Wetland SSSIs thought to be under Diffuse Pollution Pressure: Spey Bay

Commissioned Report No. 732

Commissioned Report No. 732
Project No: 13700
Contractor: EnviroCentre Ltd.
Year of publication: 2015

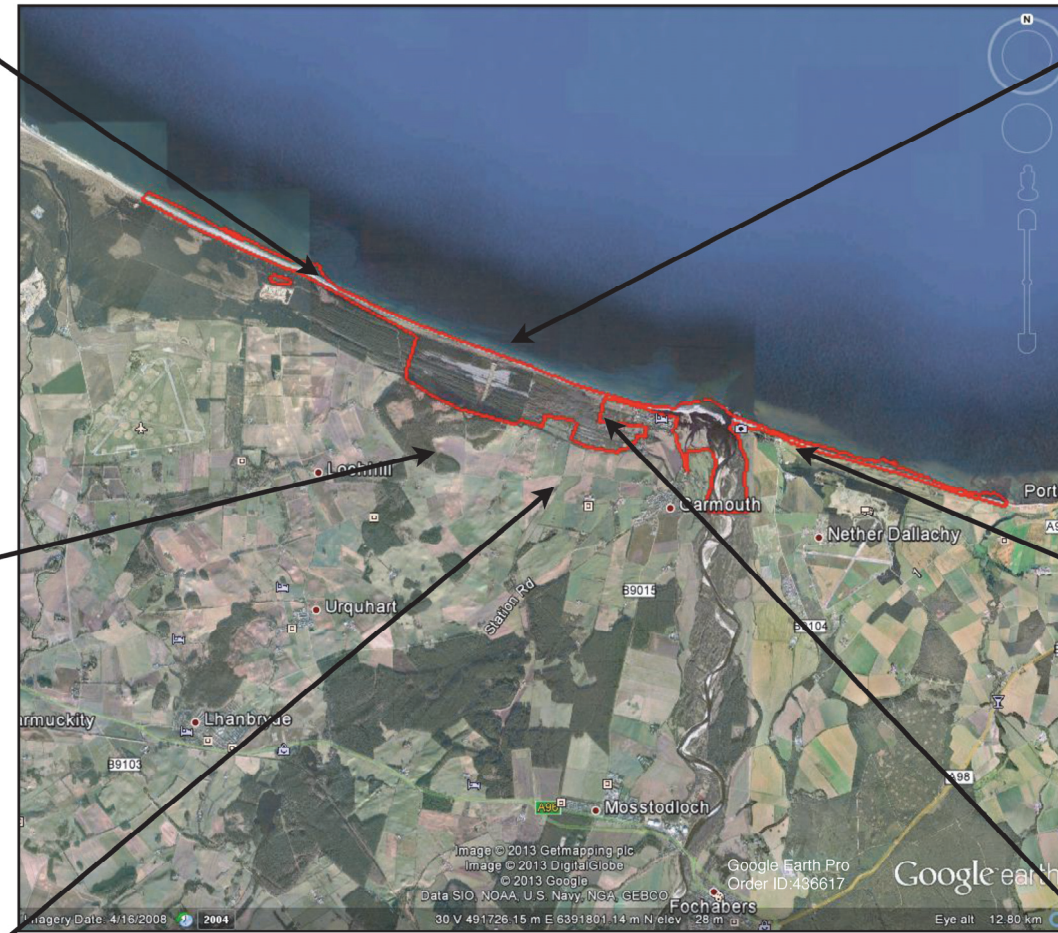
Figure 2.4: Photographs of Surrounding Land Use

- Geo-referenced photograph locations of surrounding land use (refer to Figure 2.4 in Annex 1) ;
- Adjacent land use;
- Identified and potential pollution sources; and
- Atypical or unusual site features (e.g. fly tipping, vandalism, etc.).
