# Investigation of Standing Water and Wetland SSSIs thought to be under Diffuse Pollution Pressure: Wartle Moss

**Commissioned Report No. 733**

**Commissioned Report No. 733**  
**Project No: 13700**  
**Contractor: EnviroCentre Ltd.**  
**Year of publication: 2015**

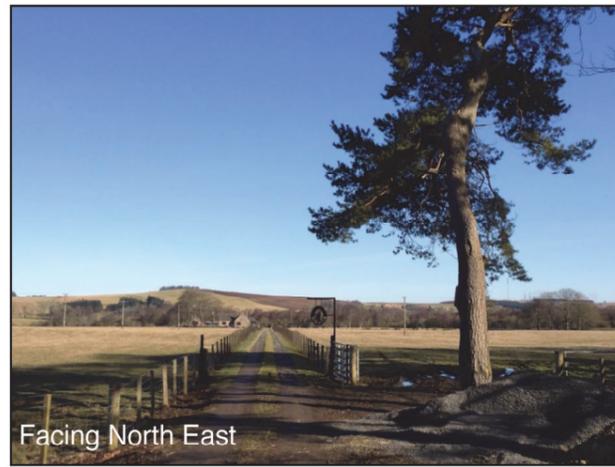
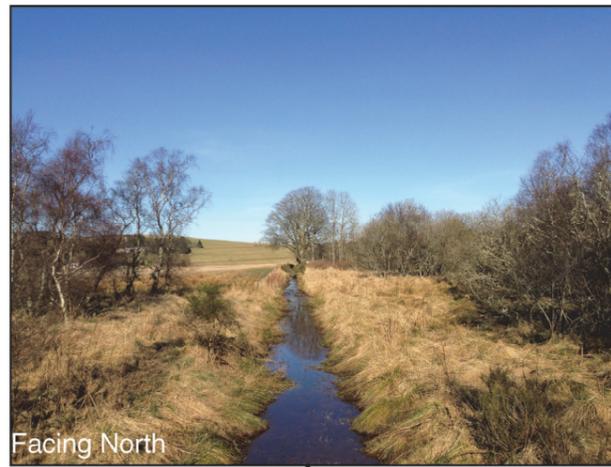
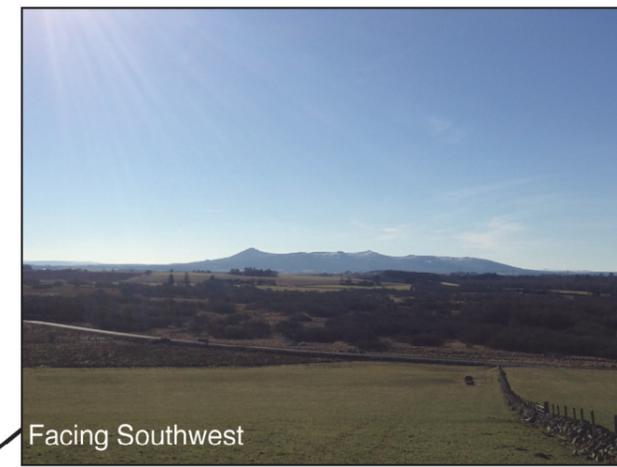
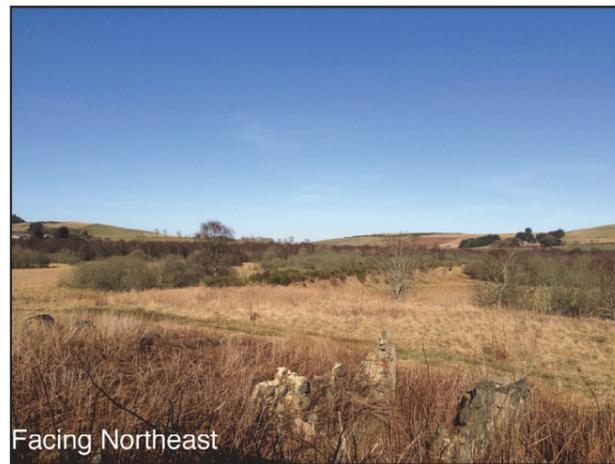
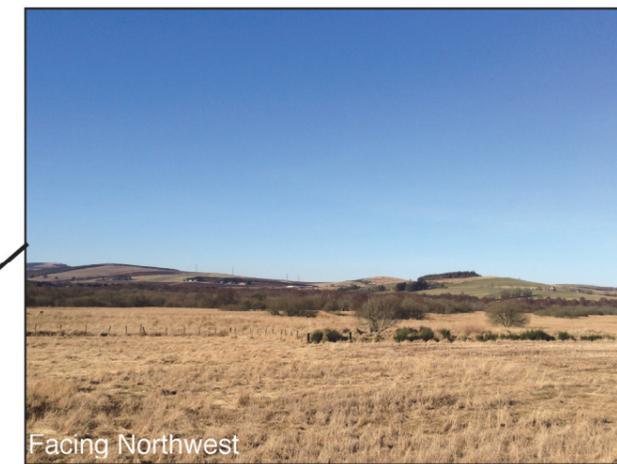
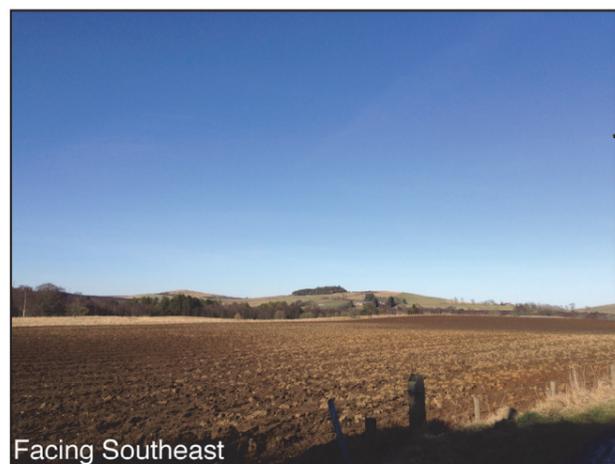
Figure 2.3: Sampling Location Photographs

All sampling methods were carried out by trained personnel. Photographs of each sampling location were taken (see Figure 2.3 in Annex 1) and grid references for each location recorded.

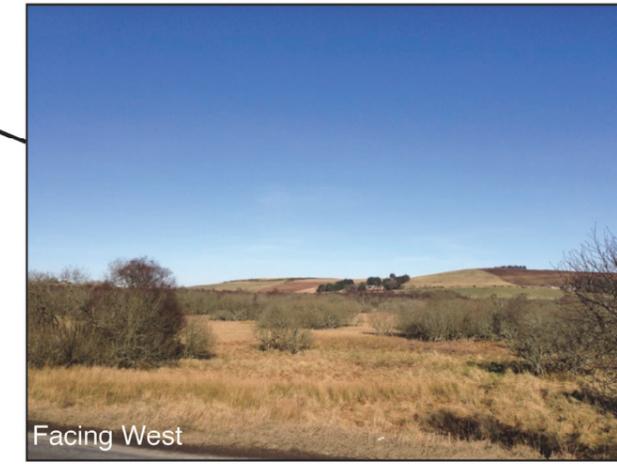
Figure 2.4: Surrounding Land Use Photographs

- Geo-referenced photograph locations of surrounding land use (refer to Figure 2.4 in Annex 1);
- Adjacent land use;
- Identified and potential pollution sources; and
- Atypical or unusual site features (e.g. fly tipping, vandalism, etc.).

- The site was free of litter. No visible pollution sources were observed within the site boundary.
- Drainage ditches run through the site and are present along the site boundaries. They appear to be for agricultural purposes.
- During the visit to site, surface runoff from the B9001 was observed.
- Stagnant water was observed in the ditch to the west of the railway which traverses the western section of the site.
- A wind turbine was in proximity to the site but it is located downstream of the site.
- The fields to the east of the site boundary are used for arable purposes. Fields to the south of the site are improved pasture for grazing purposes.
- There are a series of farms and properties located adjacent to the eastern and southern site boundaries. Private septic tanks are therefore assumed to be present.
