# Investigation of Standing Water and Wetland SSSIs thought to be under Diffuse Pollution Pressure: Yetholm Loch

**Commissioned Report No. 734**

## **Investigation of Standing Water and Wetland SSSIs thought to be under Diffuse Pollution Pressure: Yetholm Loch**

**Commissioned Report No. 734**  
**Project No: 13700**  
**Contractor: EnviroCentre Ltd.**  
**Year of publication: 2015**

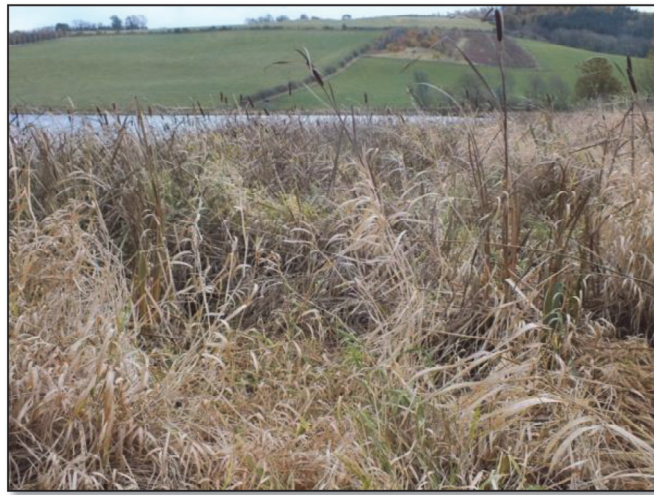
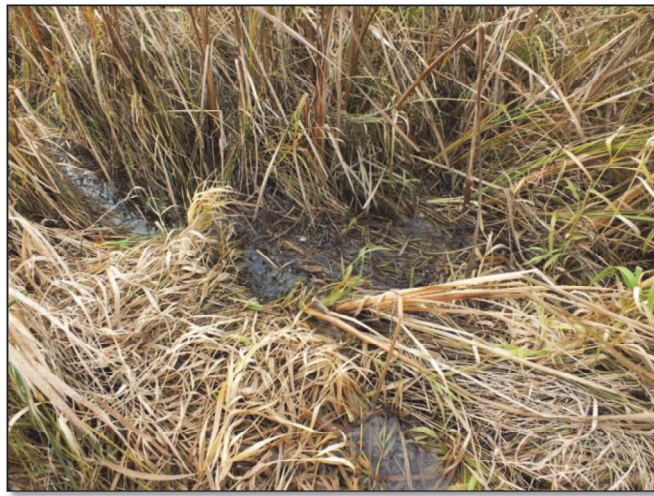
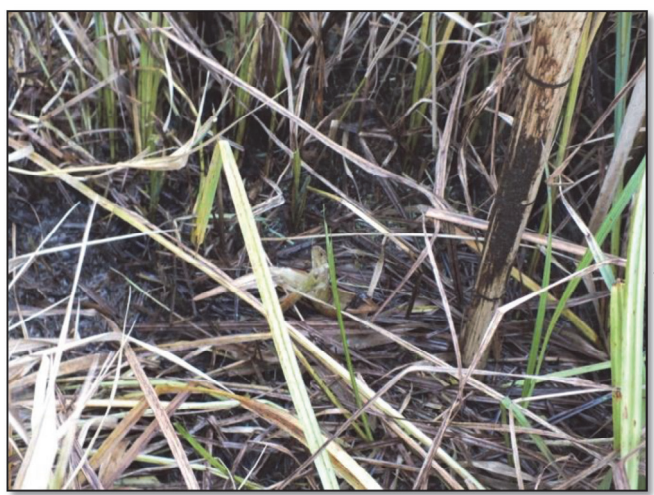
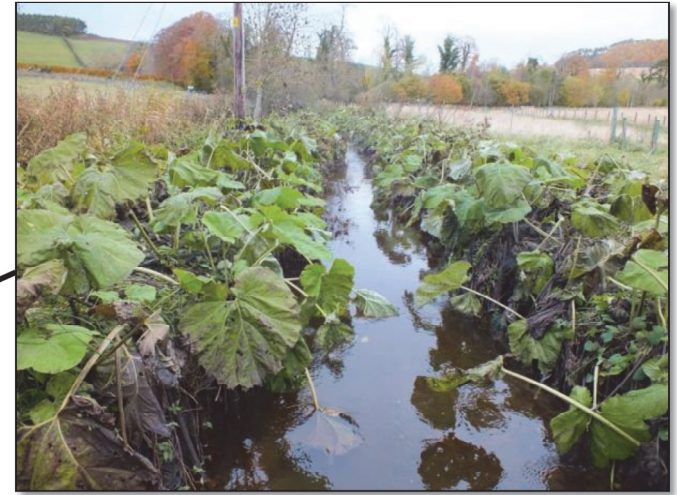
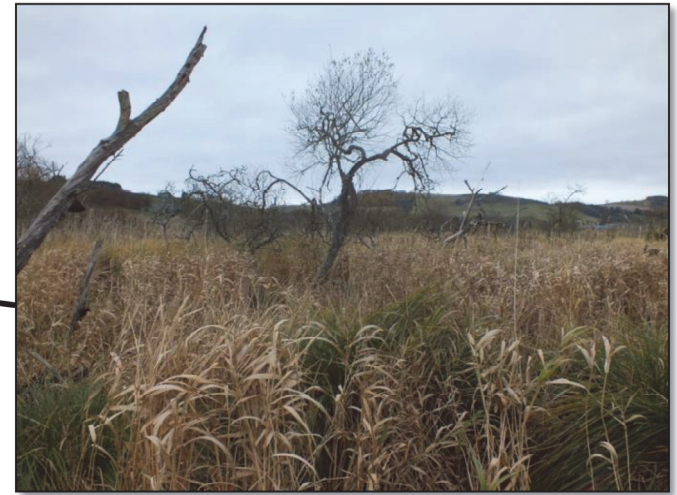
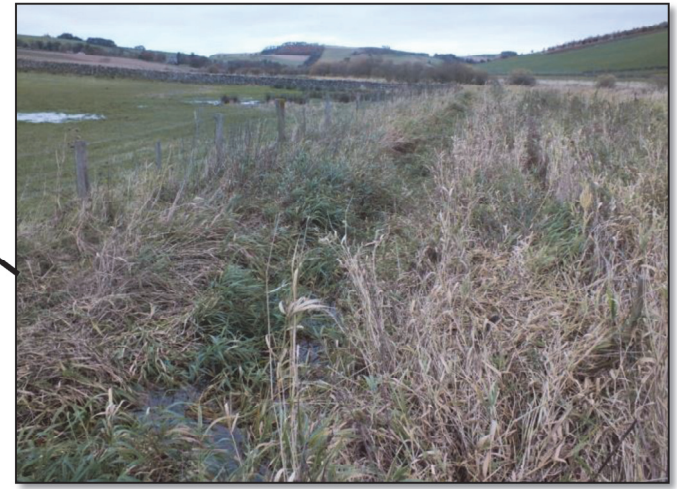
Figure 2.3a: Photographs of each Sampling Location

All sampling methods were carried out by trained personnel. Photographs of each sampling location were taken (see Figure 2.3 in Annex 1) and grid references for each location recorded.

**Photograph Log (A) - Sample Locations  
(Photographs taken on 7<sup>th</sup> November 2012)**

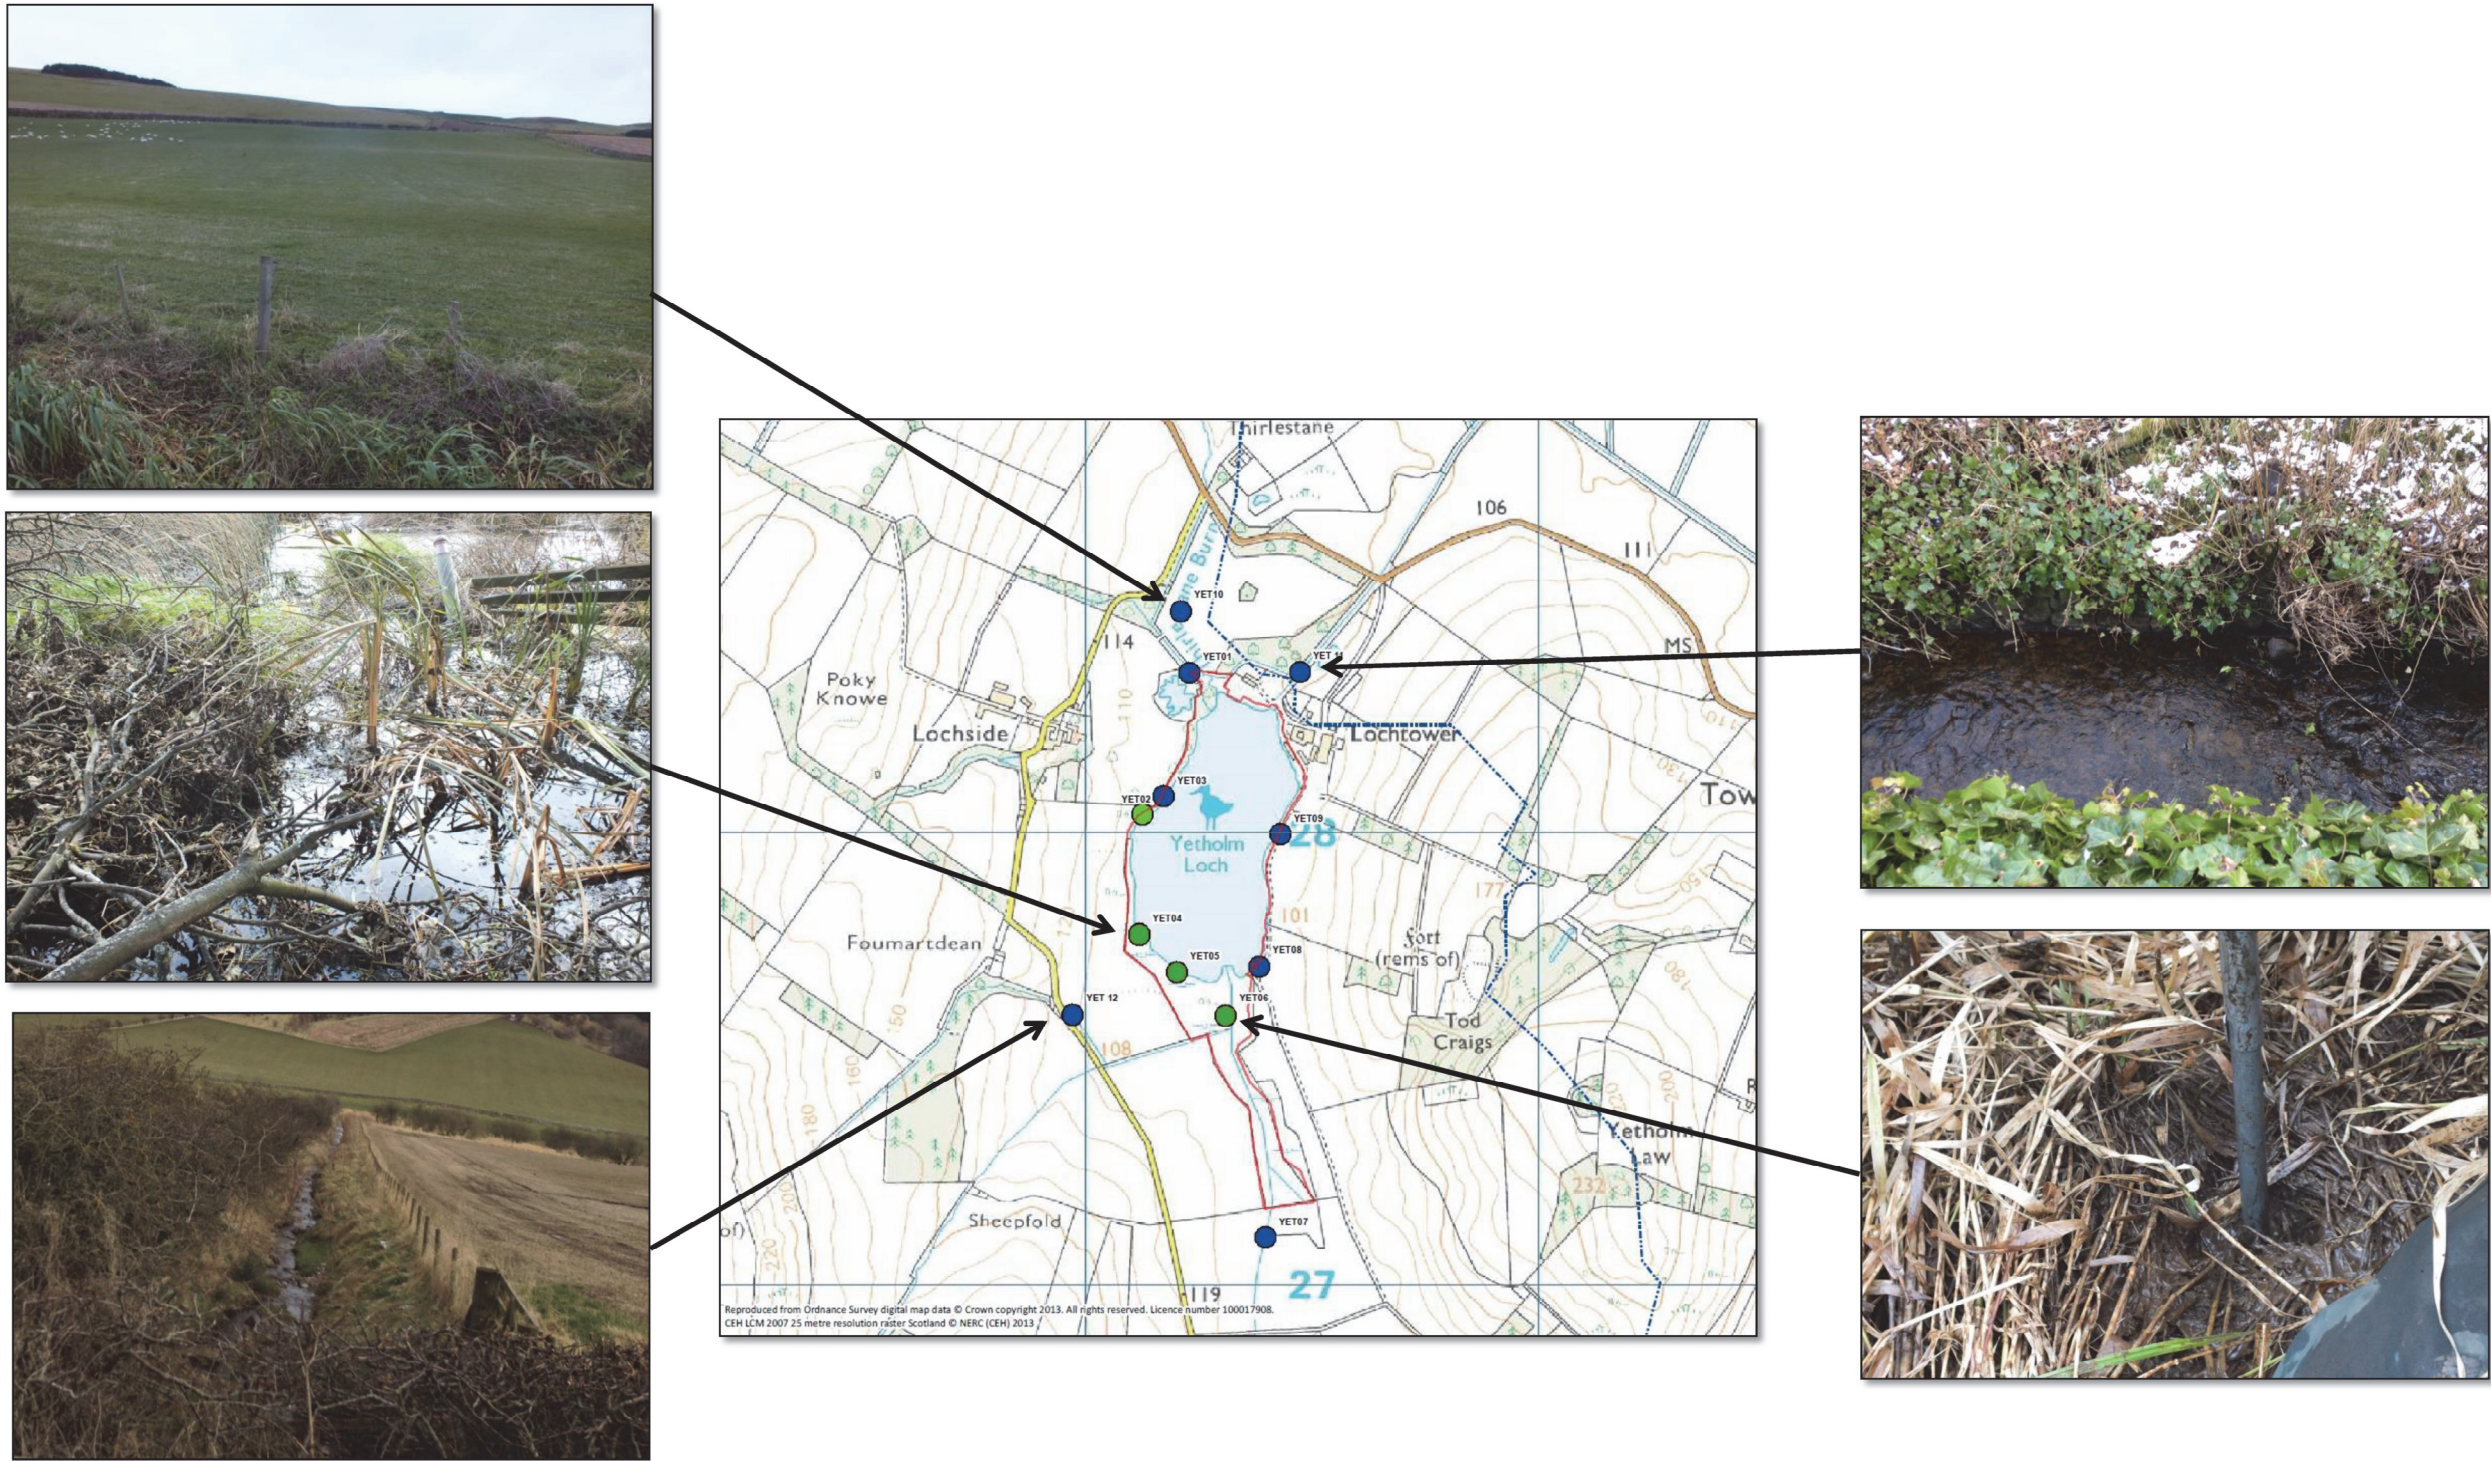
*Figure 2.3b: Photographs of each Sampling Location*

**Photograph Log (B) - Sample Locations**  
**(Photographs taken on 7<sup>th</sup> November 2012 & 12<sup>th</sup> March 2013)**

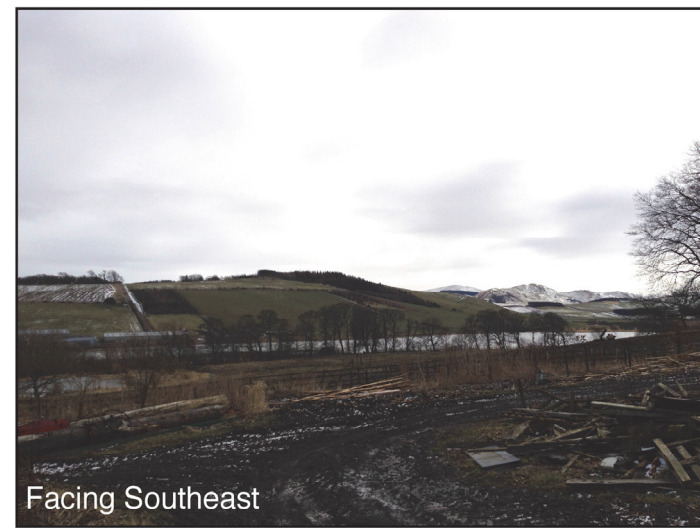
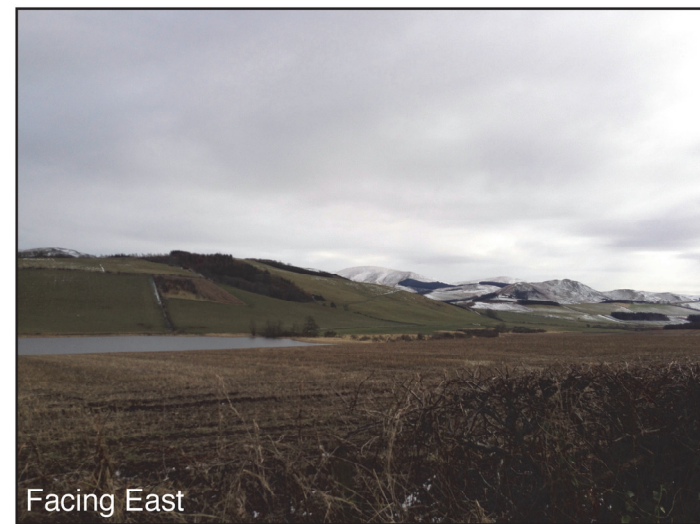
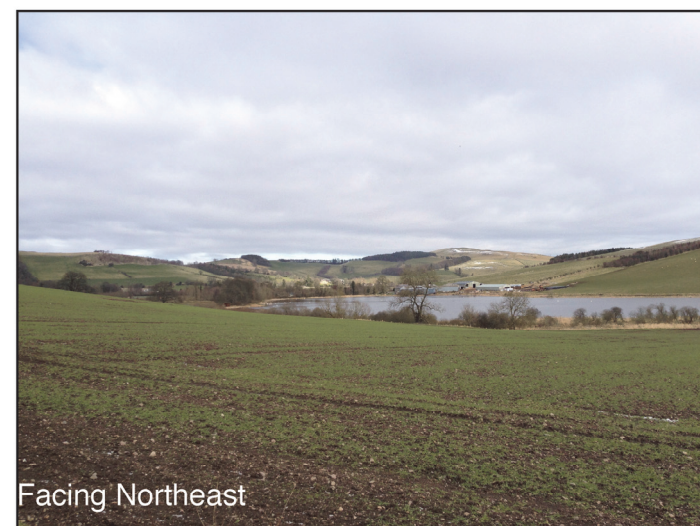
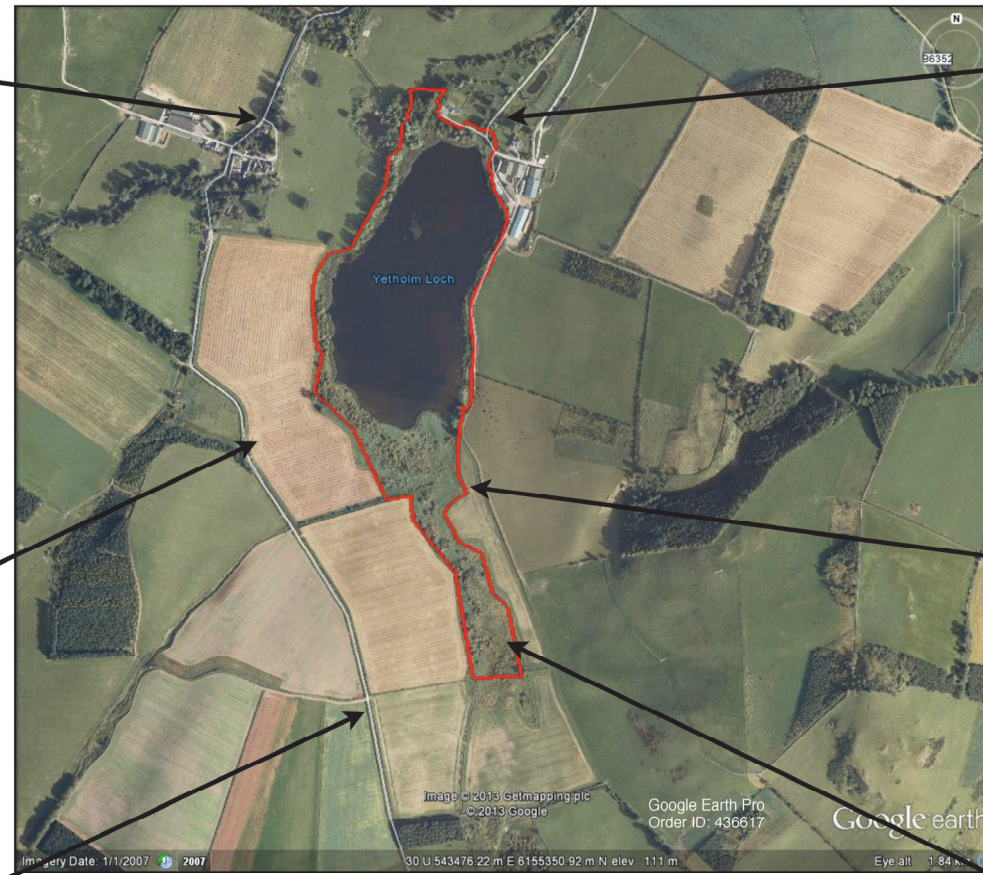
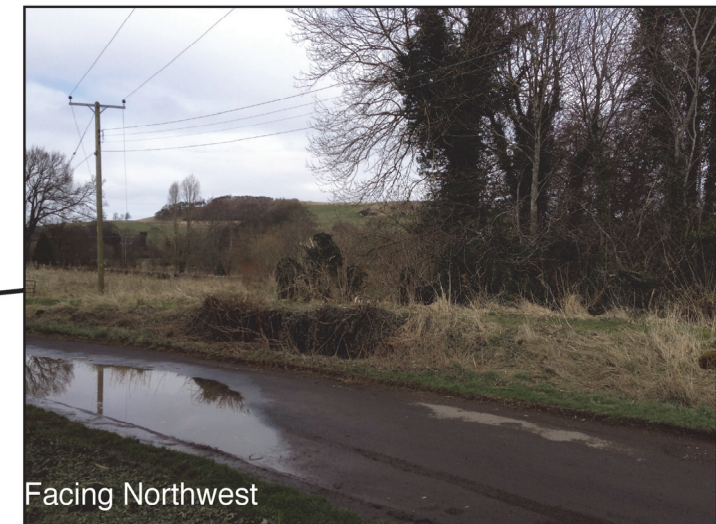
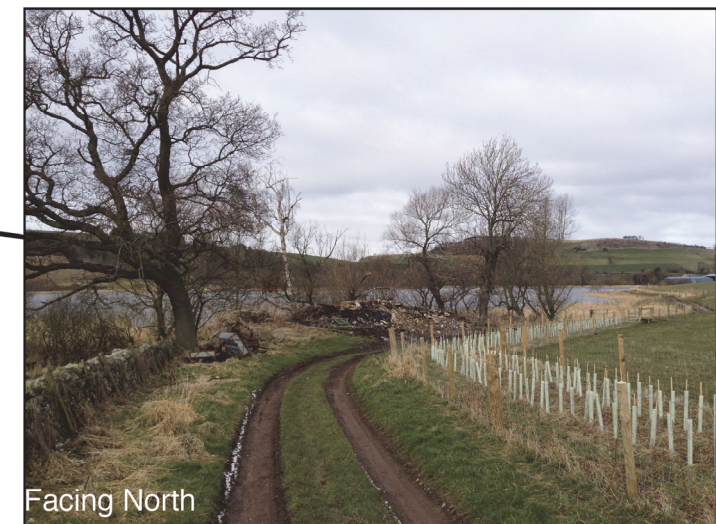
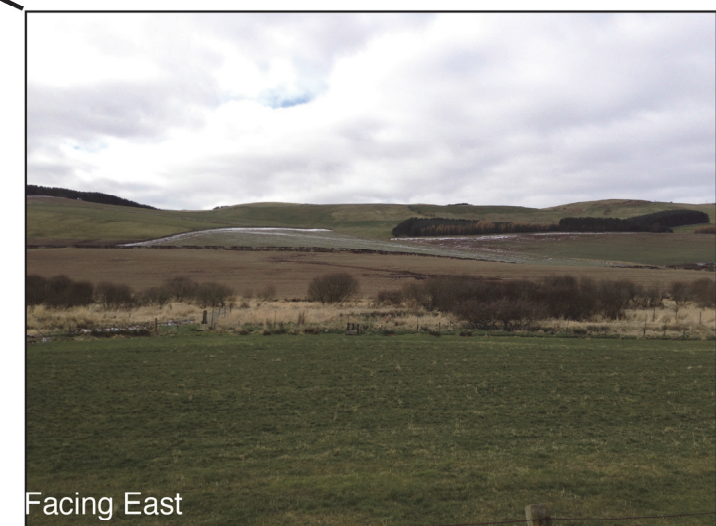
Figure 2.4: Photographs of Surrounding Land Use

- Large areas of reed (identified as *Phragmites spp.* and/or *Phalaris spp.*) were observed in the margins of the loch.
- Adjacent to the site there are areas of improved grassland for grazing purposes along with areas of heavily mechanised arable land.

The greatest potential impact to the site, as deduced from the observations made during the study, is the land management approaches employed on the adjacent arable land and the adjacent woodland. This finding is heightened by the repeat observations in the SNH Condition Monitoring Statements outlining such. The most notable observation which does not appear to have been fully assessed is the potential for runoff and nutrient enrichment affecting the inflow to the SSSI and loch from the immediate catchment. The permeable nature of the underlying sandstone geology is expected to aid migration of nutrients to groundwater from the intensively managed arable land and potential less frequent grazing of stock. This will be enhanced through losses of vegetation during the harvesting cycle, increased runoff from ploughed land and the seasonal application of soil conditions, artificial fertilisers and herbicides – the extent and volumes of which are unknown. Coupled to this there are questions to be raised with the corresponding landowners regarding the management of wastes (*i.e.* burning practices and vehicle maintenance) immediately adjacent to the loch.

Photograph Log- Surrounding Catchment  
Photograph Taken 12 March 2013
