Commissioned Report No. 808

**2014 site condition monitoring survey and
biotope mapping of the intertidal sediment
flats of the Kentra Bay and Moss SSSI**

Project No: 14988

Contractor: Heriot-Watt University

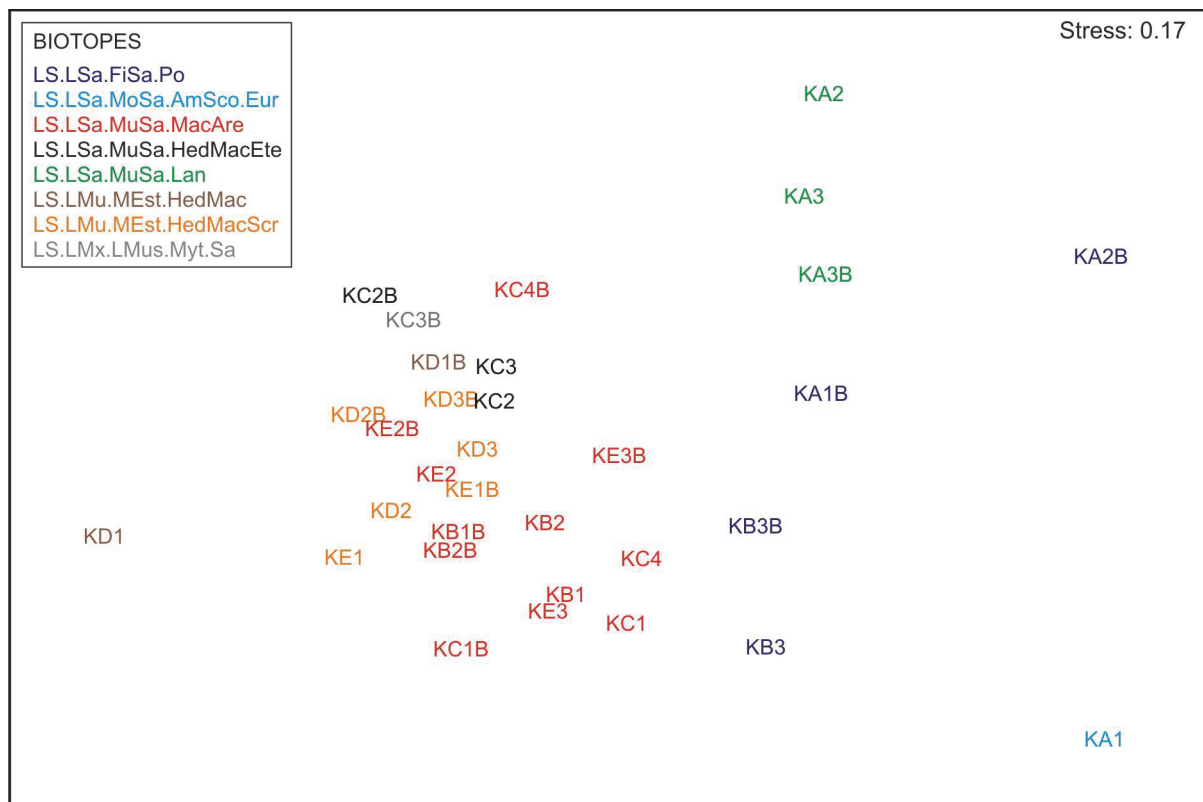
Figure 3. Non-metric multidimensional scaling ordination of macrofaunal abundance data (transformed to SACFOR scale) from Kentra Bay SCM transect stations from the current survey and from the 2003 baseline survey. Station labels are colour coded to correspond with the assigned biotopes. Baseline survey station labels have the suffix 'B'.

MDS ordination of the SACFOR values from this latter table is presented in Figure 3, which also includes the data from the 2003 survey. This clearly shows the difference in species composition between the more exposed sites in the outer and central region of the sediment flats on the right of the plot, and the more sheltered sites on the left. This plot aided biotope ascription and some clustering of similar biotope records is apparent, although final biotope ascription took into account specific characterising species and environmental factors.

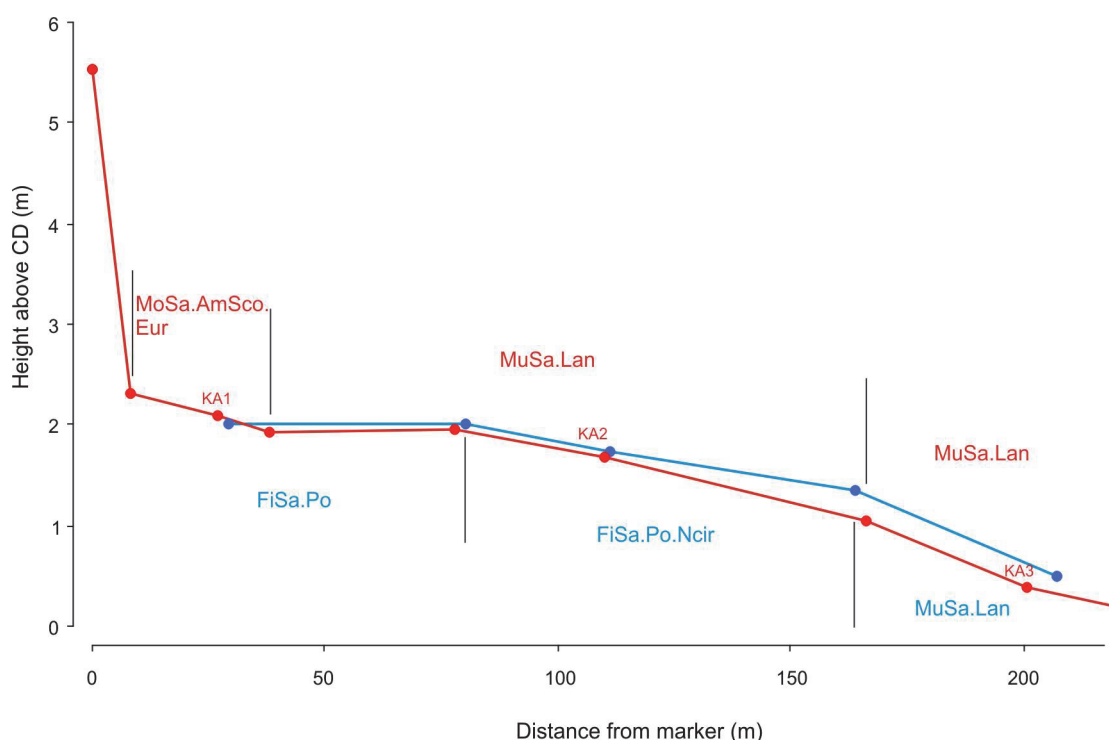
Figure 4 shows the relatively large temporal change in species composition at stations KA1 and KA2, although these are in fact reflections of diversity differences, with a temporal reduction in taxon richness at KA1 from 12 to 4 and increase at KA2 from 20 to 30. KA3 also showed an increase from 20 to 33. A two-way analysis of variance (ANOVA) revealed no overall significant change in diversity along the transect as a whole.

Temporal differences in biotopes were recorded within the upper two zones of the shore. Whereas in 2003 **LS.LSa.FiSa.Po** extended throughout this region, as a result of upshore encroachment of the *Lanice* population, most of this area in 2014 was assigned to **LS.LSa.MuSa.Lan**. The faunally impoverished band of dry sand at the top of the shore (**LS.LSa.MoSa.AmSco.Eur**) was not recorded in 2003, although contemporaneous photographs suggest that a much narrower strip of this habitat may have been present in that year, below which the sand appears to be damper and more compacted than in 2014.

Figure 4. Comparison of profiles of transect KA in 2014 (red) and 2003 (blue), showing component zones, delineated by vertical lines, and corresponding biotopes.

degree of wave action, with winter storms causing destabilisation of sediment and faunal loss. This transect is located in the most wave-exposed region of the Kentra sediment flats within an area of undulating sand banks and close to expanses of megarippled sediment, visible on the aerial imagery. Recorded temporal changes in the physical and biological conditions along the transect are consistent with natural variation that one would expect at such a hydrodynamic location.

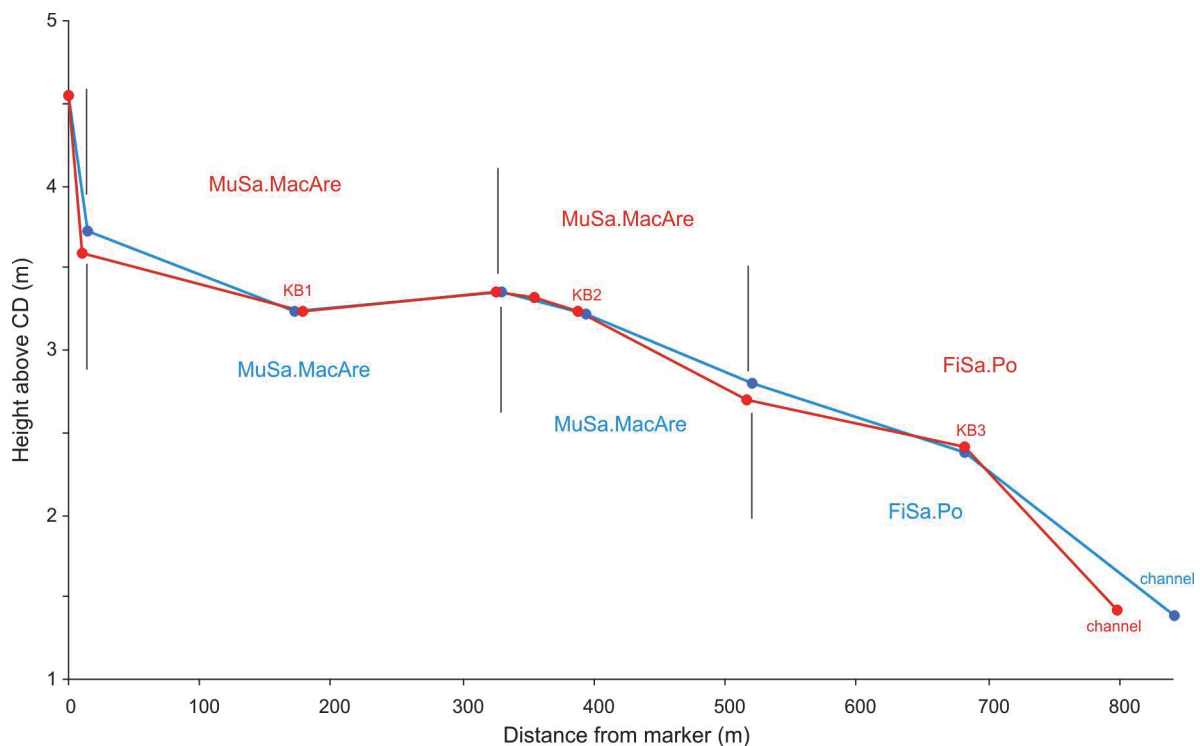
Figure 5. Comparison of profiles of transect KB in 2014 (red) and 2003 (blue), showing component zones, delineated by vertical lines, and corresponding biotopes.

There was little temporal change in the transect profile (Figure 5), apart from some movement in the course of the channel at the bottom of the transect. Sediment composition (Table 1.3, Annex 1) and the sequence and distribution of biotopes were similar in both years. ANOVA revealed no significant temporal difference in taxon richness values along the transect as a whole, although at station KB3 only 8 taxa were recorded in 2014 compared to 14 in 2003. (Table 2). The replicated core sample data (Table 1.4, Annex 1) shows that this level of difference is present even between replicate samples at the same site.

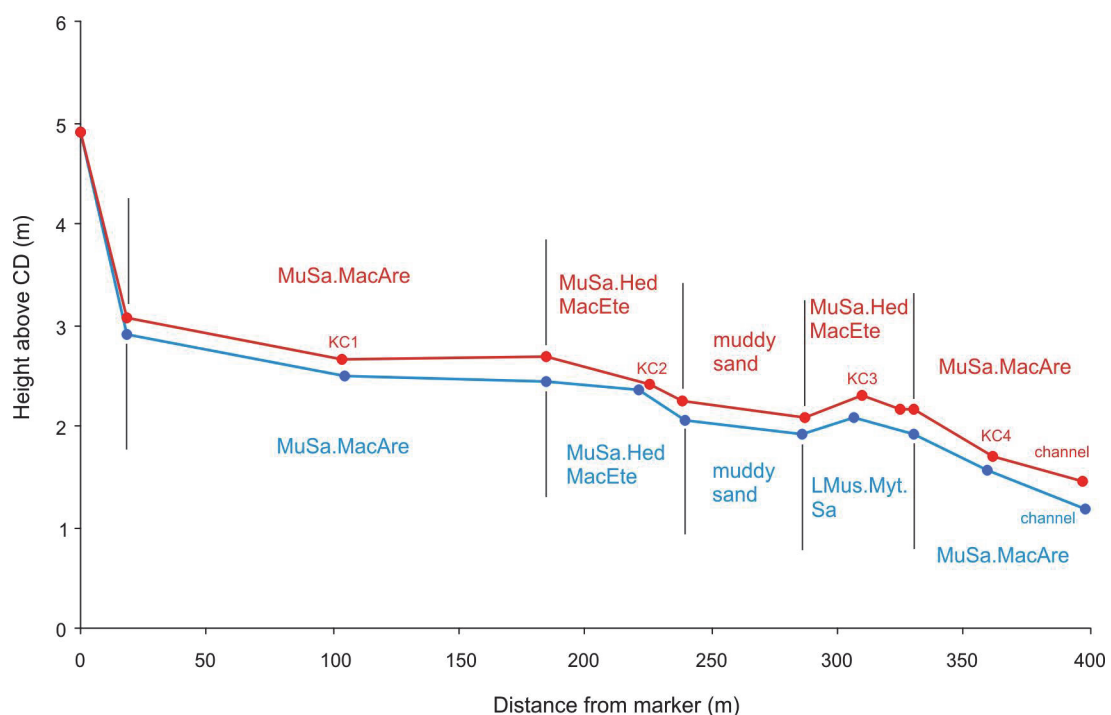
Figure 6. Comparison of profiles of transect KC in 2014 (red) and 2003 (blue), showing component zones, delineated by vertical lines, and corresponding biotopes.

The sequence and distribution of biotopes along the transect is almost exactly the same as that found in 2003 (Figure 6). The only exception is that the lower gravel bank in 2003 supported a sparse mussel bed (**LS.LBR.LMus.Myt.Sa**), although otherwise the fauna was similar (Figure 6). Mussels were also present in 2014 but were only occasional at station KC3, although elsewhere in the zone they were locally frequent. Lyndon *et al.* (2004) reported the presence of a dense mussel bed, starting approximately 15 m west of station KC3 in 2003. The biotope mapping survey recorded the presence of a mussel bed, where *Mytilus edulis* was common, around 80 m to the west of KC3, so some localised reduction in *Mytilus* density appears to have taken place. Taxon richness values recorded along the transect were very similar in 2003 and 2014 (Table 2). In 2014 a member of the public brought the attention of the surveyors to a live specimen of the native oyster, *Ostrea edulis*, that had been found in the vicinity of station KC4. This species is a priority marine feature (see SNH, 2014).

The transect profile in 2014 closely mirrored that in 2003. A slight offset of around 17 cm is likely to be due to a minor difference in the location of the start of the transect, due to the disappearance of the marker stake. It should be noted that a large height difference (1.08 m) was recorded between station KC2 and the upper boundary of this zone in 2003. Inspection of contemporaneous photographic imagery of the transect and recalculation of the tidal height of KC2 based on time-stamped video footage of the imminent flooding of the station, indicates that the true height difference was probably 0.08 m, a figure which has been employed in constructing Figure 6. Some temporal change in gravel content of the sediment was recorded along the transect, with maximum change at KC4, where there was a reduction of 23% and a concomitant increase in sand content (Table 1.3, Annex 1). Such a difference might be expected from natural translocation along a transect exhibiting scattered gravel patches.

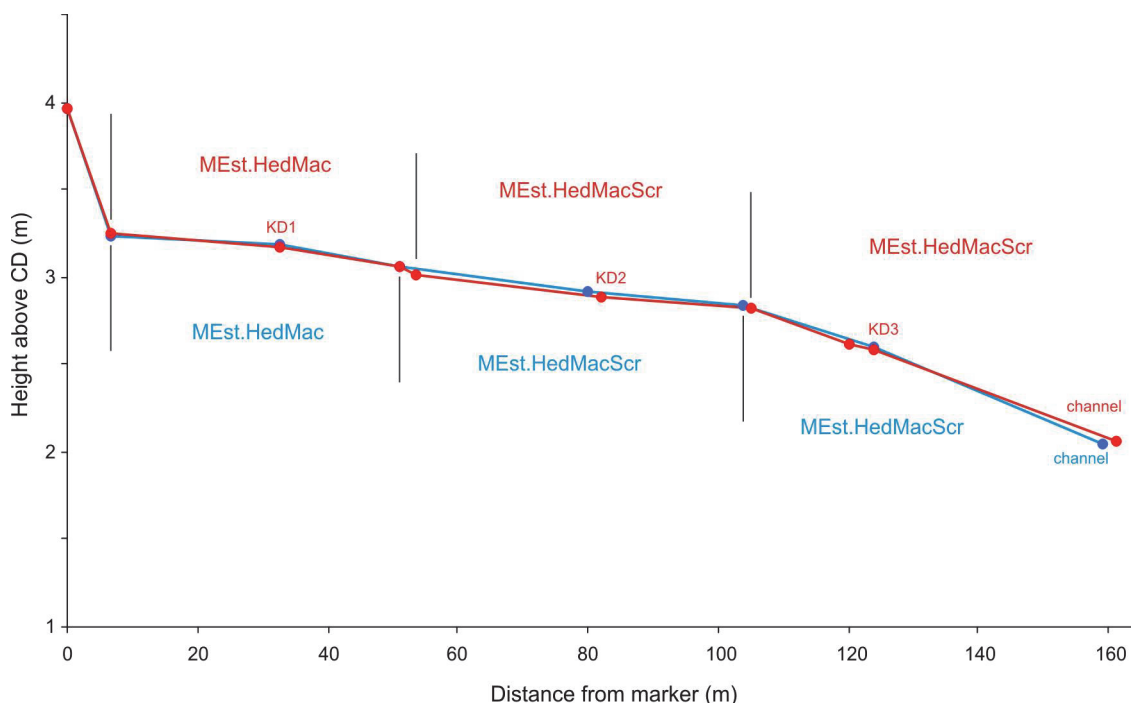
Figure 7. Comparison of profiles of transect KD in 2014 (red) and 2003 (blue), showing component zones, delineated by vertical lines, and corresponding biotopes.

The transect profile, as well as the sequence and distribution of biotopes (Figure 7) and taxon richness (Table 2) closely match those recorded in 2003. Species composition in the

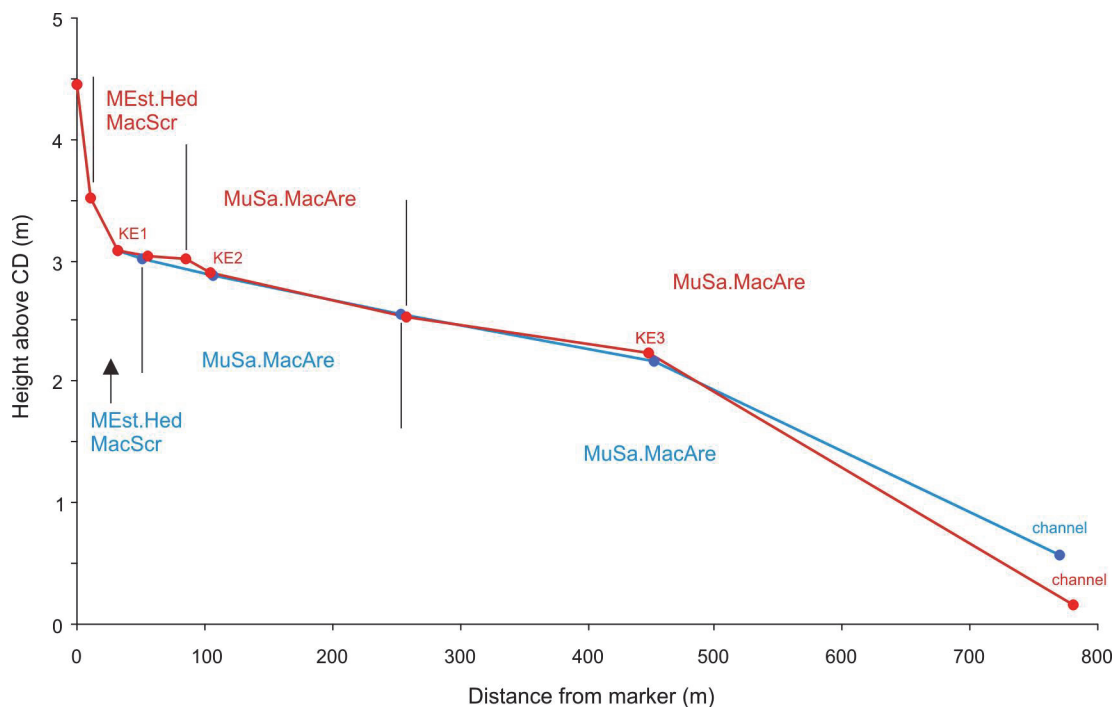
Figure 8. Comparison of profiles of transect KE in 2014 (red) and 2003 (blue), showing component zones, delineated by vertical lines, and corresponding biotopes.

No temporal change in the sequence of biotopes along the transect is apparent (Figure 8), although the perceived lower boundary of the **LS.LMu.MEst.HedMacScr** zone has extended downshore by around 30 m. Taxon richness values recorded at all three stations are very similar in both survey years (Table 2). There are no marked temporal changes in species

The only apparently significant temporal change in the transect profile was observed at the bottom of the transect. The height recorded at the channel edge was 40 cm lower in 2014; however, this may merely reflect the volume of water in the channel at the times of measurement.

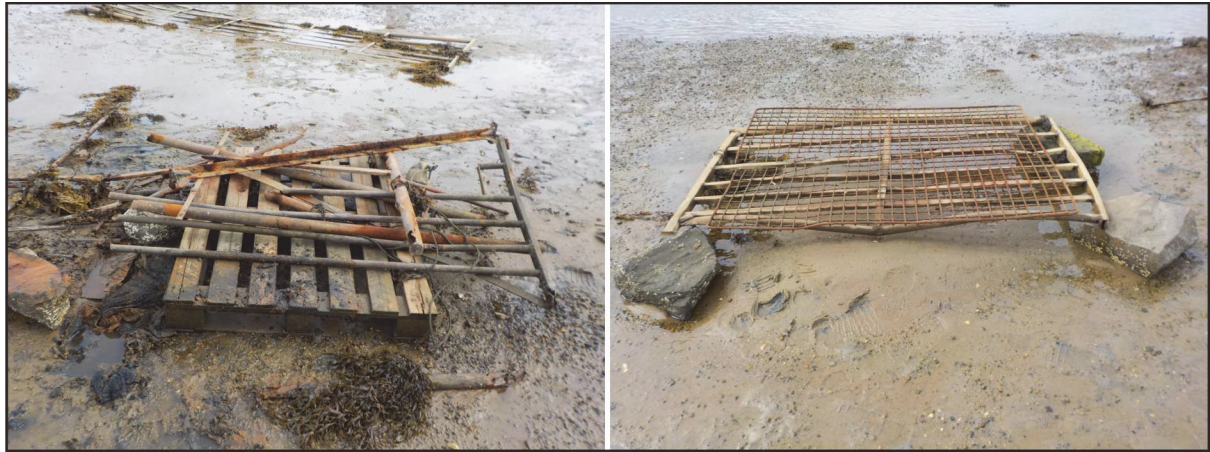
A single bait digger was encountered during the survey, probably targeting *Alitta* (= *Neanthes*) *virens*, large specimens of which were present in the area. Small boat moorings for about five vessels were present in the sheltered embayment off the pier near Ardtoe. At least some of these dry at low tide. A mooring for a small polystyrene raft was located at the mouth of the burn, Faodhail Bhan. In the same vicinity three features were observed that appeared to be the remains of crude forms of oyster trestles: a farm gate (Figure 10, left, background), a gate with metal grating resting on stones (Figure 10, right), and a wooden pallet with assorted ironwork and two nets, probably for oysters (Figure 10,

left, foreground). None of the above mentioned activities or features appeared to be causing significant damage to the sediment flats, merely highly localised disturbance, although the intensity of bait digging is unknown.

Figure 10. Presumed crude oyster trestles observed off Kentra.

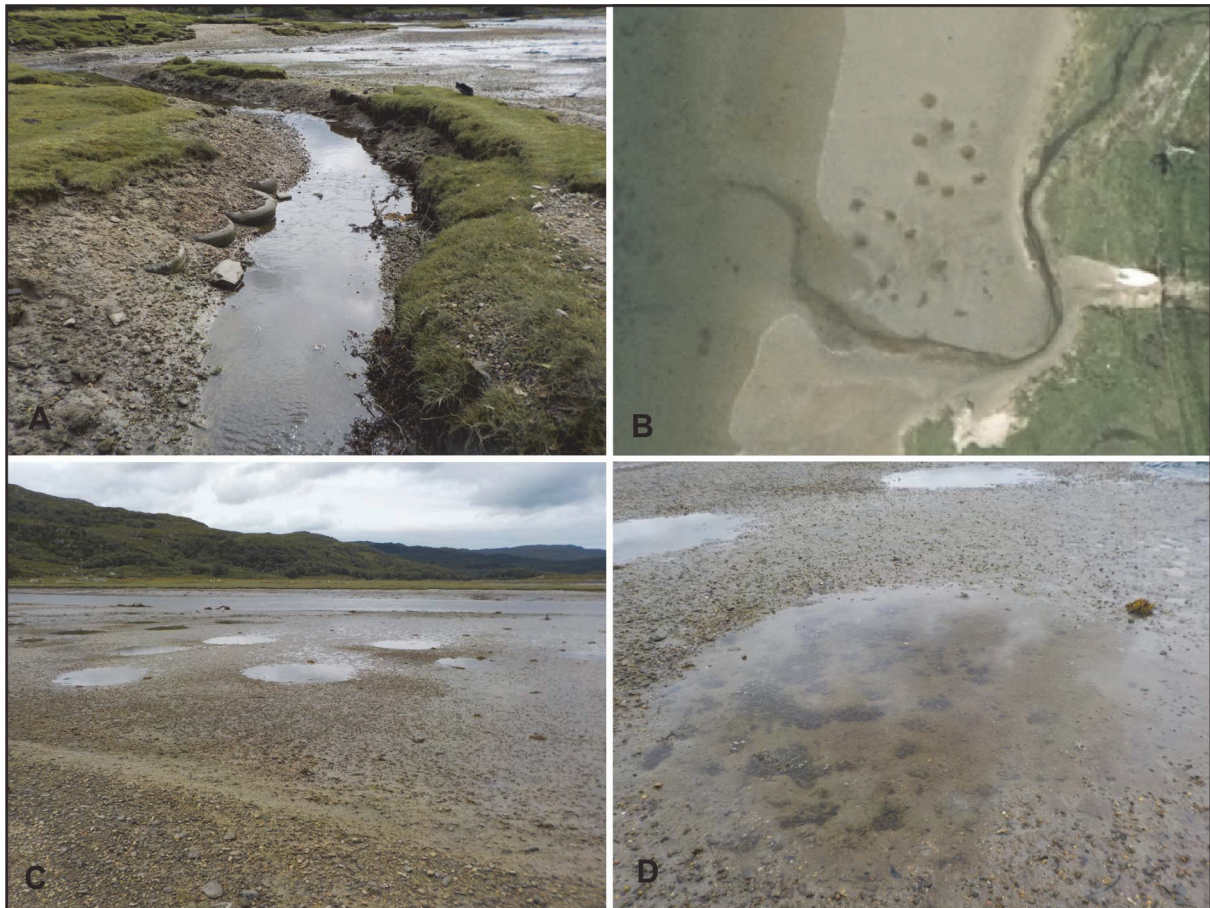
Figure 11. Tyre dumping and sediment crater site at Arivegaig. A, tyre-lined creek; B, aerial imagery of sediment craters; C, view of craters looking south-west; D, close-up of crater. Aerial imagery from 21/07/2013, other images from 15/08/2014.

None of the anthropogenic impacts observed during the 2014 survey work appear to be causing significant damage to the sediment flats and therefore are not believed to warrant remedial action. The Arivegaig sediment craters continue to constitute a visual impact but recovery of the biological condition of the habitat appears to have largely taken place. The process of natural accretion within the craters should be left to continue.

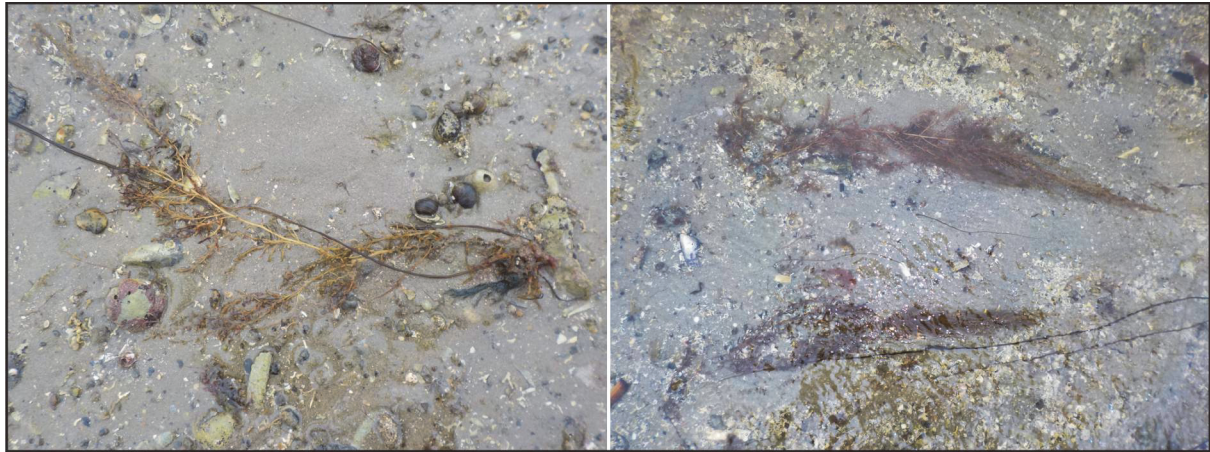
Transect KA also experienced a compositional change in the lowest zone (KA3), with the incursion by the invasive alga, *Sargassum muticum* (Figure 12). However, the current population density is very low and any impact on the character or condition of the biotope must be considered insignificant at the present time.

Figure 12. *Sargassum muticum*. Photographed within 20 m of station KE3 on 12/08/2014.
