An assessment of the results of soil and water samples from a range of wetland sites – Bishop Loch SSSI

Research Report No. 1101

Contractor: OHES Environmental Ltd

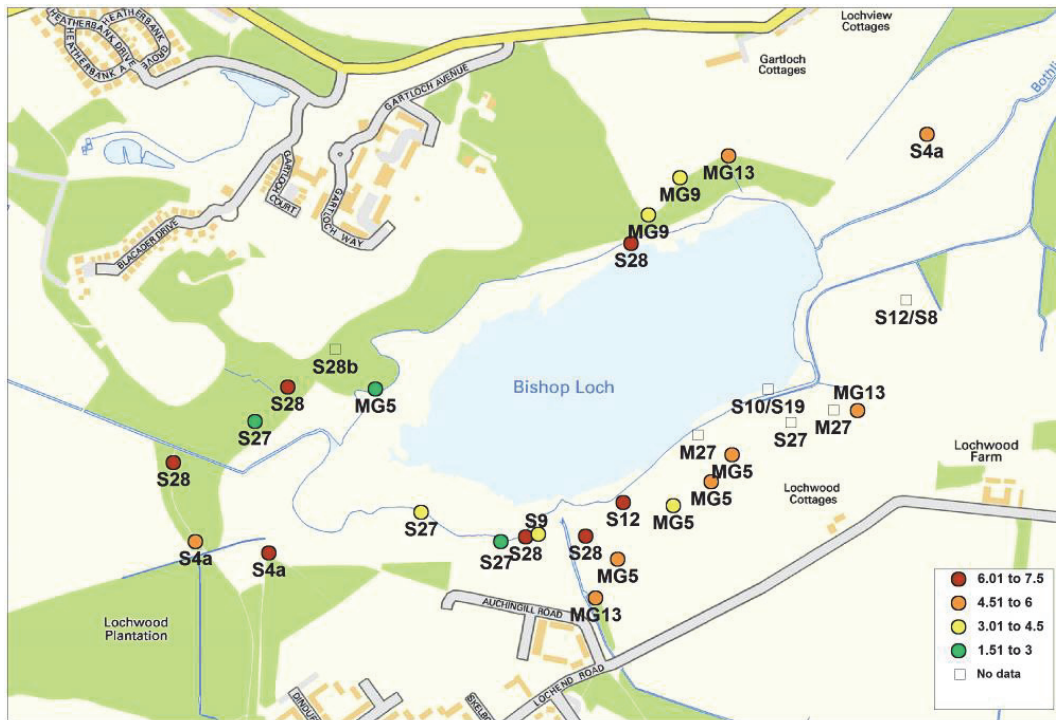
Figure 8. Ellenberg Indicator Values for Nitrogen at Bishop Loch (from 2008 NVC).

Using the 2008 NVC quadrat data, Ellenberg Indicator values for Nitrogen and Moisture have been calculated and are displayed in Figures 8 and 9. They indicate that the most eutrophic tolerant communities (S28 and S4) are located close to inflows (such as the three ditches entering the loch from the west) or around the edges of the loch itself. As expected, moisture levels appear to be highest in the S4, S9 and S12 stands, with S27 and S28 marking slightly drier situations.

- Using the 2008 NVC quadrat data, Ellenberg Indicator Values for Nitrogen and Moisture have been calculated and are displayed. They indicate that the most eutrophic communities (S28 and S4) are located close to inflows (such as the three ditches entering the loch from the west) or around the edges of the loch itself.

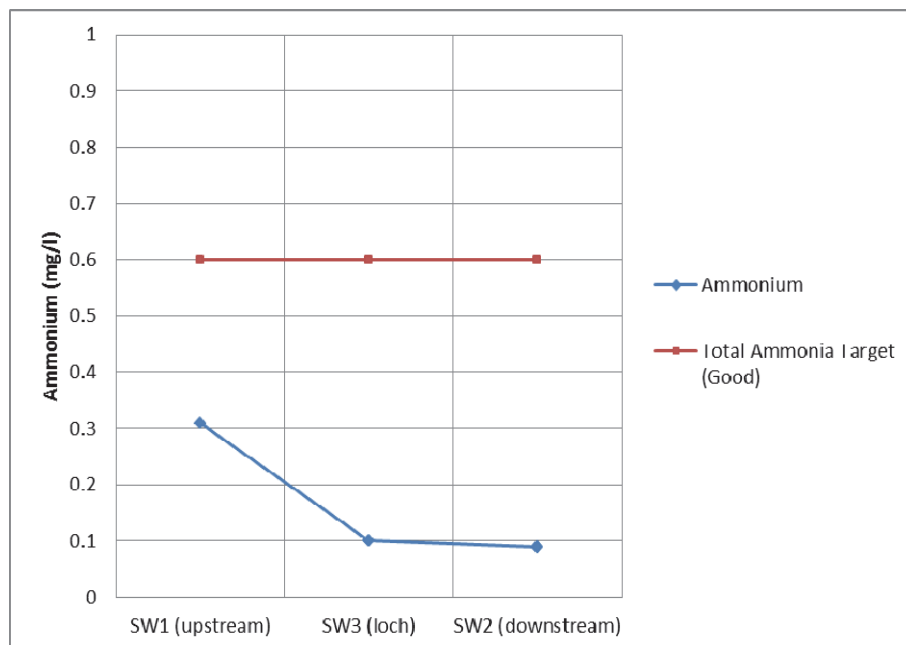
Figure 10. Ammonium recording at Bishop Loch (blue line) against SRBDD standards for Total Ammonia

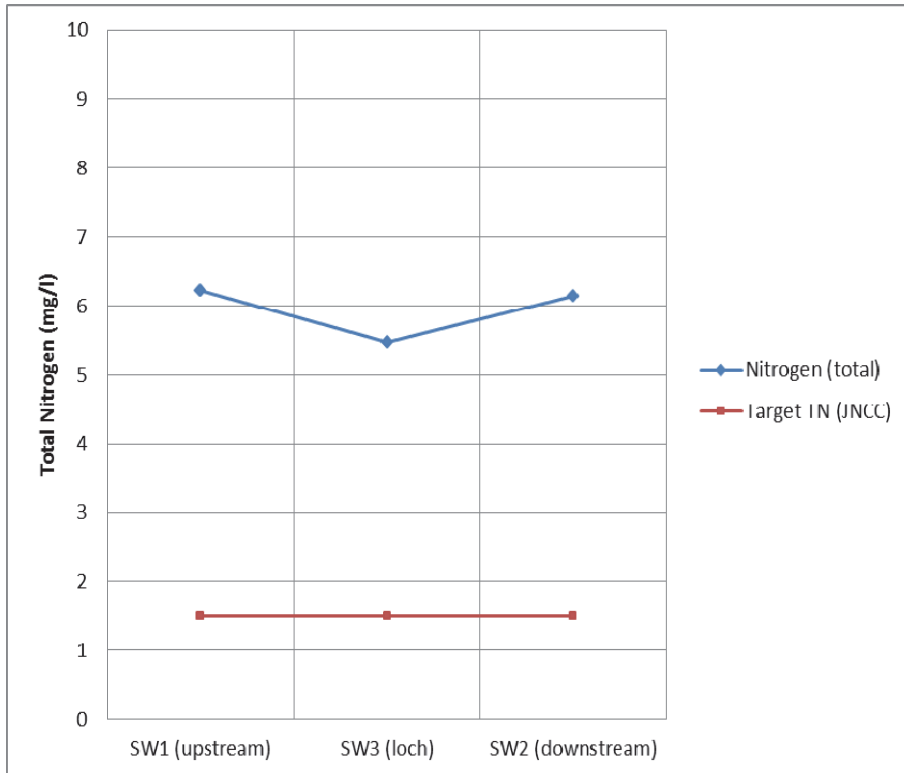
Figure 11. Total Nitrogen recording at Bishop Loch (blue line) against JNCC

Total Nitrogen levels (as shown in Figure 11) indicate other forms of Nitrogen are more problematic, with TN recorded in all surface samples exceeding ECOFRAME and JNCC levels.
