Research Report No. 1102

**An assessment of the results of soil and
water samples from a range of wetland sites
– Bogton Loch SSSI**

Contractor: OHES Environmental Ltd

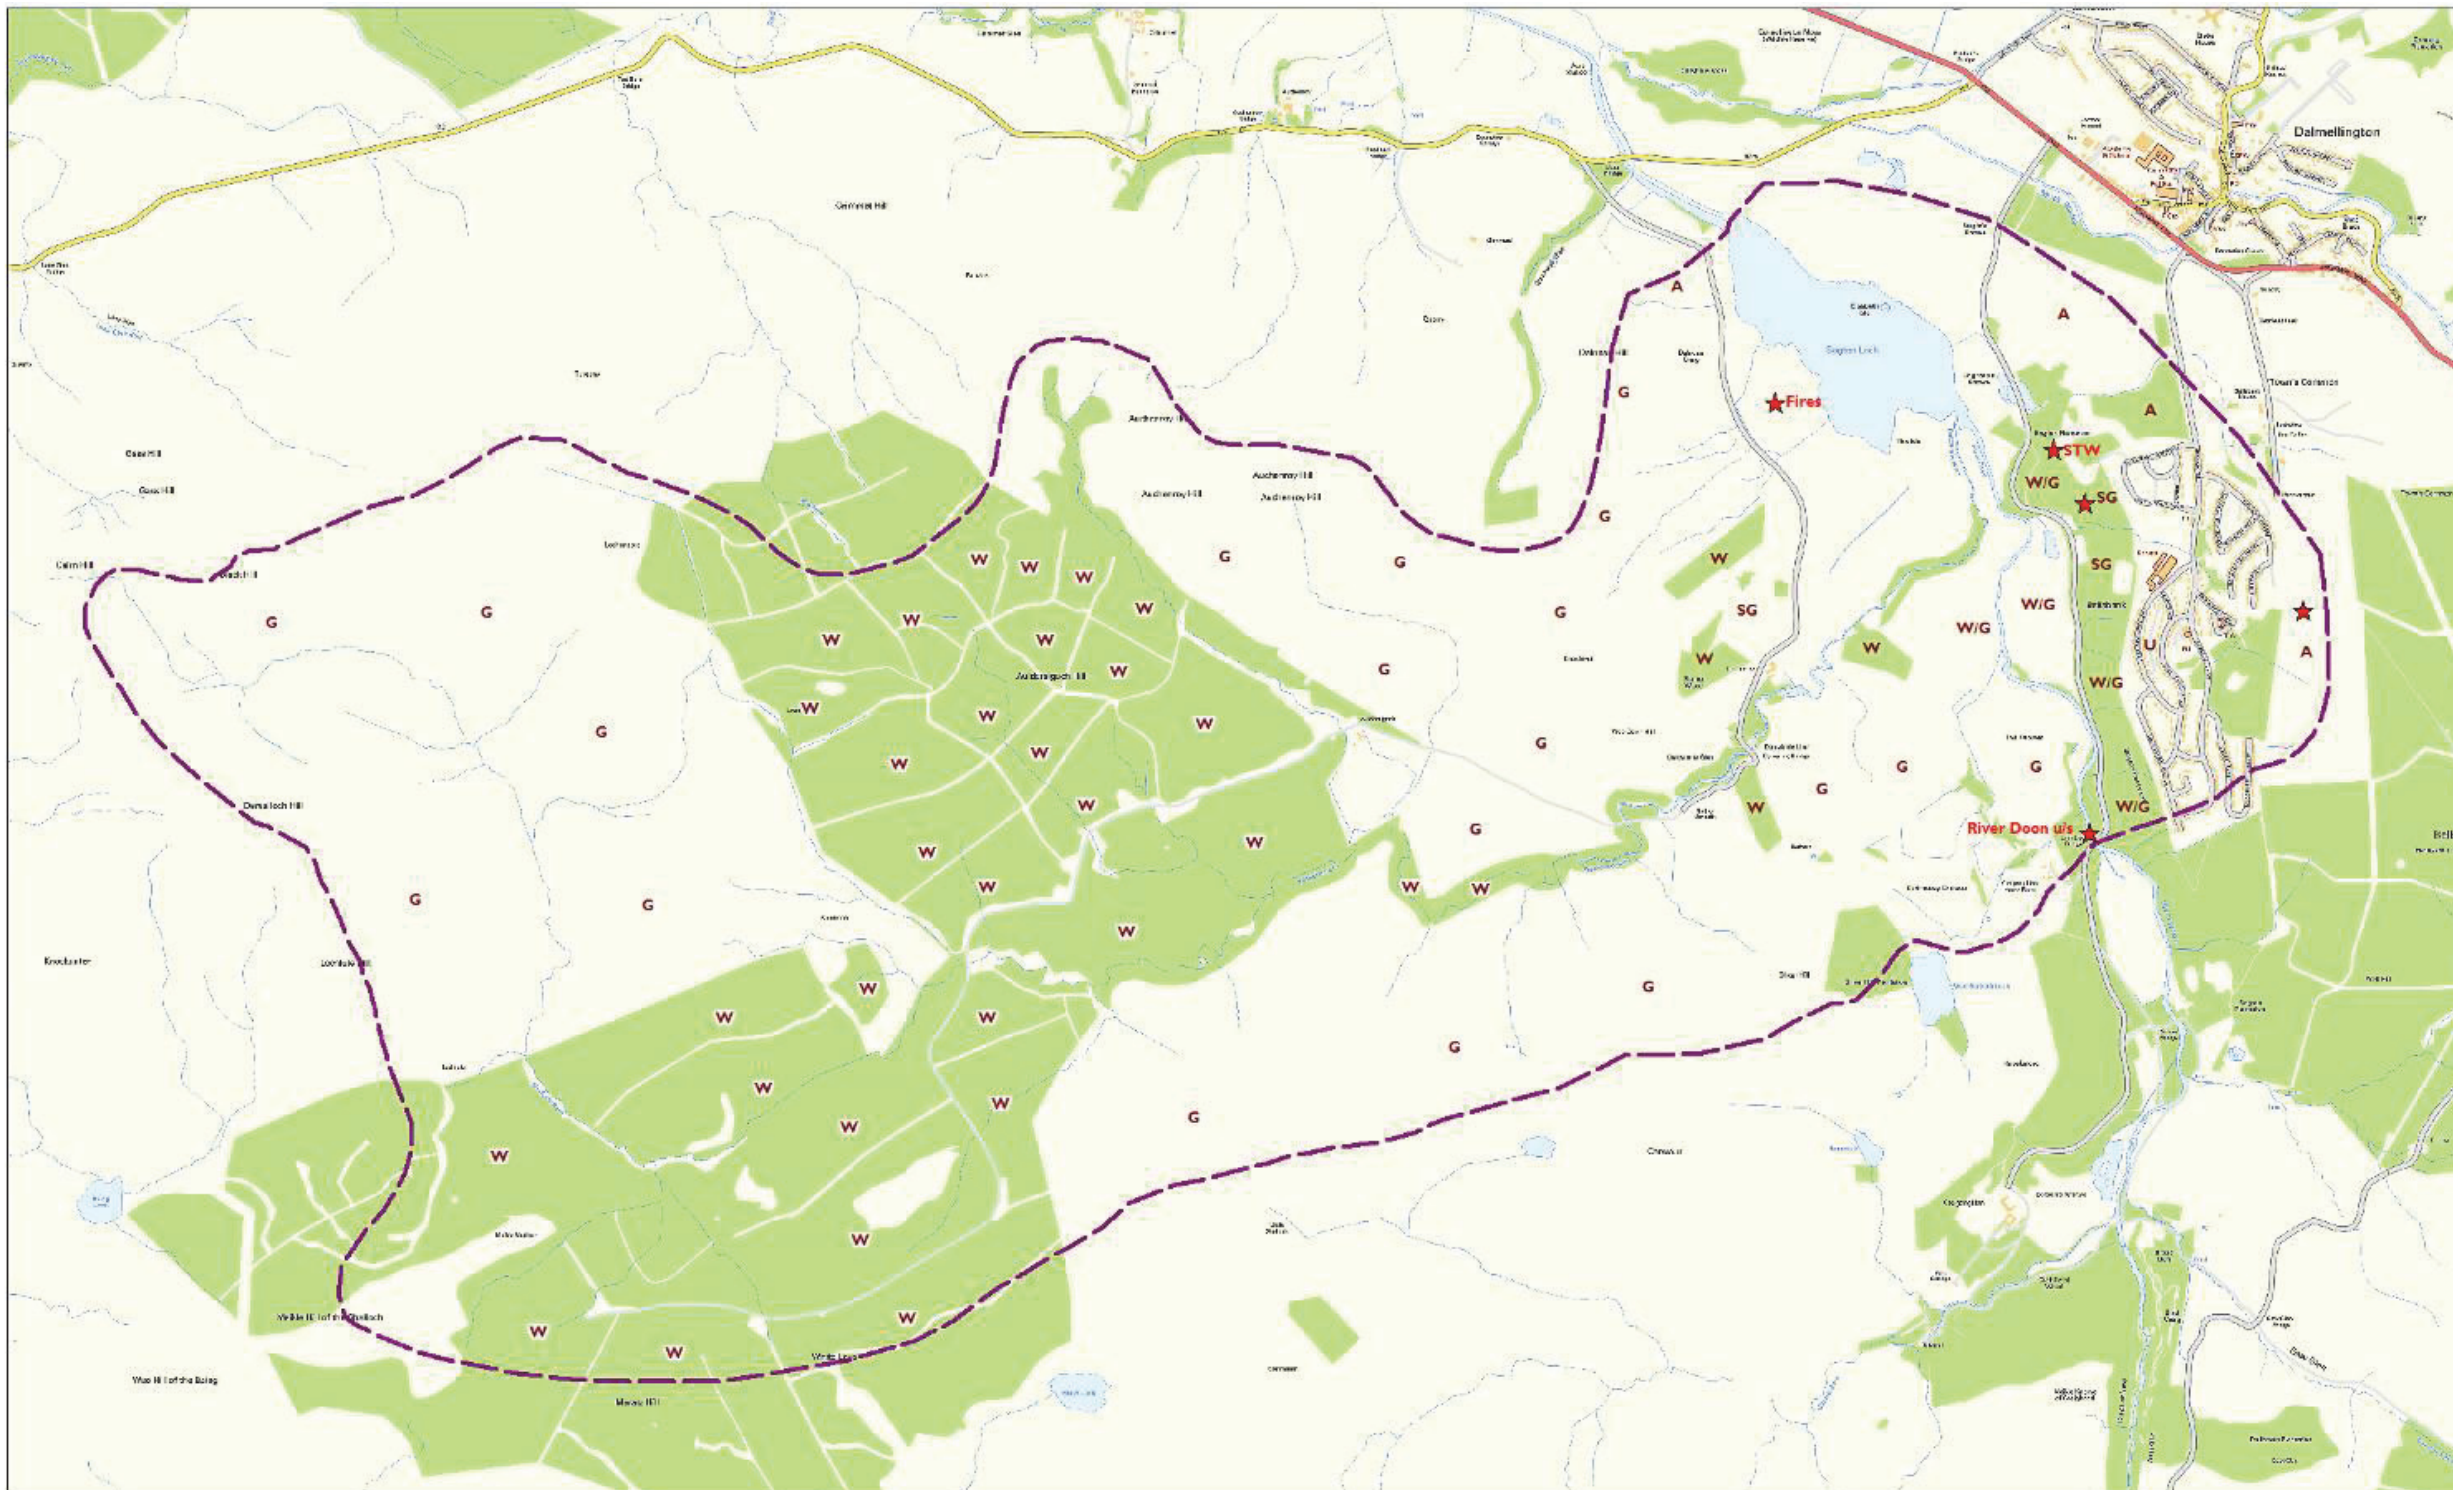
M = Marsh	IG = Improved Grassland	= Flow direction	= Site boundary
G = Grassland	SG = Semi-improved Grassland	= Suspected nutrient source	= Surface water catchment
W = Woodland	A = Arable		
S = Swamp

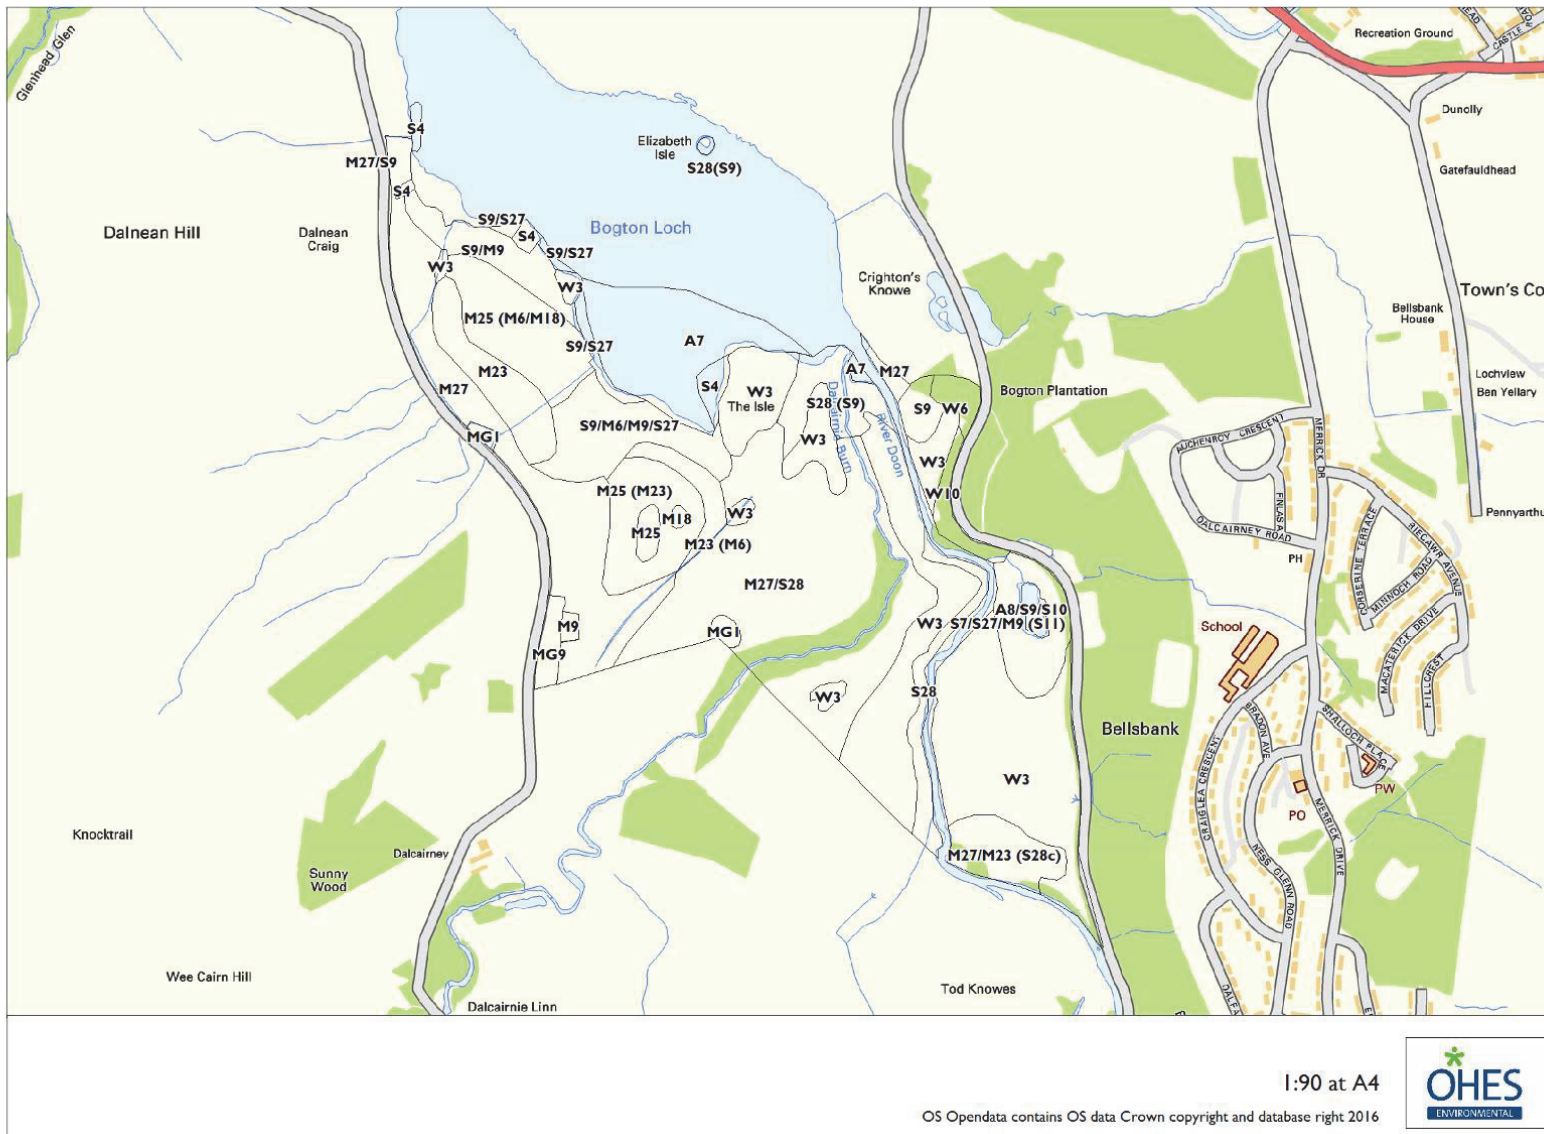
Figure 7. NVC communities recorded in 2000 (Source: SNH Site Management Statement)

When the 1990 and 2000 NVC maps are directly compared, there is little apparent change in the distribution and extent of S4, S9 or S27 communities around the loch edge (though there was some evidence of an increase in *Phragmites* in places during the 2008 survey). Interestingly, of the 8 quadrats taken in 1990, none of them contained *Phragmites* or *Phalaris*. In contrast, the land to the south of the loch shows some clearer changes. Most obvious is the expansion of S28 swamp on land between the Dalcairnie burn and River Doon from 2000 onwards, into what was formerly M23 in 1990. Also within this same area, the extent of S27 on the western side of the River Doon appears to have reduced due to encroachment of W3 woodland. This suggests land to the south of the loch (around the two main inputs into the loch) is reducing condition and requires remedial measures.

Finally, one of the fields immediately to the west of Dalcairnie Burn appears to show a shift from S27 / S10 to M27 / S28 in the 2000 survey, but this is not borne out by the 2008 Site Condition Monitoring, which again showed the field as a S27 and S10 mixture.
