An assessment of the results of soil and water samples from a range of wetland sites – Dunbog Bog SSSI

Research Report No. 1103

Research Report No. 1103
Contractor: OHES Environmental Ltd
Year of publication: 2019

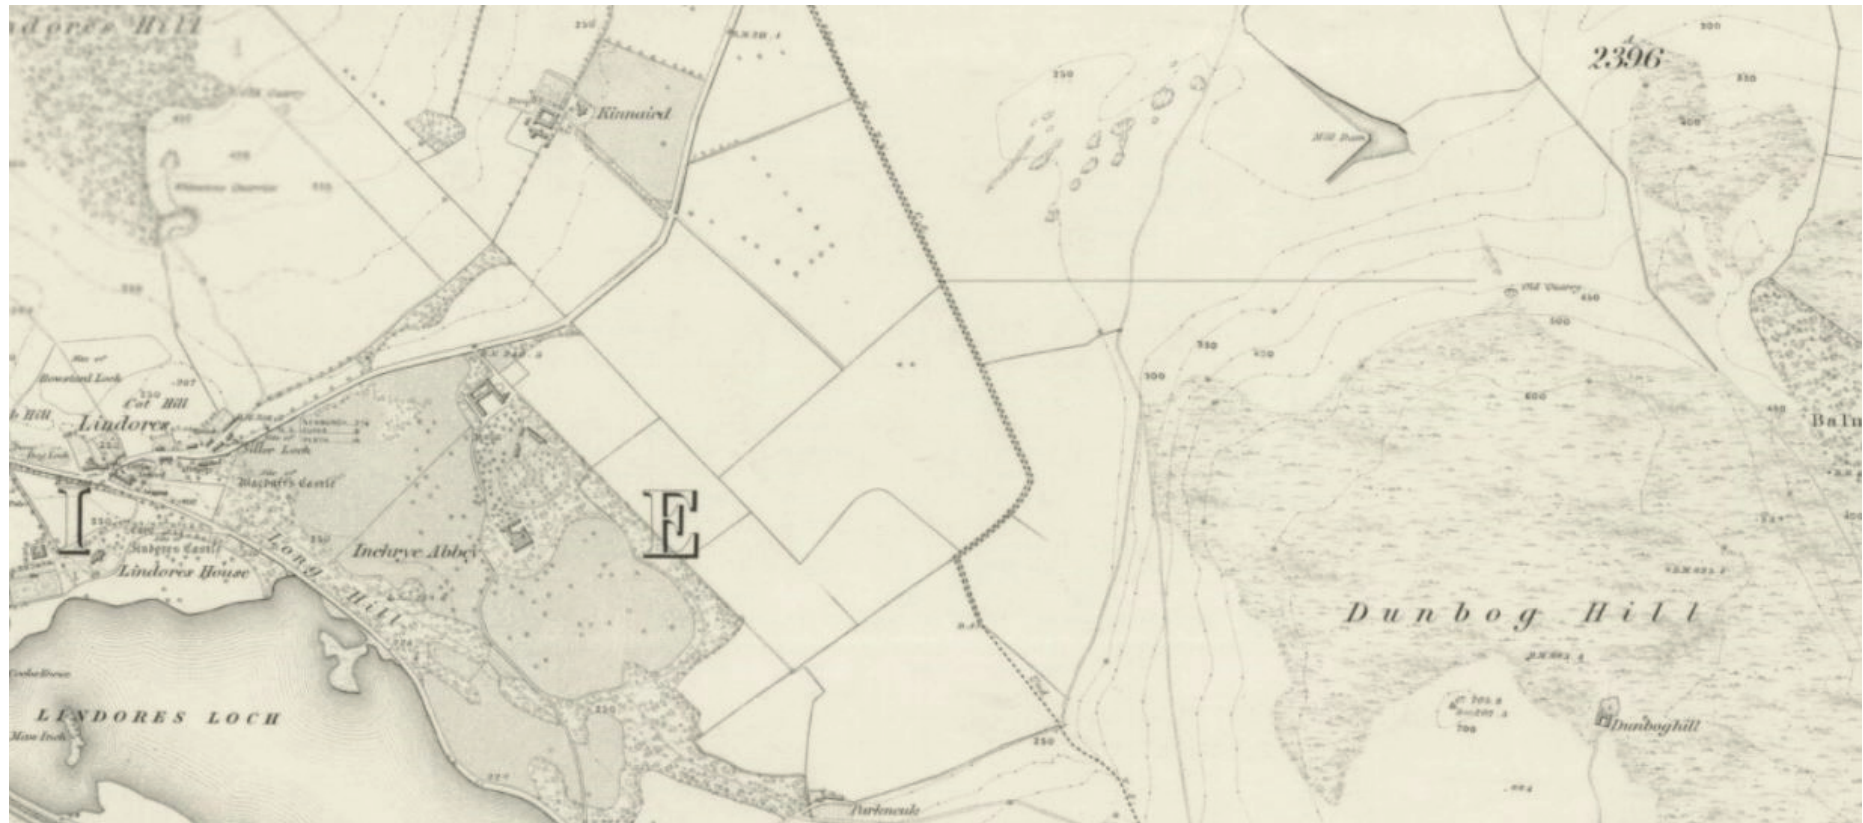
Figure 2. Ordnance Survey Six Inch 1843 – 1882 map (Source: National Library of Scotland)

Reeds were burnt and cut on a regular basis in the south of the site during the early 1980s but following the designation in 1984 these practices were undertaken away from areas of high botanical interest. Cutting and burning no longer takes place on the site, this has led to the spread of reedswamp, resulting in a loss of species diversity. Figure 2 shows the Dunbog site in the 1800s.
