# Control of New Zealand pygmyweed (*Crassula helmsii*) at Mochrum Lochs SSSI: phase I, 2007 – 2008

**Commissioned Report No. 483**

**Control of New Zealand pygmyweed  
(*Crassula helmsii*) at Mochrum Lochs SSSI:  
phase I, 2007 – 2008**

**Contractor: ECUS Ltd.**

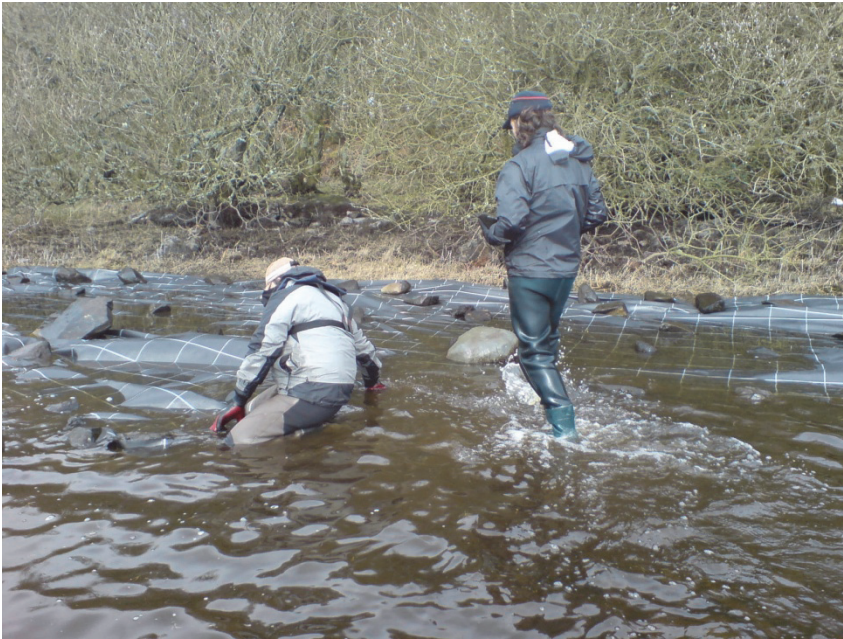
*Plate 1. Installation of WCF at Drumwalt Plantation/Scar Islands*

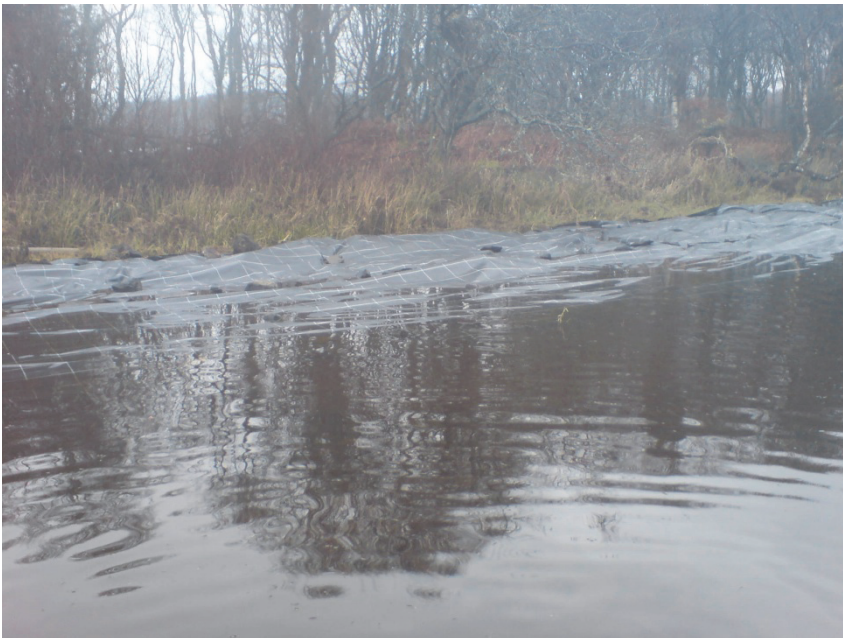
*Plate 2. WCF installed at the bay adjacent to Park Hill*

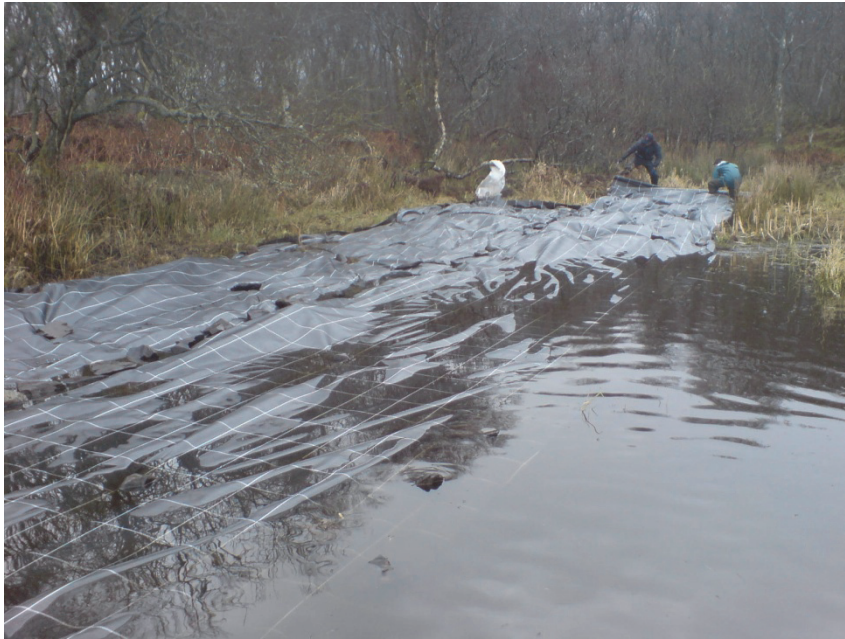
*Plate 3. Installation of WCF at Heathery Ward Wood, south bay*

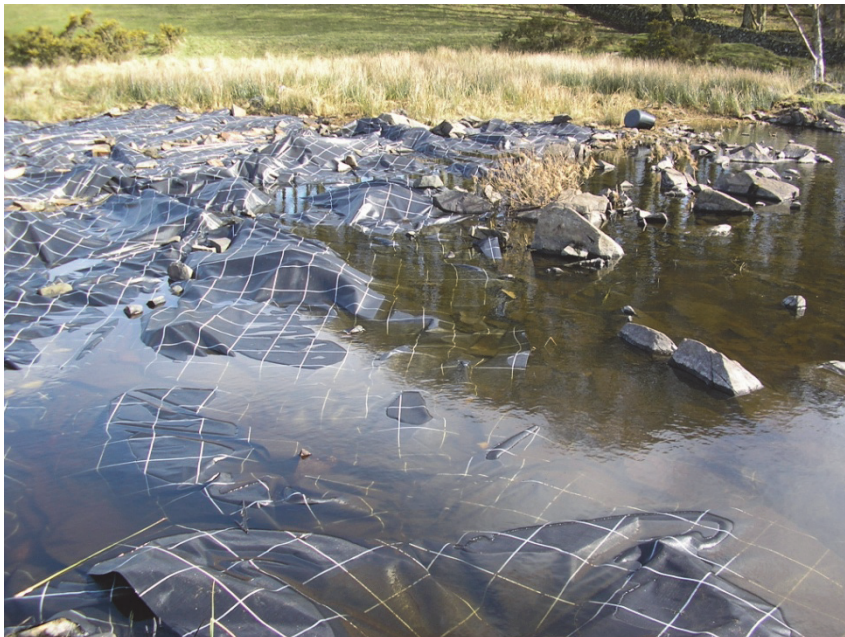
*Plate 4. WCF installed over Wee Hill Cove strand line*

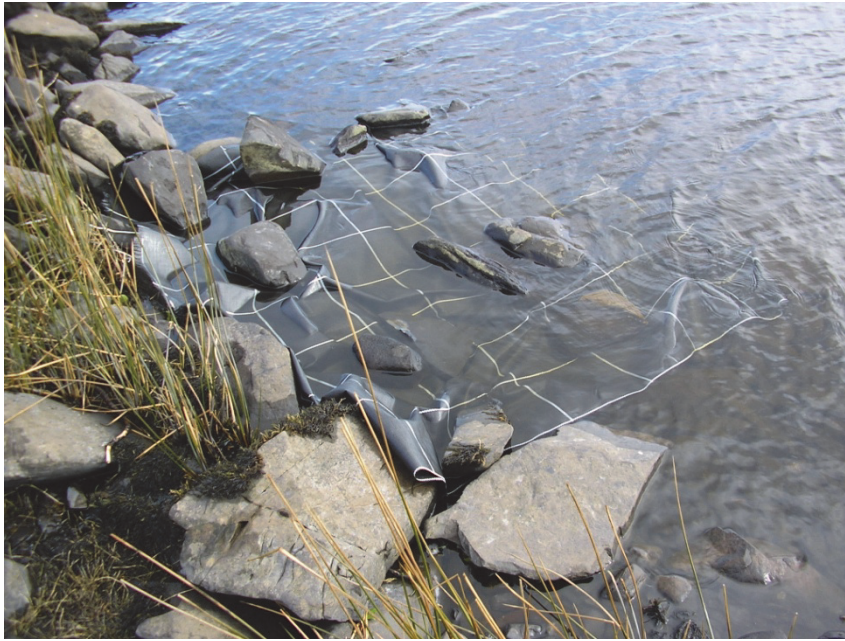
*Plate 5. A small patch of WCF on the west shore/Gargrie Moor*

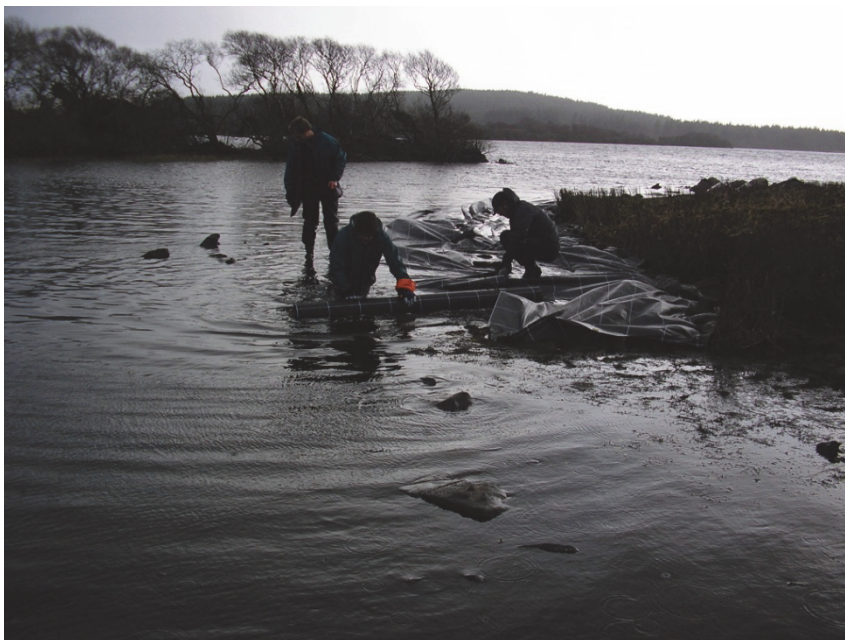
*Plate 6. Installation of WCF on west shore, opposite Rowan Island*

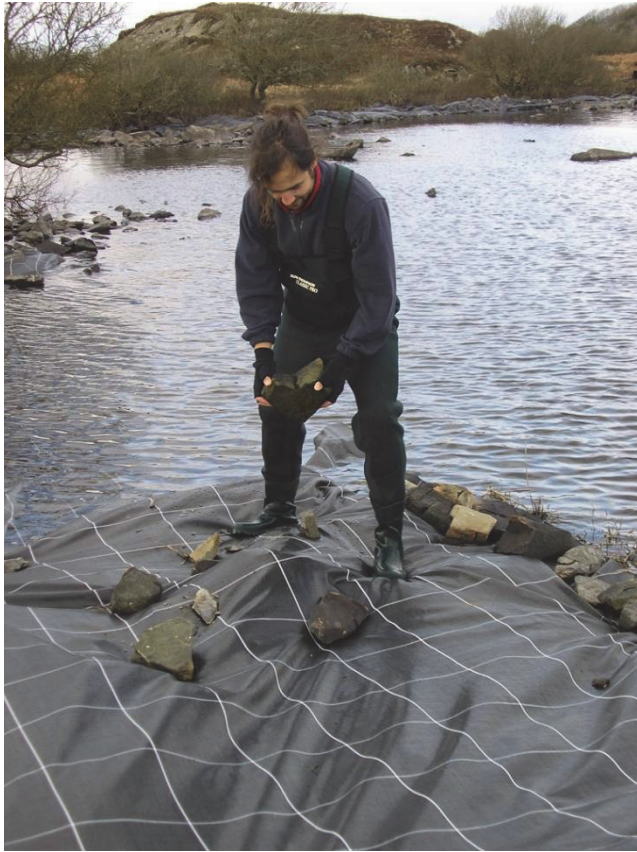
*Plate 7. Rock placement at bay on west shore north of Rowan Island*

Initially, corners of fabric were weighted in place with stones from within the loch, to aid the initial sinking of the material. However, it was discovered during the initial field trials, that material tended to billow when secured solely in this manner. It was considered that this increased the risk of fabric becoming loose in some locations, so where soft substrates exist, WCF control pegs were used to secure the edges of fabric, particularly around the strandline.

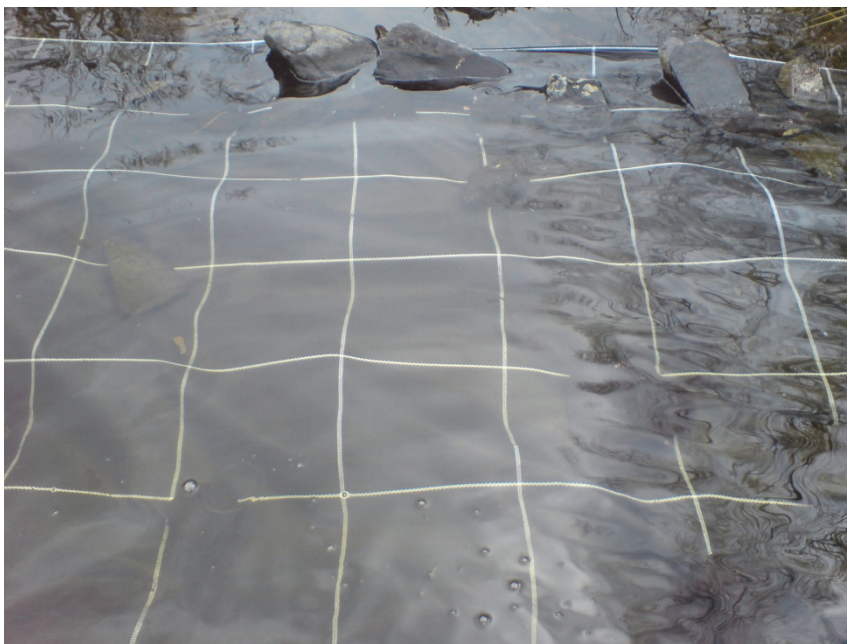
*Plate 8. Boulder placement and folded edge of WCF*

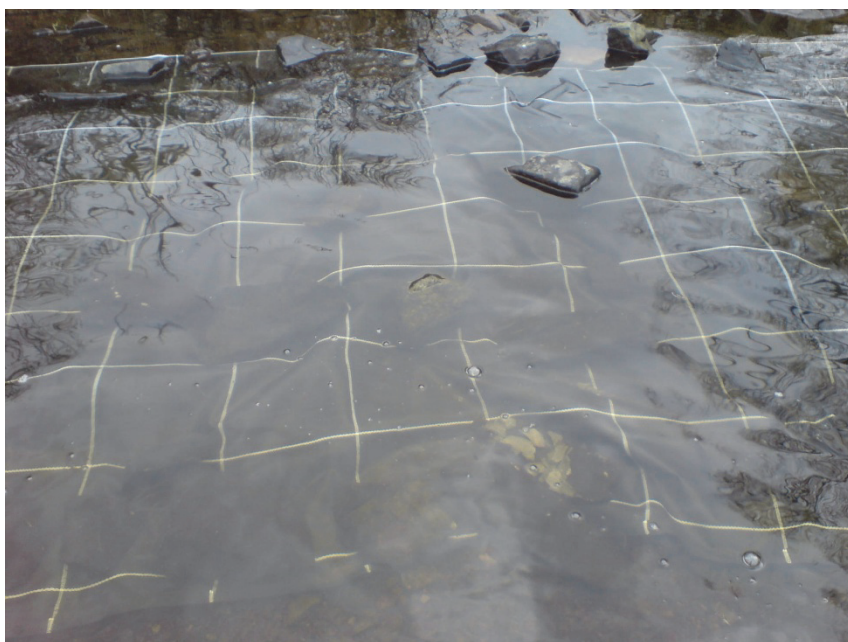
*Plate 9. Weighting the join between two lengths of fabric*

WCF of 2 m width was utilised during the initial treatment visit. Where infestations of *C. helmsii* of greater than 2 m width were present, lengths of fabric were sewn together on the bank, to create larger sheets of 4 or 6 m width. This approach was preferred, as it was considered that overlaying narrower sections without joining materials increased the risk that layers would separate under adverse weather conditions. It was considered that this could result in either too much light being allowed to penetrate to enable control of *C. helmsii* to be achieved, or individual sheets to come adrift within the loch.
