Experimental shading to control/eradicate Canadian waterweed

Commissioned Report No. 557

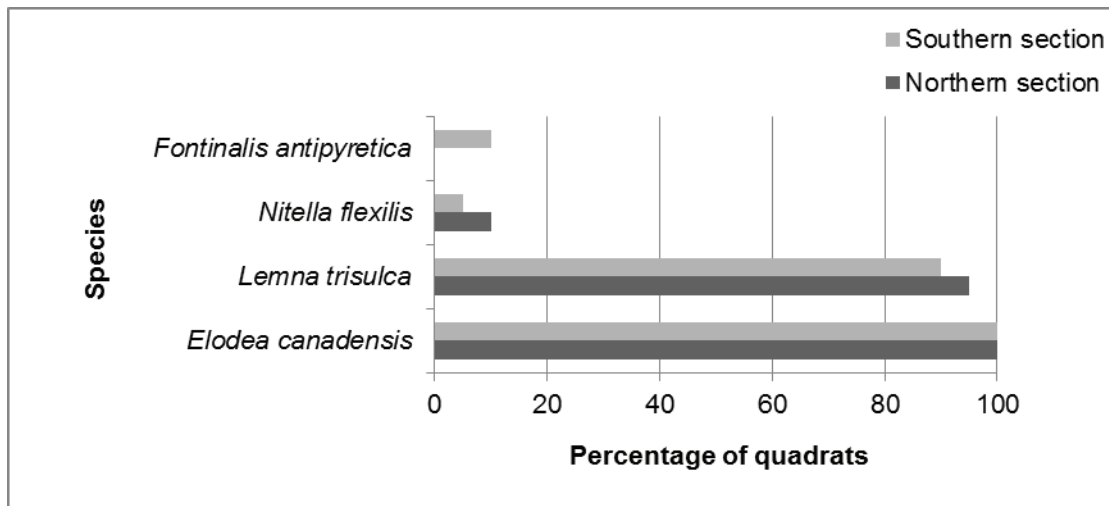
Figure 3.1: Frequency of species recorded from 20 quadrats in the south-western outflow bay

E. canadensis dominates both the northern and southern portion of the bay, and *L. trisulca* also occurs at a high frequency. Within the randomly placed quadrats, *F. antipyretica* was only recorded in the southern part of the bay (although it was also present in the northern area outwith the quadrats). *N. flexilis* was also recorded at low frequency in both areas.

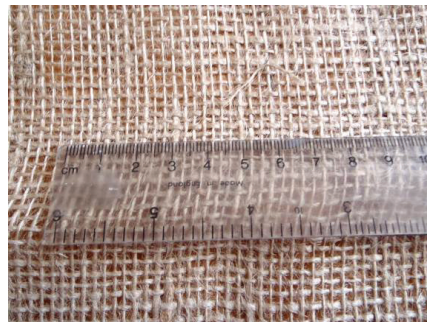
Figure 3.3: Jute material installed in 2011

The material selected for installation in 2011 was chosen as being most similar to the material which has been used in Ireland. It comprised a jute fabric manufactured from unbleached jute fibre. It is designed to degrade in 1 – 2 seasons and is recommended for use in areas where short term protection is required. It holds up to five times its own weight in water (Greenfix, 2009). The weight of the material is 305 gsm and it is supplied in rolls that weigh approximately 25 kg. The material is 1.22 m wide and approximately 68.58 m long. It can also be obtained in rolls of 3 m and 5 m width. Figure 3.3 shows a close up view of the material. Other pictures of the material are available in Appendix A.

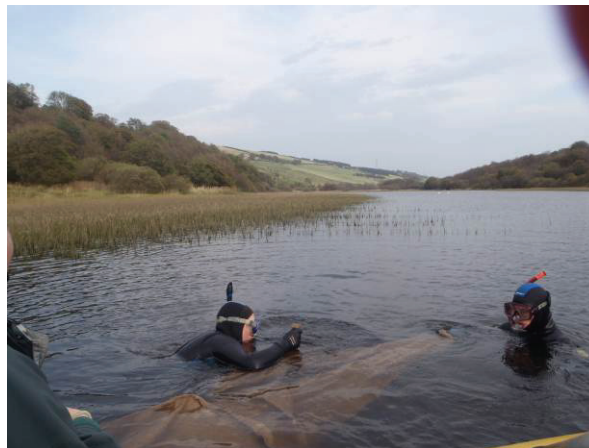
Figure 4.2: Snorkel team installing the jute matting

Each sheet of material was unfolded and floated out into position by the team of snorkellers (see Figure 4.2). Once in position, the material was positioned on the bed of the loch. It was then fixed in place using bags of stones along its edge and in the middle. It was hoped that it would be sufficient to place bags of stones at approximately 5 m intervals, but this did not provide adequate anchorage. This was partly owing to the height of the *E. canadensis* bed. Once all the sheets were installed in the desired positions, the snorkel team checked that there was adequate overlap between sheets and re-located bags of stones and fixing materials to ensure that the sheets were firmly secured. Bags were mainly positioned close to the edge of sheets, but some were also added to the middle of sheets to help pin the material more closely to the underlying *E. canadensis*. Air bubbles became trapped under the surface of the matting, which the snorkel team tried to eliminate by forcing the air through the weave of the material.

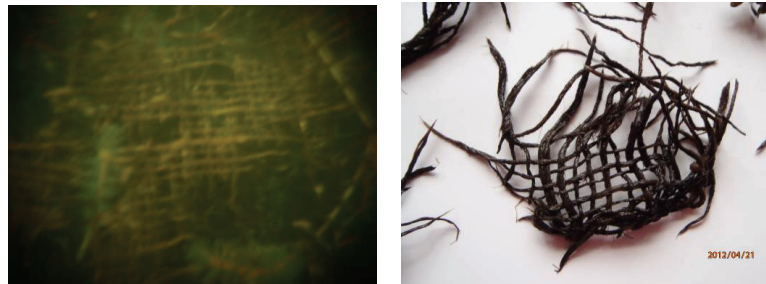
Figure 5.1: Views of matting after immersion in Loch Libo for 6 months (a) in situ and (b) out of the water

In the remaining 15% of quadrats it was assessed as a mixture of disintegrating on contact and fully decomposed. Figure 5.1 shows how the material had degraded.

The matting had decomposed substantially over the 6 months that it had been in place. It was assessed as having fully decomposed (or disappeared) from 85% of the 20 quadrats.

The matting introduced for the first treatment in September 2011 was found to have lost its integrity by April 2012 and had broken into smaller sections. This contrasts with the situation in Lough Corrib, where jute matting of a similar specification was found to maintain its integrity for longer. It was considered to be fully functional for up to 7 months; by 10 months, the matting appeared intact, but could be relatively easily torn; and by 17 months it was visually intact, although it disintegrated on contact (Caffrey *et. al.* 2010).

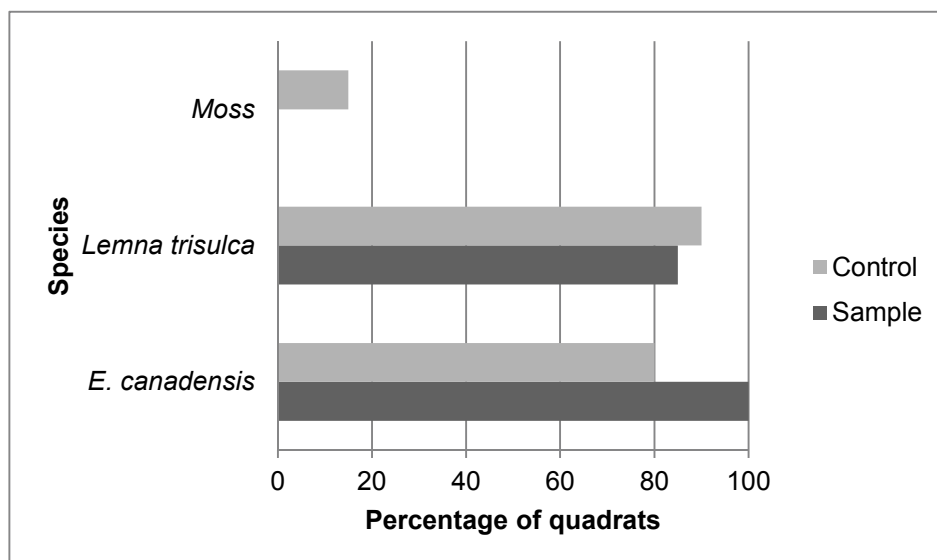
Figure 5.2: Frequency of occurrence of species in control and sample sections during early season monitoring visit

The species recorded within the sample and control sections are shown in Figure 5.2. Very few species were recorded, which is consistent with a survey early in the macrophyte growing season. The main difference in species occurrence was the presence of a small amount of moss, believed to be *Fontinalis antipyretica*, in the control section.

E. canadensis was recorded from all quadrats within the sample area. However, much of this *E. canadensis* did not appear to be rooted, although it showed signs of regeneration as evidenced by the presence of fresh green tips to shoots. By contrast, in the control area, *E. canadensis* was confirmed as rooted in 12 of the 20 quadrats. There were also differences in the height of the macrophyte beds in each area. *E. canadensis* in the control area formed a bed which varied in height between 50 – 60 cm, whilst in the sample area it was estimated to be in the order of 15 cm high.

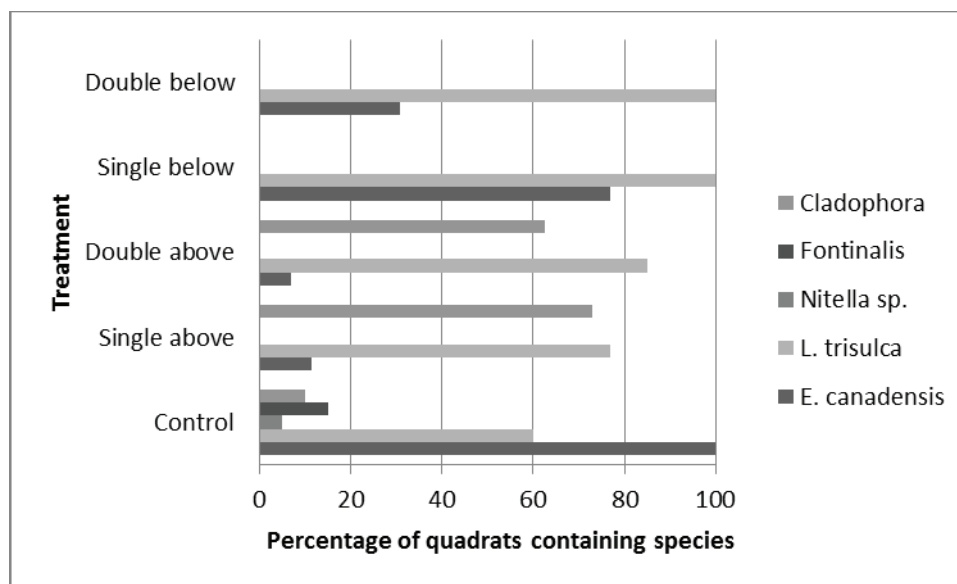
Figure 5.4: Percentage occurrence of each species within quadrats in the sample and control areas

The frequency of occurrence of *E. canadensis* was lower in all treatment areas when compared to the control area, and was lowest on top of the matting than underneath it for both treatments. By contrast, the frequency of *L. trisulca* was higher in both of the treatment areas than in the control area, and was highest below the matting (of either thickness) than above it. Further comments on these observations are provided below.

The abundance of *E. canadensis* below the matting (both single and double thicknesses) was highly significantly lower than that found in the control plots ($p < 0.001$, Fisher's exact test). The levels of *E. canadensis* below the double layers of matting were significantly lower ($p = 0.009$ Fisher's exact test) than those recorded below the single thickness of material (modal cover score = 0 in 9 of 13 quadrats under double thickness compared to modal score = 3 in nine of 26 quadrats under single thickness); cover scores of 2 and 0 were both recorded in seven of the quadrats.

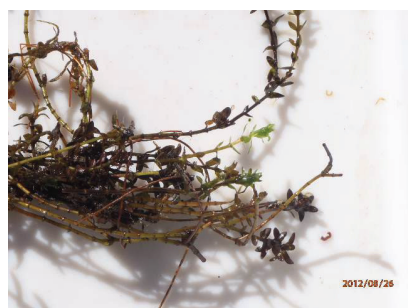
Figure 5.5: Example of decomposing *E. canadensis* extracted from below matting

There were highly significant differences in the condition of *E. canadensis* under the matting compared to that in the control area. Handfuls of the plant material were pulled out from below the matting and examined. These were mainly black, and decomposing with some green tips to stems (see Figure 5.5). The modal condition score was 2/3 – indicating that the *E. canadensis* was a mixture of decaying or fully decomposed. Material in the control area was healthy ($p < 0.0001$ Fisher's exact test). There was also a significant difference between the condition of *E. canadensis* below the single thickness of material compared to the double thickness ($p = 0.0172$), with material below the double thickness showing a greater degree of degradation.

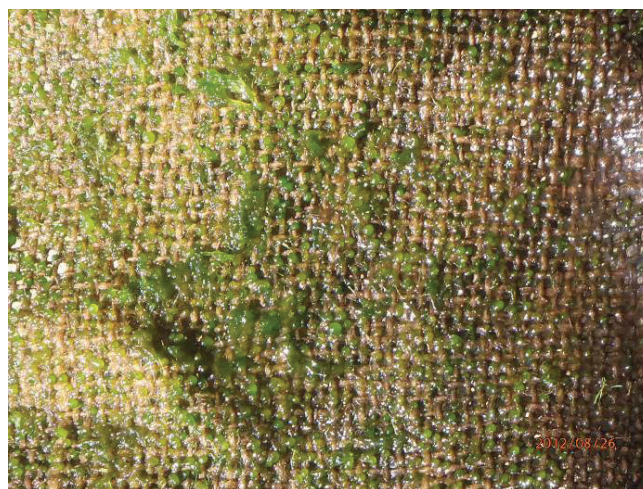
Figure 6.1: Example of algae developing on surface of matting

Algae were also found on the surface of the matting. This was growing in and acting to block the holes in the material. (See Figure 6.1).

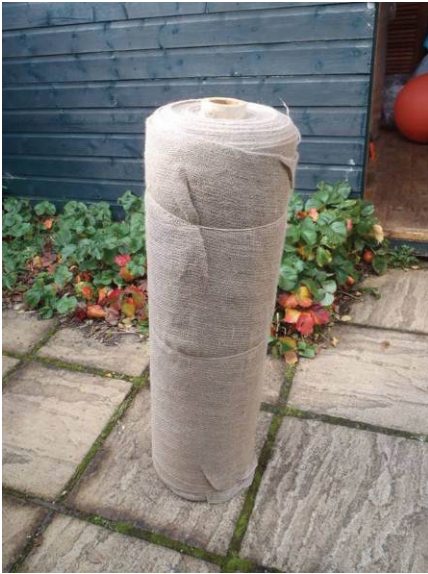
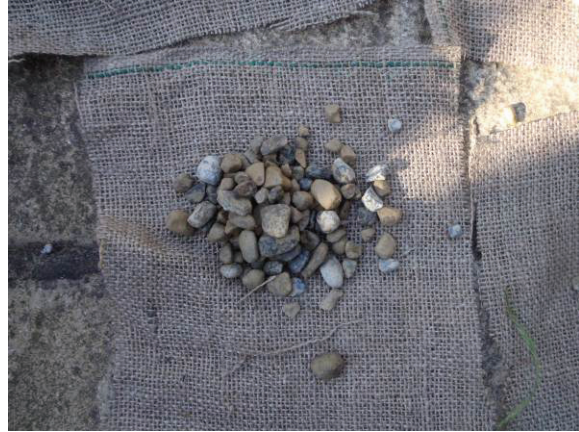
Rolls of jute as delivered from the supplier in 2011 (left) and creation of small, weighted bags for fixing jute matting to the substrate (right)

It was decided to construct a number of small Hessian 'bags' containing washed gravel/ small stones. The bags were constructed using the same material as the sheeting. This was cut into small squares, stones were added, and the ends tied together using a biodegradable garden string (see Appendix A). The gravel was commercially available material, of varying sizes, available from garden centres for paths and was chosen as an inert material that was unlikely to influence water quality conditions in the loch.

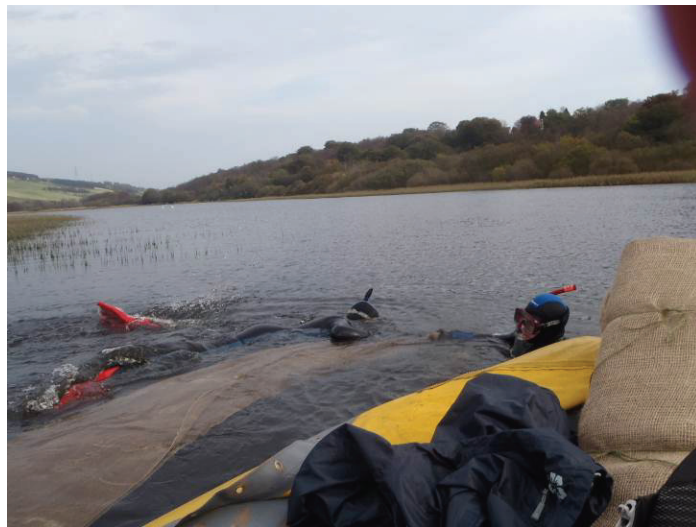
Divers towing jute matting out to required position from inflatable boat (2011)

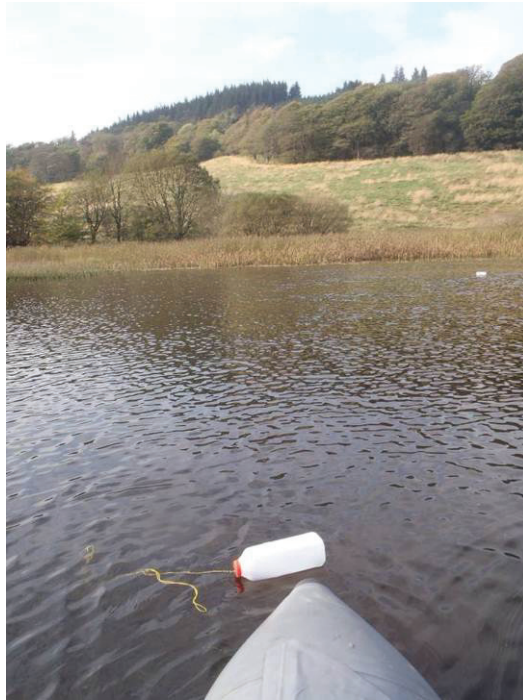
Study area seen from the surface of the loch. The jute lies between the plastic buoys

The jute matting was relatively easy to install with a small team. In the shallow conditions at Loch Libo, it could be installed using a snorkel team, rather than using full sub-aqua equipment, which reduces the costs and scale of health & safety requirements.

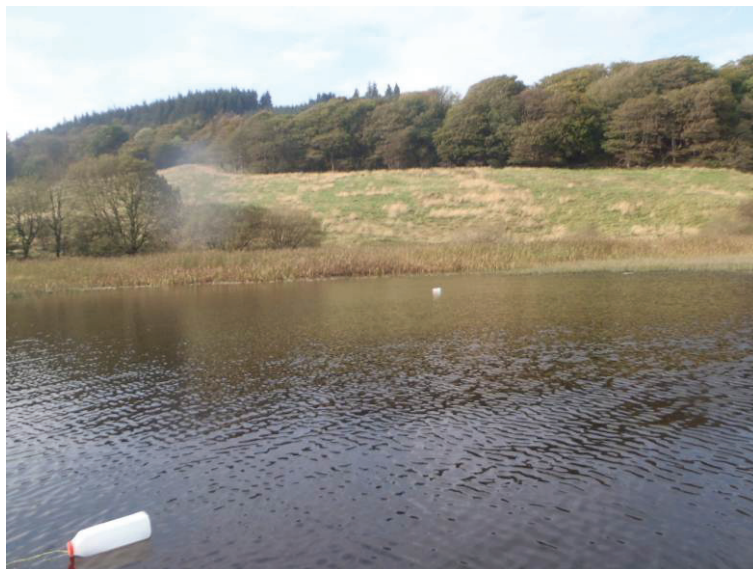
Surface view of study area
