Golspie dunes: Coastal erosion options appraisal

Scottish Natural Heritage
Dualchas Nàdair na h-Alba

Commissioned Report No. 635

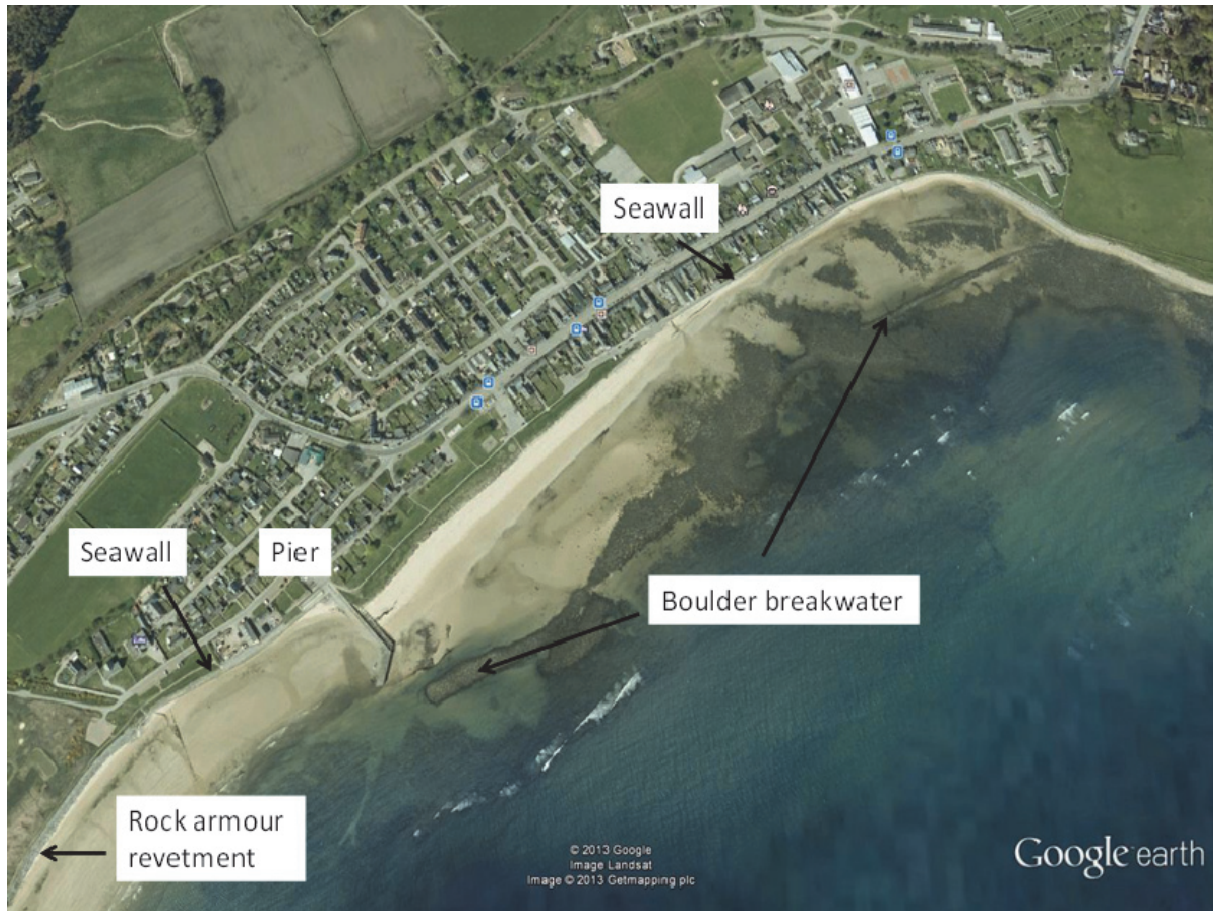
Figure 3: Golspie seawalls, pier and breakwater fronting the town and rock armour revetment fronting the northern part of the golf course.

In view of the low altitude of the coastal edge and its sand and gravel composition, coastal erosion has been a feature of this coastline for many years, the rates and timing of which are detailed below. The response of both the Local Authority and golf course alike has been to favour hard engineering structures in an attempt to halt the loss of land. One of these structures is a masonry wall built in the late 1950's to replace earlier wooden structures in the north at Golspie town and a coast-parallel boulder breakwater of earlier but unknown age (Figure 3).

In 1979 rubble from a demolished railway bridge in Golspie was placed along the coastal edge below the golf course clubhouse and in 1980 funding from Highland Region saw the 3rd hole and most of the 4th hole given rock armour protection and four years later a similar scheme was effected around the 5th green and 6th tee. This led to a gravel storm ridge developing between the two lengths of rock armour revetment but this too has been subsequently replaced by a rock armour revetment so that the entire golf course frontage is artificially protected. Such a piecemeal down-coast extension of defences is typical where hard defences are installed on soft shorelines. It effectively exports the erosion 'problem' to adjacent sections of coast and fails to address the underlying cause. The most recent phase of coastal protection work along the golf course frontage occurred as a result of a storm in late 2012 when substantial lengths of the golf course rock armour revetment frontage was undermined, dropping in height to allow erosion of sediments behind the wall and overwash onto lower parts of the course itself. The remedial works focussed on reinstatement of the rock armour revetment to a slope of ca. 20-30° and seated onto geotextile. Larger grade boulders were added together with a marginal increase in the rock armour revetment height and a gathering up of the coarser natural beach boulders harvested from the immediate foreshore. The planimetry of the reinstated rock armour revetment wall deviates into a series of mini headlands, particularly south from the Golf clubhouse, that follow the line of the erosional damage in the 2012 event whilst preserving the line of the holes and tees of the golf course. At the southern end of the rock armour revetment, at the 7th tee, the revetment is replaced by a rectilinear wall composed of over one hundred 1 m x 1 m gabion baskets that are seated directly onto geotextile over the natural beach material and fronted by rock armour revetment along the seaward face of the tee. The gabion wall takes an abrupt 90 degree turn inland for 4 m at the north and 11 m at the south of the tee before curving back toward an approximately coast-parallel orientation for 52 m (Figure 3).

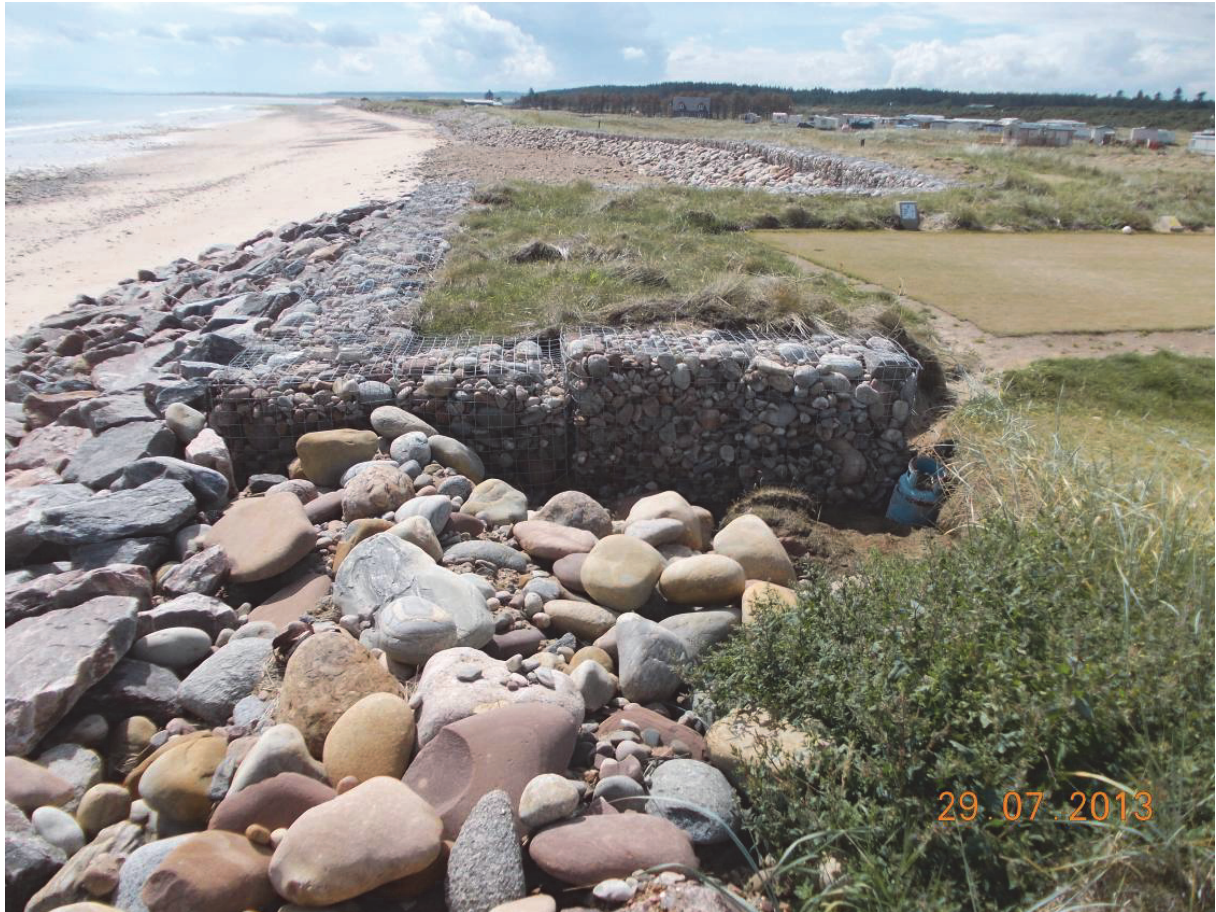
Figure 4: Position of the gabion baskets at the 7th tee and the erosional bight to the south.

Indeed there is a clear difference between the generally higher golf course land to the north of this point of 4-5 mOD (although there are a few lower parts) and the lower topography (2-3 mOD) of the caravan park, Kart Track and the northern part of the NNR (Figure 2). Along the caravan park frontage there is evidence of earlier work to reform the coastal edge to a height of ca. 3 mOD with sand and gravel taken from the upper beach, this strategy has been continued in the aftermath of the 2012 storm and augmented using gravel cleared from the overwash lobes that extended into the caravan park itself, mainly at its northern and lowest end where wave overtopping occurred in the 2012 storm, leading to marine flooding of the caravan park to a depth of 1-1.5 m. In spite of this the reformed coastal dune retains the characteristics of a natural ridge but it remains narrow and thus vulnerable to further wave erosion and overtopping to access lower land behind (Figure 4).

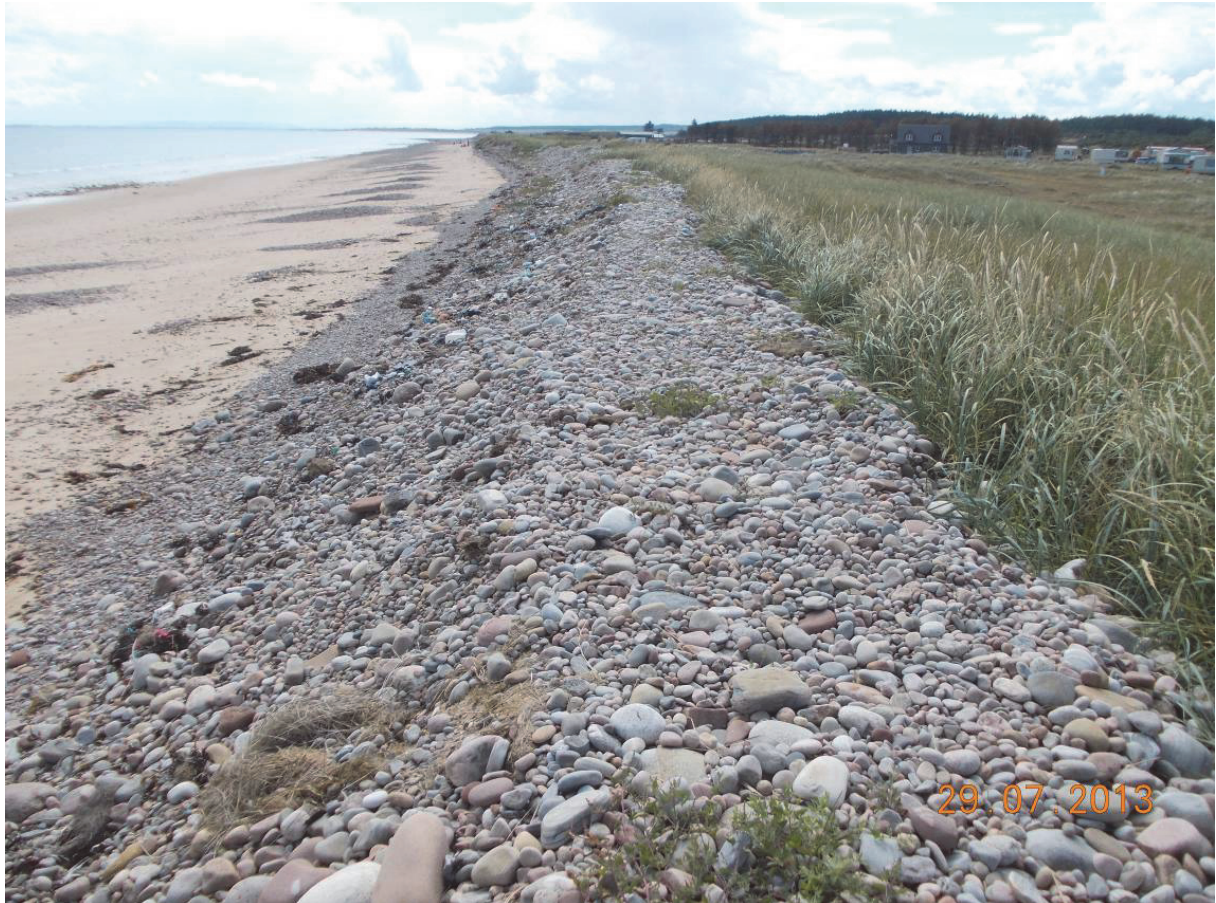
Figure 5: Reprofiled coastal ridge at the caravan park and lower land to the rear.

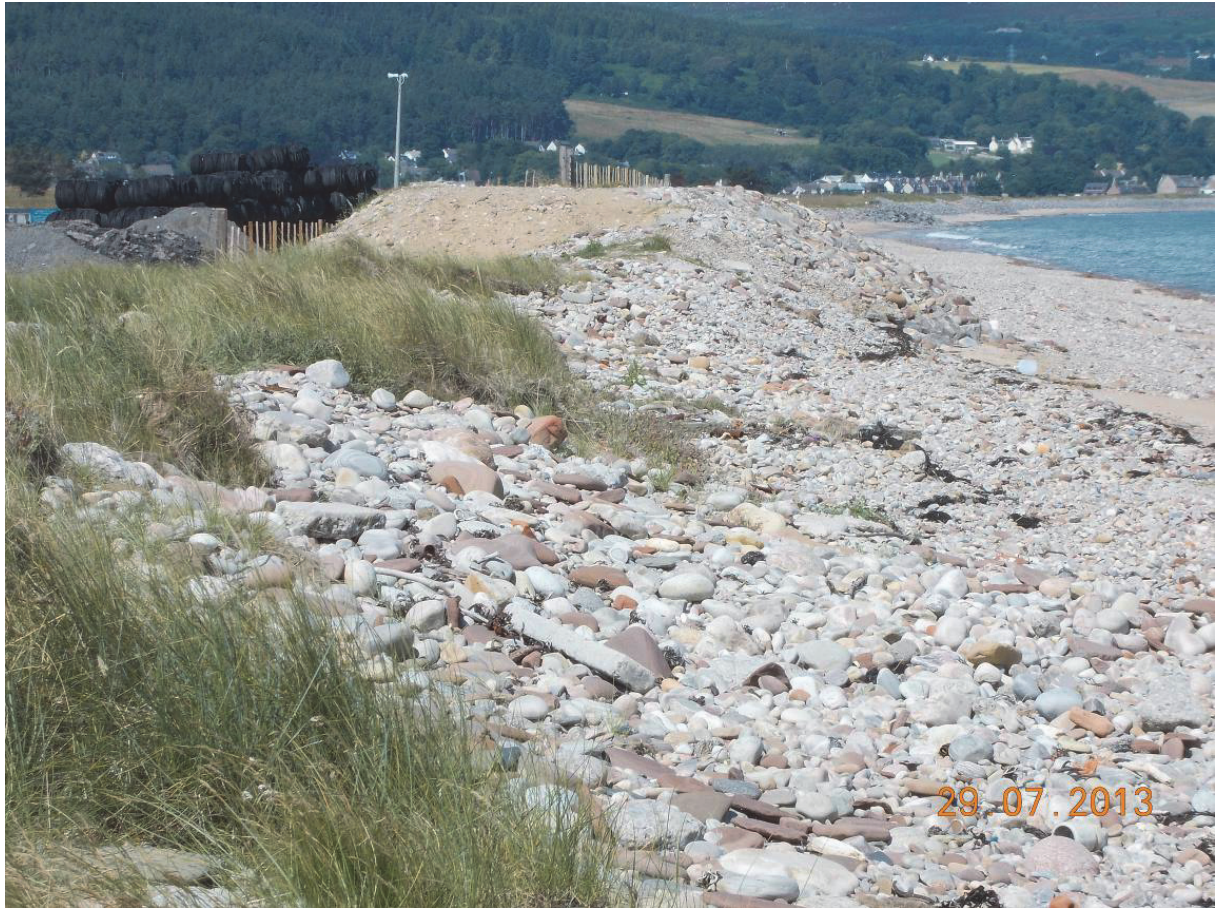
Figure 6: The Kart Track embankment lies 2m vertically above the height of the adjacent coastal edge to the south.

Another key point about the Kart Track embankment is its abrupt termination at the Kart Track boundary where it is replaced by a natural low gravel beach ridge whose altitude is a full 2-3 m lower than the crest of the embankment (Figure 6). Gravel overwash lobes at this point indicates that this area was overwashed during the 2012 storm with marine incursion onto the low-lying land behind.

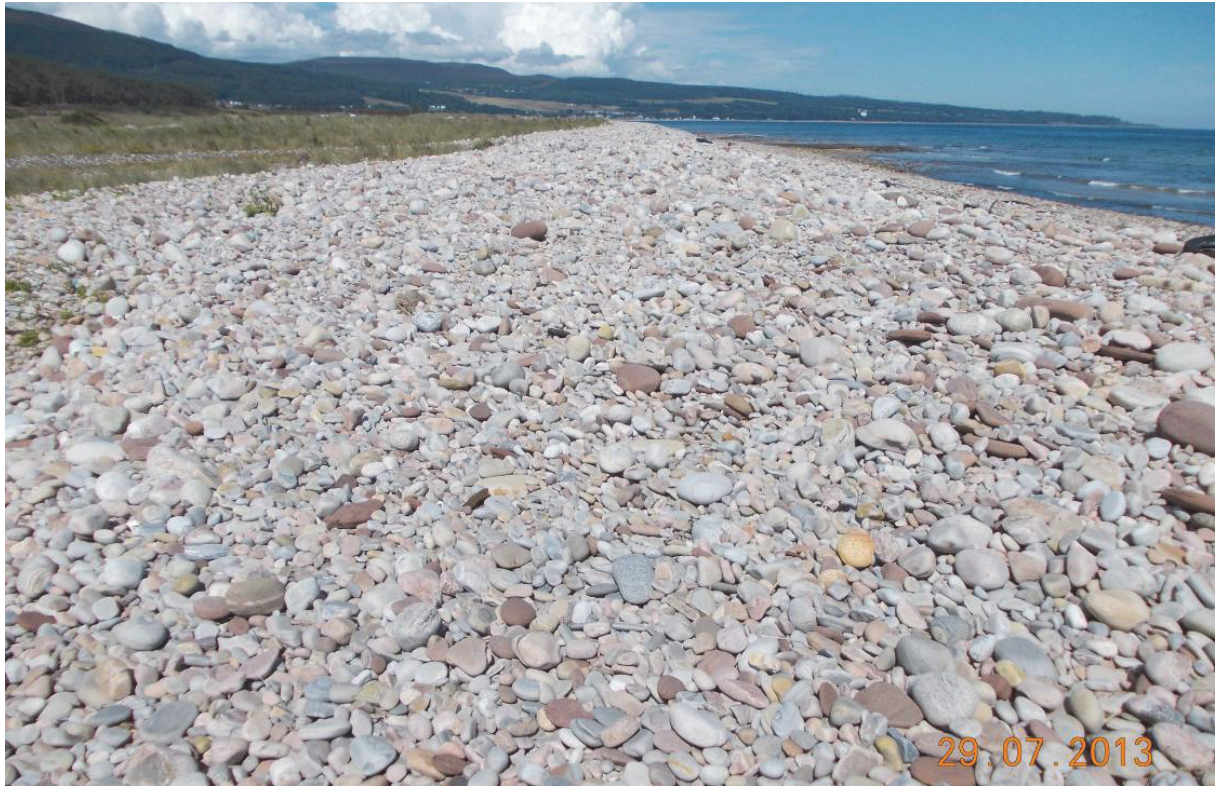
Figure 7: To the south newly deposited gravels form substantial coastal parallel ridges.

The beach and back beach to the immediate south of the Kart Track is composed mainly of medium sized gravels with a significant proportion of smaller concrete and brick rubble excavated from the eroding sections updrift. The upper and lower beach is dominated by a substantial gravel ridge (Figure 7) to just over 1km south of the Kart Track boundary where a substantial gravel and boulder bank extends seaward at MLWS and across which wave breaking can be observed. Smith and Mather (1973) note that these lower intertidal boulders appear to be immobile lag deposits and this appears to be currently the case. Although gravel ridges occur along the upper beach and gravel and boulders occur on the lower beach, to south of this point increasingly the lower beach becomes dominated by sand. Eventually the sand extends to include the upper beach with the low back beach ridges being replaced by low sand dunes that grow in height to the south and the Loch Fleet exit. It is clear that the greatest amount of planimetric change associated with the 2012 storm occurred within the NNR (particularly close to profile 81 with MHWS moving post-event by 70 m inland but this had stabilised at about 30-40 m inland by July 2013).

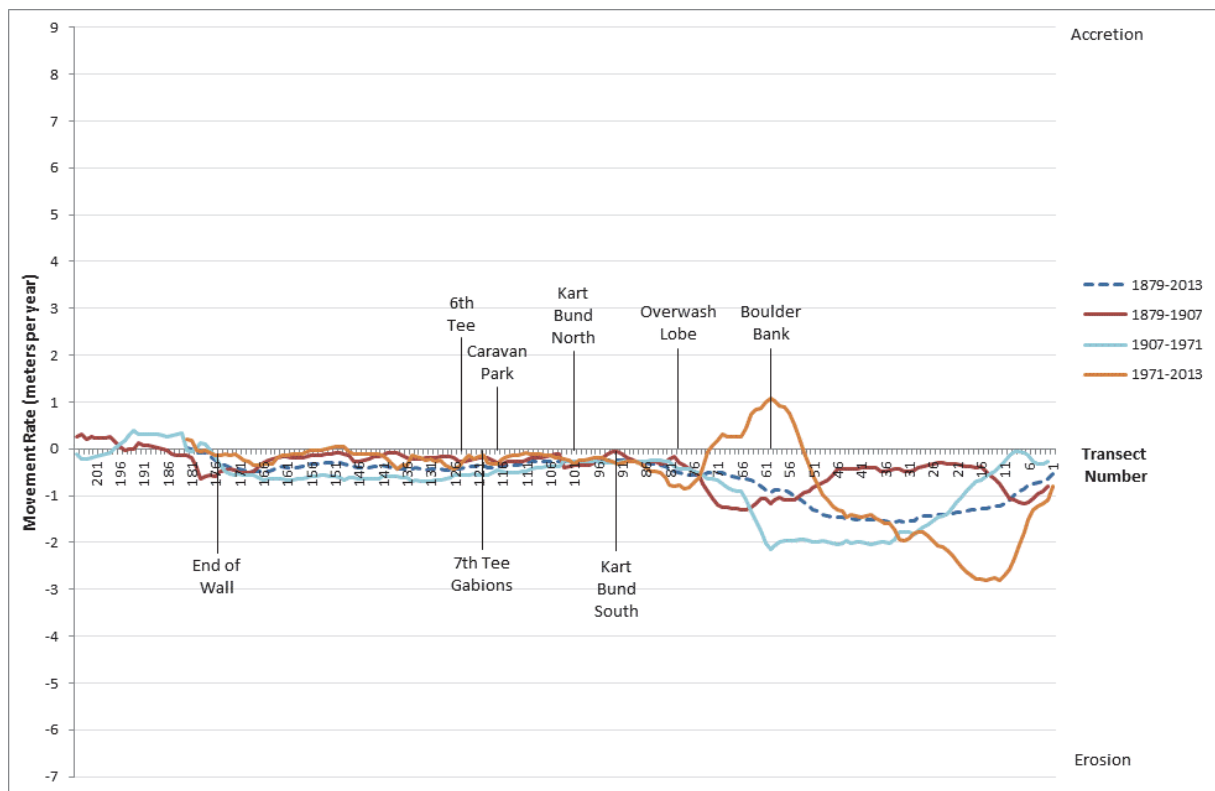
Figure 10: Mean High Water Spring Movement Rates (1879-2013).

Plotting the change in position of MHWS at each of the 205 cross-beach profiles allows rates of migration of the MHWS in each of the time steps to be graphed (Figure 10 & Annex). What this demonstrates is a long-lived landward movement in MHWS along much of the shoreface, an erosional trend that confirms the on-site observations reported over the years. The erosion between 1879 and 1907 was 0.5 m/yr in the north, rising to over 1m/yr in the south, including at the Loch Fleet exit, an erosional trend that accelerated between 1907 and 1971, particularly south from profile 80 where it reached 2 m/yr, an overall recession of 128 m. The inland trending suites of gravel ridges to the rear of the present beach profiles 64-52 are evidence of this erosion and mark the MHWS position at that time. North from profile 180 (the well end at Golspie town frontage) the construction of the cobble breakwater, made ground and early seawall construction can be seen with the MHWS either stabilised or accreted seaward by a small amount. Since the 1970s, much of the town and golf course frontage has been protected and this is shown in the stability of MHWS over the period 1971-2013. Between 1971 and 2013 profiles 71-51 accreted reversing the earlier erosion centred on profile 61. To the south of this point, erosion over the period 1971-2013 increased to 2.5 m/yr, albeit with slight decrease to 0.5 m/yr close to the Loch Fleet exit.

Taking the period 1879-2013 as a whole (dark blue dotted line) then the underlying trend is of a low coast that is susceptible to erosion of around 0.5 m/yr in the north increasing to 1.5m/yr in the south (Figure 10 & Annex). However, it should be noted that this overall trend masks a trend over the last 40 years of engineered stability in the north and natural erosion in the south with an area of accretion at the junction (profile 61) marked by the recent construction of a new gravel ridge (Figure 7). The rate of coastline erosion along the unprotected frontage of the Kart Track and caravan park (profiles 102-120 on Figure 10) should be approximately the same as that along the protected rock armour revetment of the golf course north of profile 120 may be related to unofficial efforts of the managers of this stretch to replenish the eroding frontage with soft erodible sediments in order to slow erosion rates.

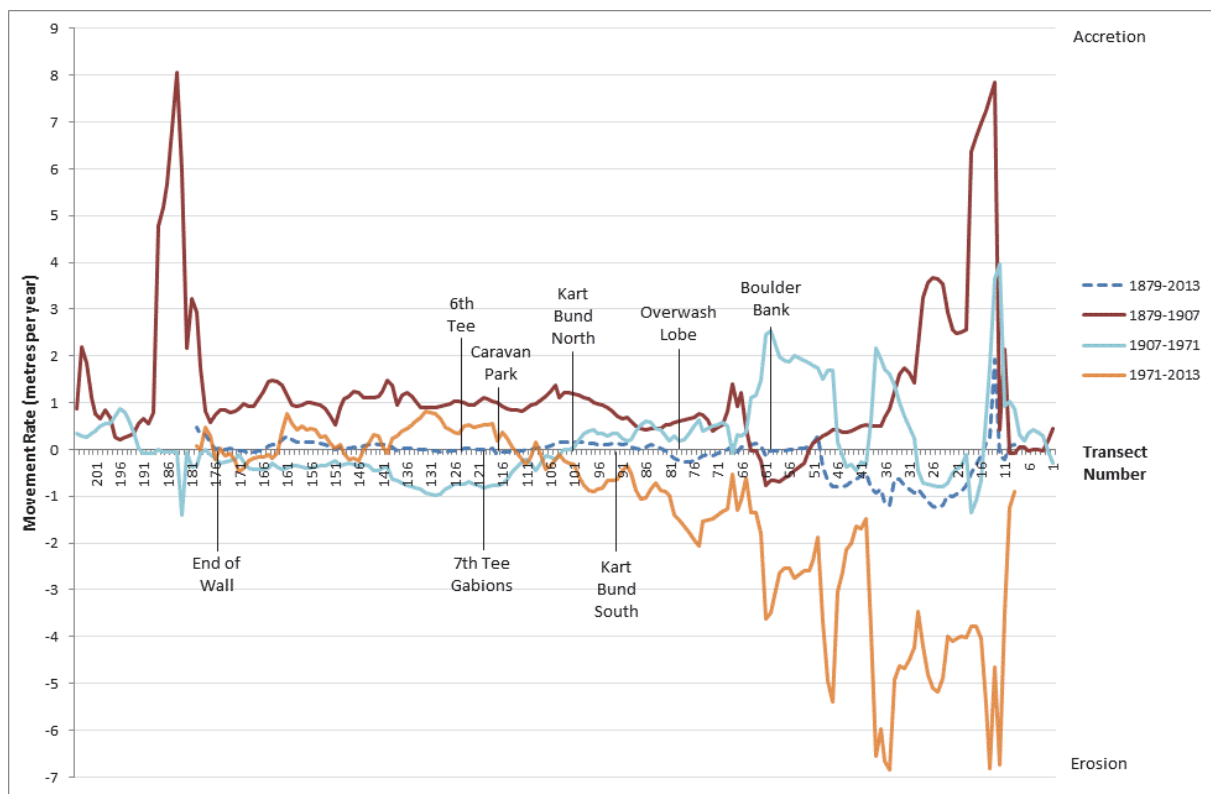
Figure 11: Mean Low Water Spring Movement Rates (1879-2013).

In comparison with the movement of MHWS, the rate of movement of MLWS is much more variable (Figure 11), which is often the case (Hansom, 2010). Over the period 1879-1907 (brown line), MLWS accreted seaward at Golspie by up to 8 m/yr on account of sediment moving south to be trapped updrift of the early timber pier at profile 180 (end of the Golspie sea wall). South of this the MLWS largely accretes seaward at an average rate of about 1 m/yr over this period, except close to the Loch Fleet exit where accretion occurs (Profile 16).

The period 1907-1971 (light blue line) shows a change in the balance toward an erosion rate of 0.5-1m/yr in the north and accretion in the south, largely in agreement with an expectation of sediment movement southward. 1971-2013 (orange line) reveals a low rate of MLWS accretion north of profile 120 and an accelerating but variable rate of erosion to the south of up to 7 m/yr. Overall the period 1879-2013 was characterised by MLWS movement seaward and landward and resolving into an approximately stable position in the north and a slight tendency toward erosion in the south with the exception of the Loch fleet exit where accretion dominates. However, it should be noted that this overall trend masks a trend over the last 40 years of erosion and landward movement of MLWS.

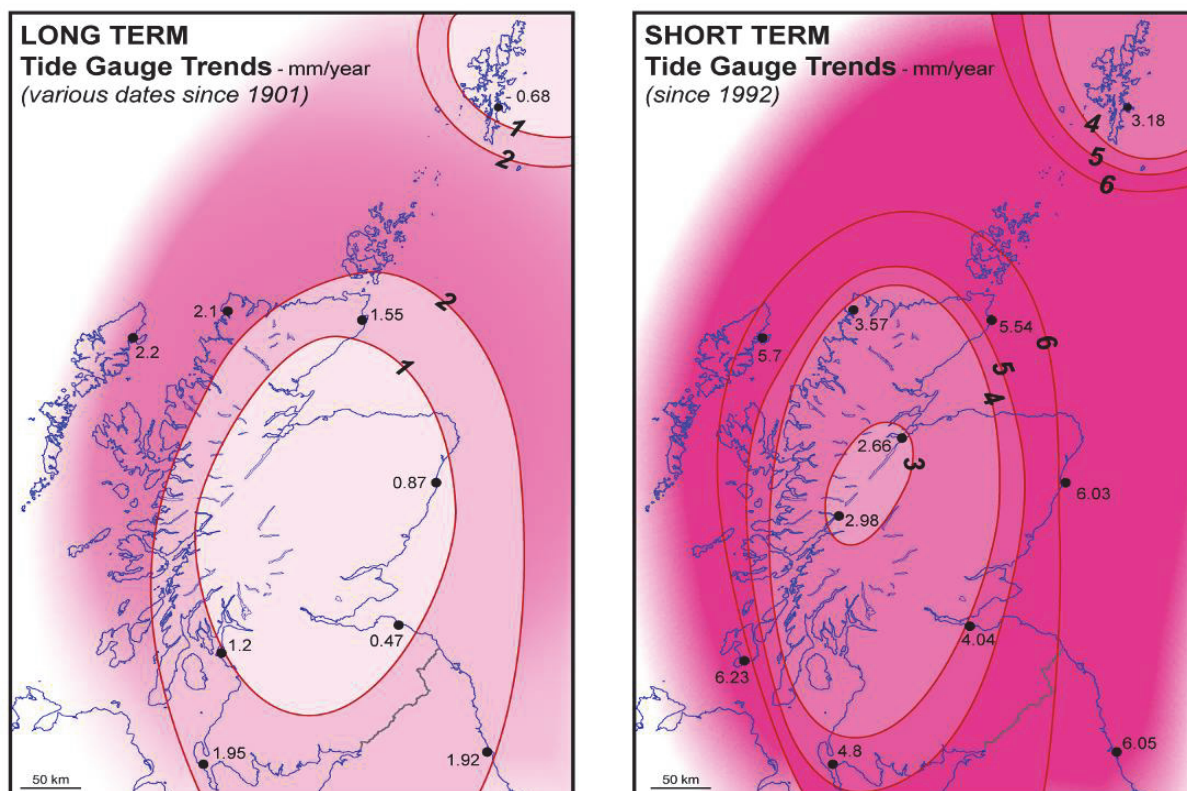
Figure 13: Short term tide gauge trends reflect an increase in relative sea level rise since 1992 over long term rates (from Rennie and Hansom, 2011).

Although it is known that isostatic uplift wanes over time, the rates are imprecise with Shennan and Horton (2002) placing rates in the Golspie area at about 0.7 mm/yr. Crucially, however the rate of global sea level has recently increased to exceed the uplift rate and tide gauges suggest that RSL may now be rising in the Golspie area by between 1 mm/yr and 4 mm/yr depending on the time period sampled (Rennie and Hansom, 2011) with the more recent time period agreeing with the global sea level rise figures of 3.4 mm/yr (Figure 13) (<http://www.ngs.noaa.gov/GRD/GPS/Projects/CB/SEALEVEL/sealevel.html>). It seems likely that if RSLR is increasing at a faster rate than previously then this will increase coastal erosion rates since waves access the coast at a higher level.

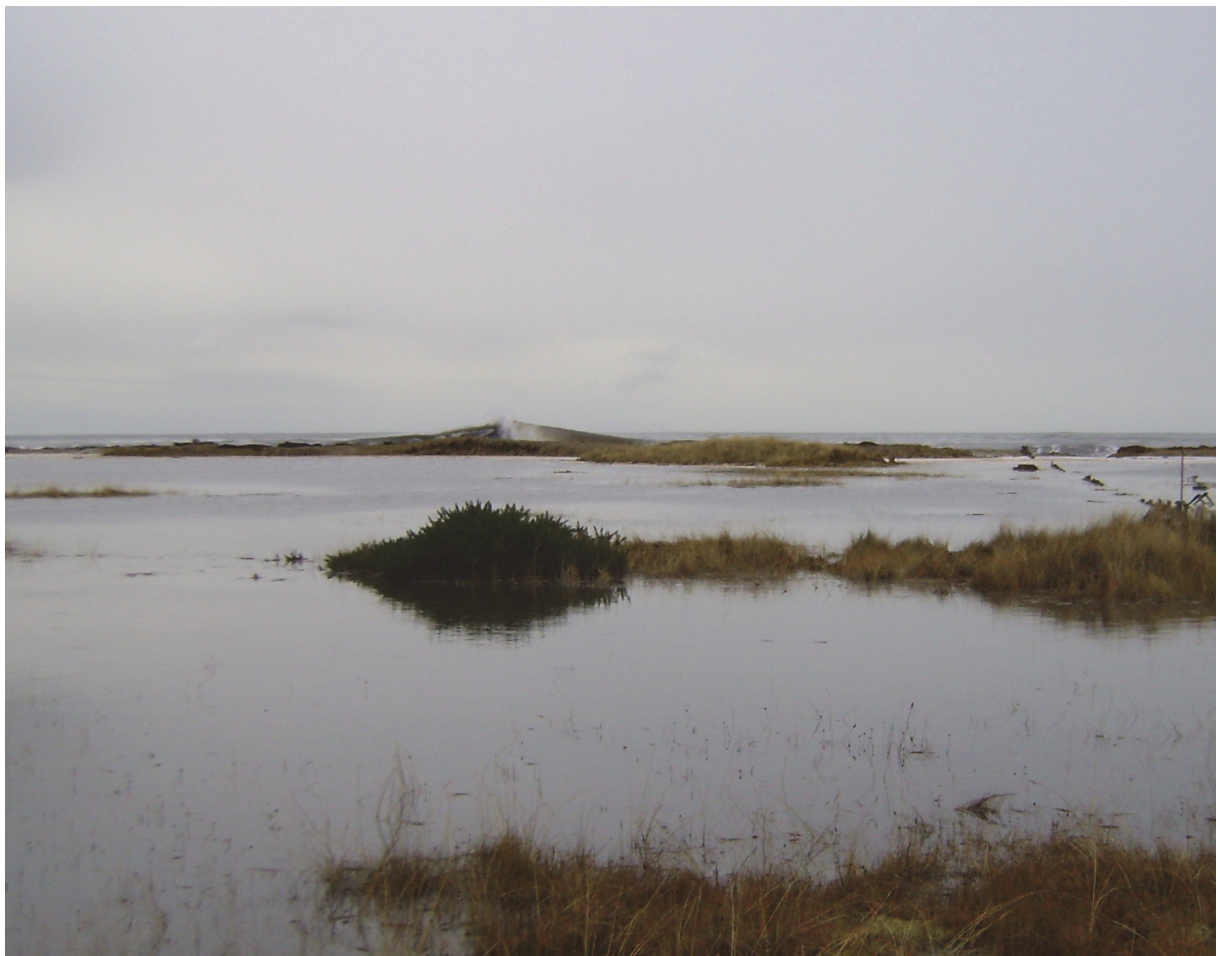
Figure 15: Large peaked wave at the 7th tee, 15 December 2012 (Photo: Neil Morrison).

The coastal edge was lowered and overtopped at this point. Ground photography taken at this position during the storm on 15th Dec 2012 clearly shows the boundary fence of the caravan park (at profile 120) and two areas of overwash, one at the boundary fence and one at the 7th tee, both of which led to flooding of the low lying area behind (Figure 15).

The centre distance of the photograph clearly shows an unusual triangular apex which is an exceptionally large partially broken wave. Such peaked waves are common where a reflected wave generates positive interference on interaction with an incoming wave, resulting in a higher wave than would otherwise be expected at this point. At this site, and under the conditions experienced in December 2012, it is very likely that waves at this location were reflected southward from the end of the rock armour at the 7th tee (possibly augmented by reflection at the 6th tee) and then positively interacted with incident waves to the south to produce higher waves than otherwise would have been the case at this point. Higher waves produce higher wave run-up than on adjacent stretches and the local conditions for enhanced erosion and overwash are enhanced.
