**MOLLINSBURN ROAD CUTTING  
SITE OF SPECIAL SCIENTIFIC INTEREST**

**SITE MANAGEMENT STATEMENT**

**Site code: 1177**

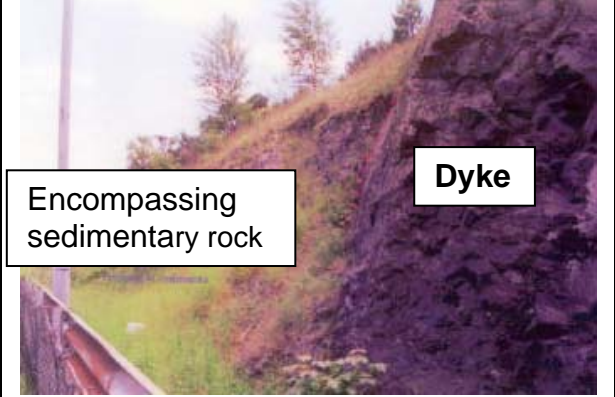
<p>The contact between the Lenzie-Torphichen Dyke and surrounding sediments.</p>	<p>A view from the edge of the M80 looking west onto the central section of the site and Mollin Craigs.</p>

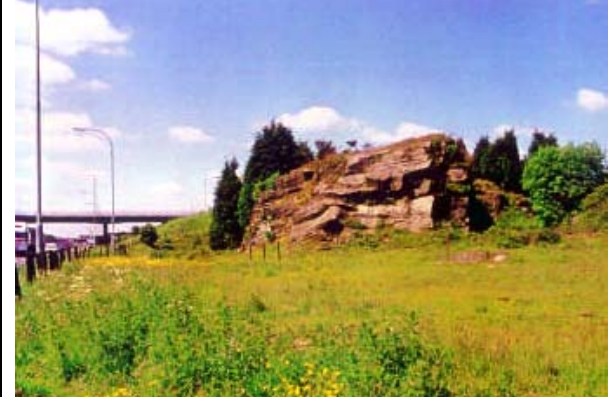
Grasses and heather are currently obscuring the visibility of some of the exposures, and rhododendron and conifers are hampering access. The encroachment of this vegetation needs to be dealt with before it is allowed to spread any further, when it will become less manageable and cause further deterioration of the natural feature. Scrub clearance, and in addition waste removal, is required in the western sections of the site, and rhododendron and large conifers need to be removed at Mollins Craigs (the native trees growing on the Craigs can be retained as they are having a minimum impact on access and visibility).

- 2. To improve the visibility and accessibility of the rock exposures** by removal of the vegetation (particularly non-native species) which has encroached within 10m of the exposures using hand-tools, removal of the waste soil and building material that has been dumped next to the rock faces, and by the erection of stiles to enable easier access over fences.
