Alder Woodland – Tree condition assessment survey:

Mound Alderwoods Site of Special Scientific Interest and Special Area of Conservation

Commissioned Report No. 499

Hendry, S.J. & Edwards, C.E. (2012). Alder Woodland – Tree condition assessment survey: Mound Alderwoods Site of Special Scientific Interest and Special Area of Conservation. *Scottish Natural Heritage Commissioned Report No. 499*

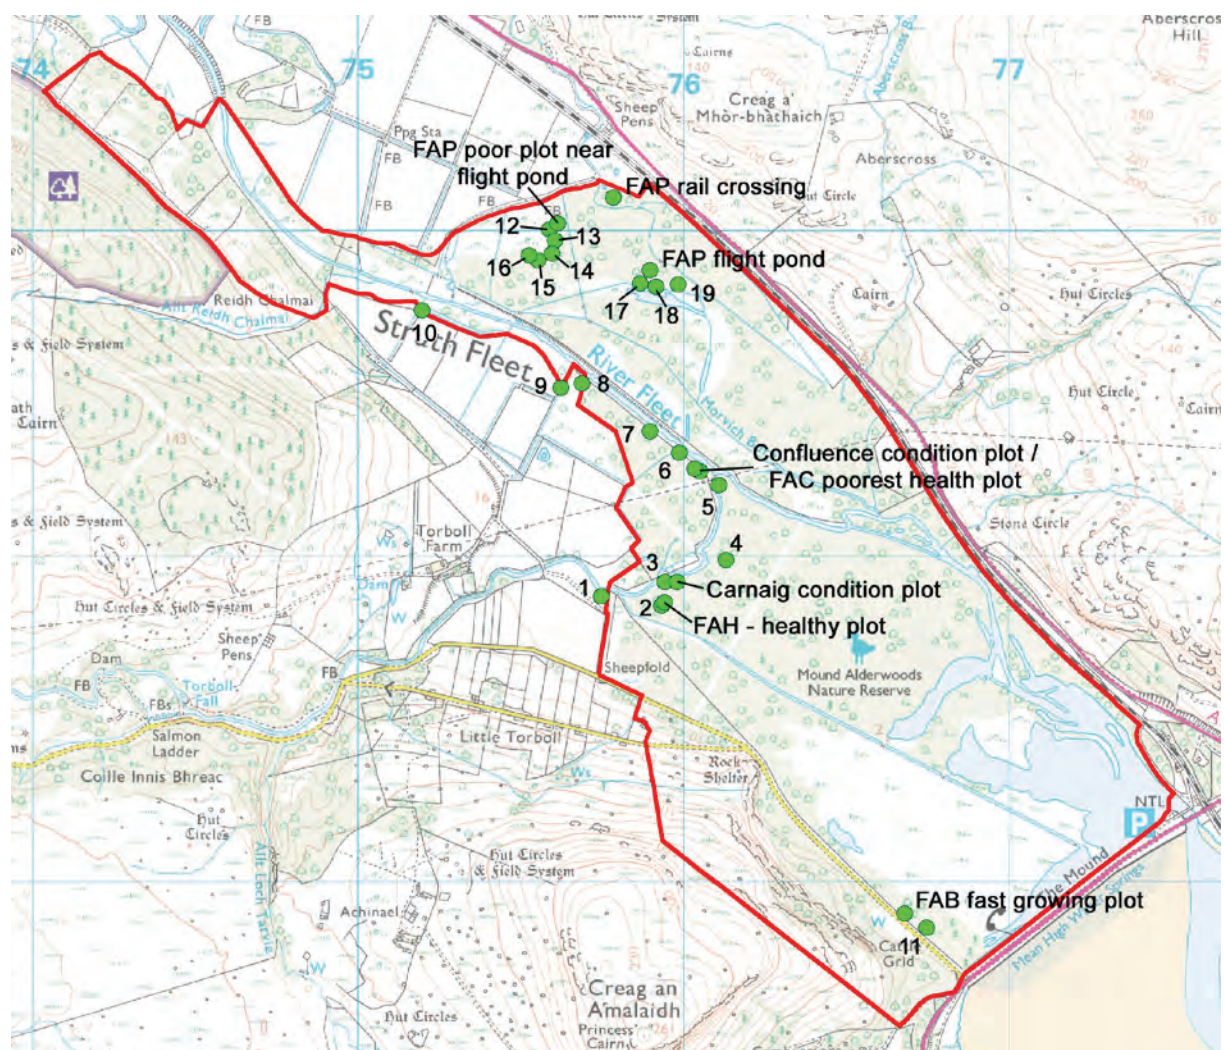
Figure 2: Locations of points at which observations were conducted, pathological investigations undertaken, condition plots established or dendrochronological samples taken. (© Crown copyright and database right [2012] All rights reserved. Ordnance Survey Licence number [100021242])

Observations of the symptoms displayed by alders were made at each of the locations indicated in Figure 2. Current dieback was not evident on trees located at points 1, 2, 3, 11, FAH healthy plot, Carnaig condition plot, FAB fast growing plot, or FAP rail crossing. These locations were generally slightly elevated in relation to the remainder of the site, being located either at its margin or along access routes where the ground level appeared to have been built up in the past. Elsewhere, the crowns of alders were noticeably thinner and more chlorotic³ than would be expected in completely healthy trees and their branching systems displayed varying degrees of dieback. Dieback was most severe in the vicinity of point 17, where mortality of occasional mature trees had occurred, and near points 5 and 6 where alder stools bore little foliage and dieback extended from the twigs and fine branches into the structural branches of many trees. Mortality of trees was also evident to the north of the Fleet opposite the length of riverbank between points 5 and 8, although ground conditions at the time of the visits prevented closer scrutiny of these particular alders.

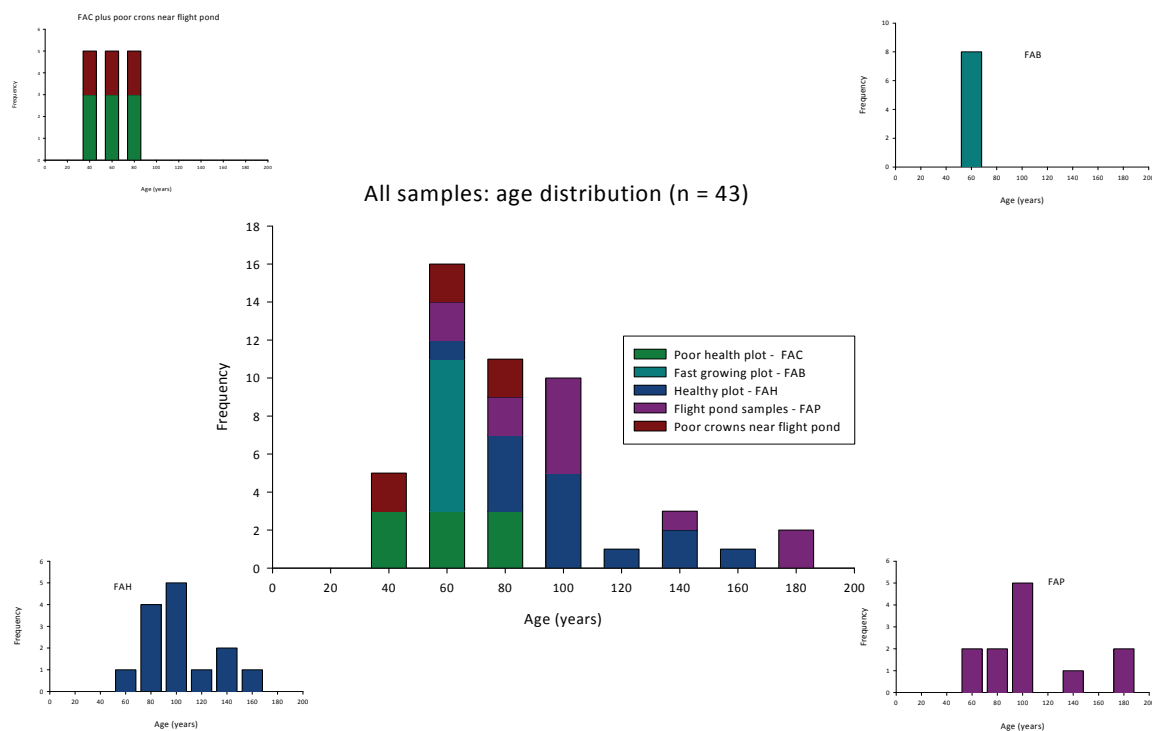
Figure 8: Age distributions for the alder samples.

A total of 49 individual alder and 9 ash tree samples were collected and analysed from four main areas. The oldest alder samples were 173 and 167 years old (recruited in 1858 and 1873 respectively) and were both located near the railway crossing in the north western corner of the site (FAP, Figure 2) on relatively dry ground. This site had predominantly young trees in a matrix of older mature and over mature individuals (Figure 8). A major period of recruitment occurred on this site 60 – 80 years ago (1930 – 50) especially in the area near to the flight pond.

The area near the healthy plot (FAH, Figure 2) also had a wide distribution of ages (see Figure 8) with a mix of old mature trees from the initial establishment phase (1830's – 70's) and another more recent recruitment from 1910 onwards. This site included numerous ash trees of which the oldest sampled was recruited around 1870 (133 years of age), while others were recruited in the late 1920's and 30's (Figure 9).

The youngest recruits were from the unhealthy plot (FAC, Figure 2) near the river confluence, and samples collected from an area close to the flight pond near to an area of cut grass. Here the age distribution was restricted to trees recruited between 1934 and 1974. Although larger, and presumably older trees, existed in the area close to the trees on the raised bank of the road, these were not aged due to rotten centres.

Interpretation of the age distributions would benefit from detailed management history for the site. It is possible that a change in management of the area occurred in the late 1890's to 1900 which allowed the rapid recruitment of a cohort of young alder. Another such recruitment period occurred between 1950 and 1960. However, care must be taken interpreting these trends as the pattern could reflect the sampling process and not be completely representative of the true age distribution across the entire site. It is interesting to note that many poor-crowned trees are located in areas of restricted age distribution and are relatively young compared with other sampled areas.

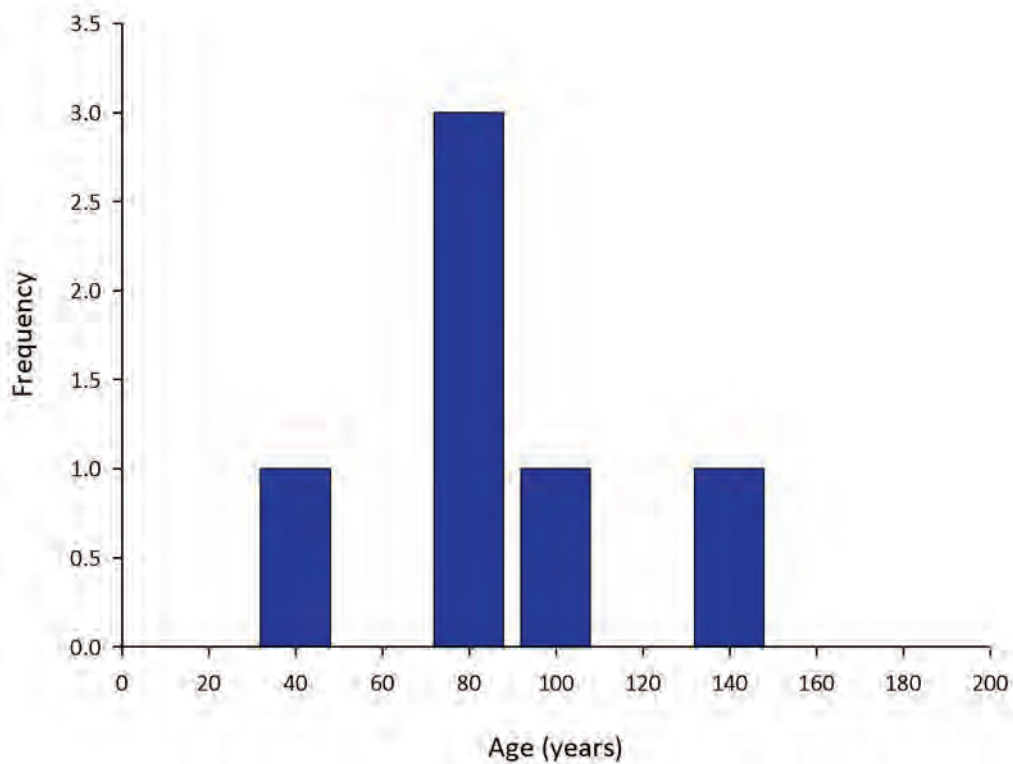
Figure 9: Age distribution for the ash samples

In addition to the alder trees that were sampled, several European ash (*Fraxinus excelsior*), which were intermixed with the alder in the healthy plot were sampled to act as a comparison between two species growing on the same site. The ash age distribution is presented in Figure 9.

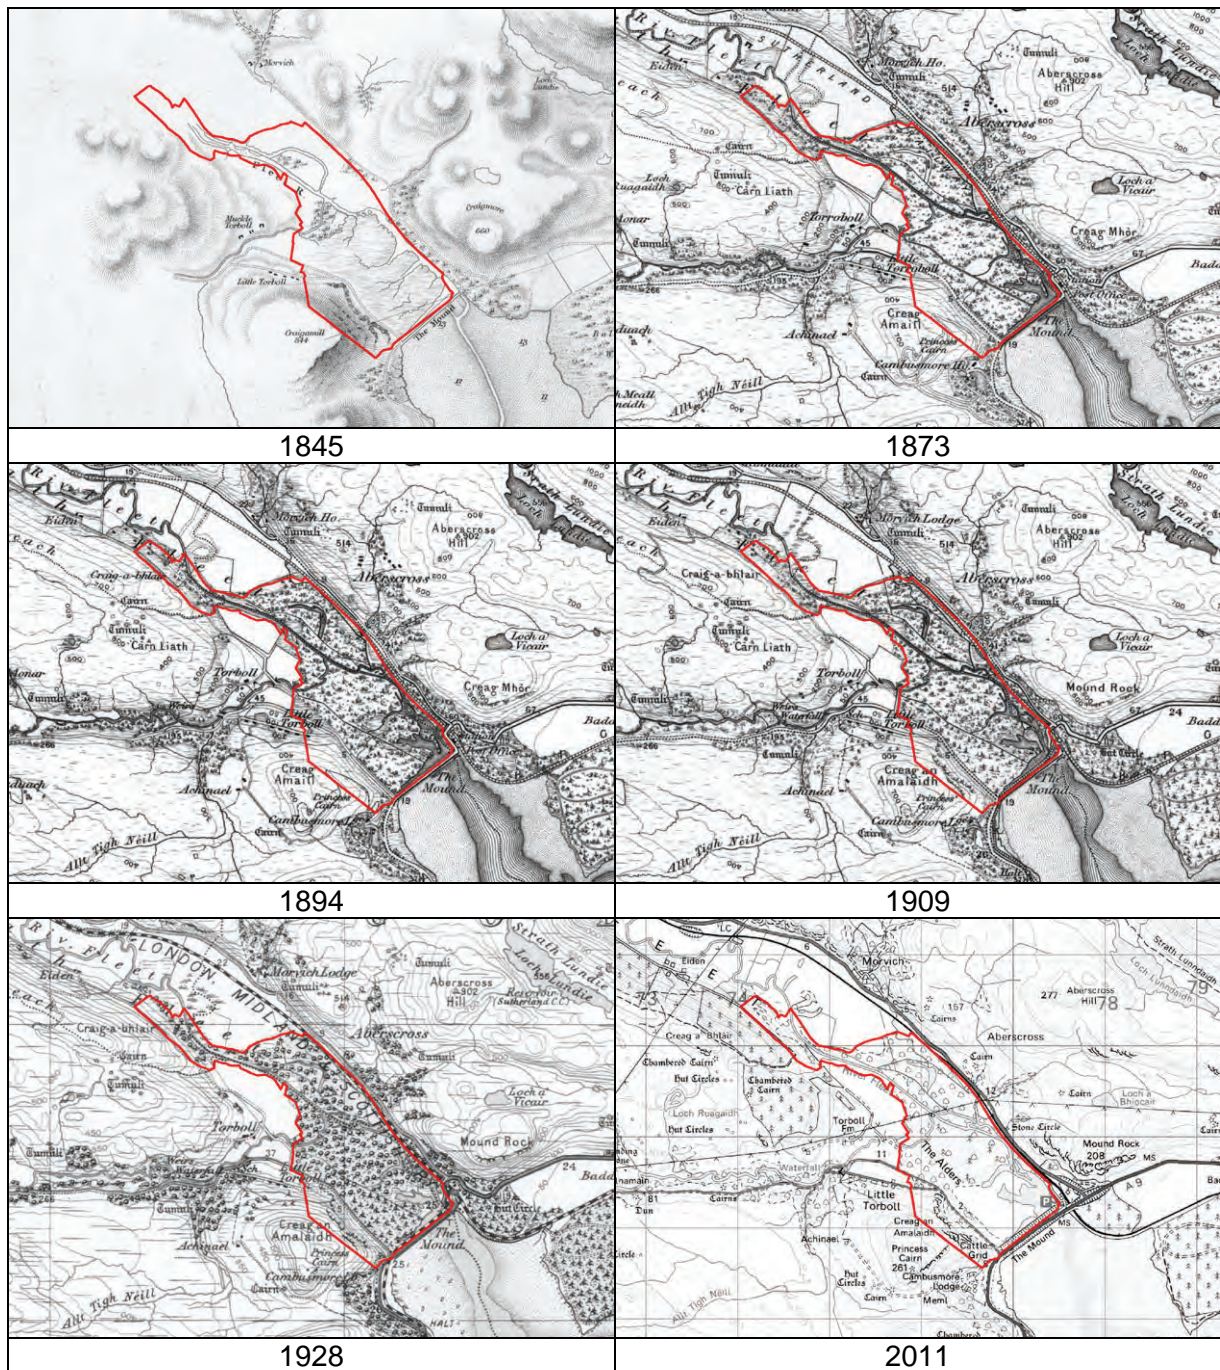
Figure 13: Historical 1 inch maps (or equivalent) of the Mound Alderwoods area from 1845 to the present. The year of the survey or revision upon which each map is based is shown below it. (© Crown copyright and database right [2012] All rights reserved. Ordnance Survey Licence number [100021242]).

Examination of the historical maps which are available for the Mound Alderwoods area shows that tree cover was extremely restricted in 1845, approximately 30 years after the construction of the tidal barrage (Figure 13). Indeed, the distribution of the trees which are shown suggests that they might well have been established before the Mound was built.

No signs of drainage or other earthworks within the area of the Mound Alderwoods are evident on the 1845 Admiralty map but such features are clearly visible on the first Ordnance Survey map based on a survey conducted in 1873, which shows that a number of major drainage channels had been dug across the site in the intervening period. By 1873 it is also clear that tree cover within the Mound had reached almost its current extent, although the composition of the woodland which is indicated suggests that conifers were quite widely distributed across the area. Little alteration in the disposition of the water courses within the site is seen after 1873 but there is a strong indication that woodland composition changed, and this is particularly evident in the southern corner of the site where the maps based on surveys in 1909 and 1928 show the presence of an almost pure conifer stand. Contrastingly, current mapping evidence shows this area of the site as having a covering of scrubby vegetation with no established woodland cover in the area.
