TROON GOLF LINKS AND FORESHORE SITE OF SPECIAL SCIENTIFIC INTEREST

SITE MANAGEMENT STATEMENT

Site code: 1565

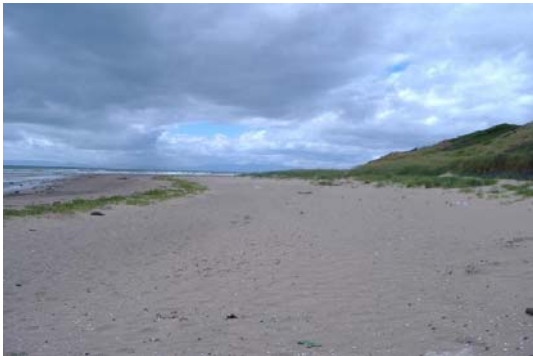
Front page photograph: View of south end of SSSI looking north, north of the estuary and showing existing strand line and foreshore (as at 19 June 2008).
