**HEWAN BANK  
Site of Special Scientific Interest**

**SITE MANAGEMENT STATEMENT**

**Site code: 779**

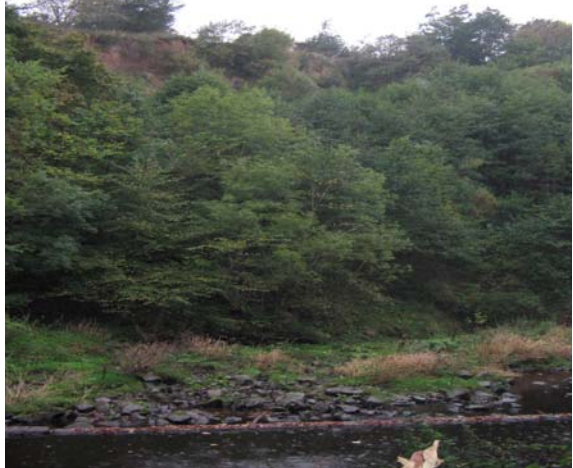
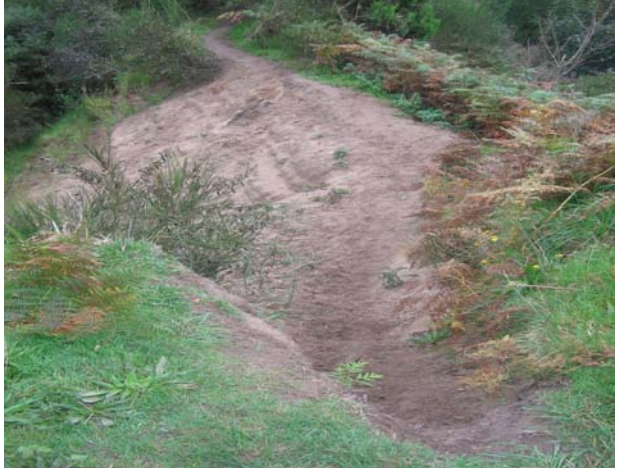
The 2006 site condition monitoring (SCM) assessment of the feature found it to be in an 'unfavourable-declining' condition. This was on account of developing tree and scrub cover which has obscured the sediment bank. However the area is prone to land-slippage and, following the SCM survey visit, a series of land-slip events occurred, resulting in the key exposures of the two types of till being buried under a layer of soil. This overlying soil layer has since re-vegetated with developing scrub. The uppermost unit of gravel and the middle unit of sand are currently visible although actively eroding.

Scrub/woodland encroachment	Path/bank erosion

Despite the provision of an alternative route, the original 'Right of Way' ridge path route is currently still used by equestrians, pedestrians and mountain bikers alike. This knife-edge route is particularly precarious and susceptible to land-slip/erosion with ongoing concerns for public safety and its use should be actively discouraged.

- 1. Maintain access to rock sediment banks through the removal of vegetation as appropriate.**
- 2. Remove non-native trees in order to restore the semi-natural nature of Hewan Wood, in keeping with the neighbouring woodland SSSIs.**
- 3. Maintain SSSI interpretation panels and manage areas around panels for amenity and access.**
